EC-2601

I-20/26/126 Corridor Improvement Project

6' x 6' RCB

Client: SCDOT

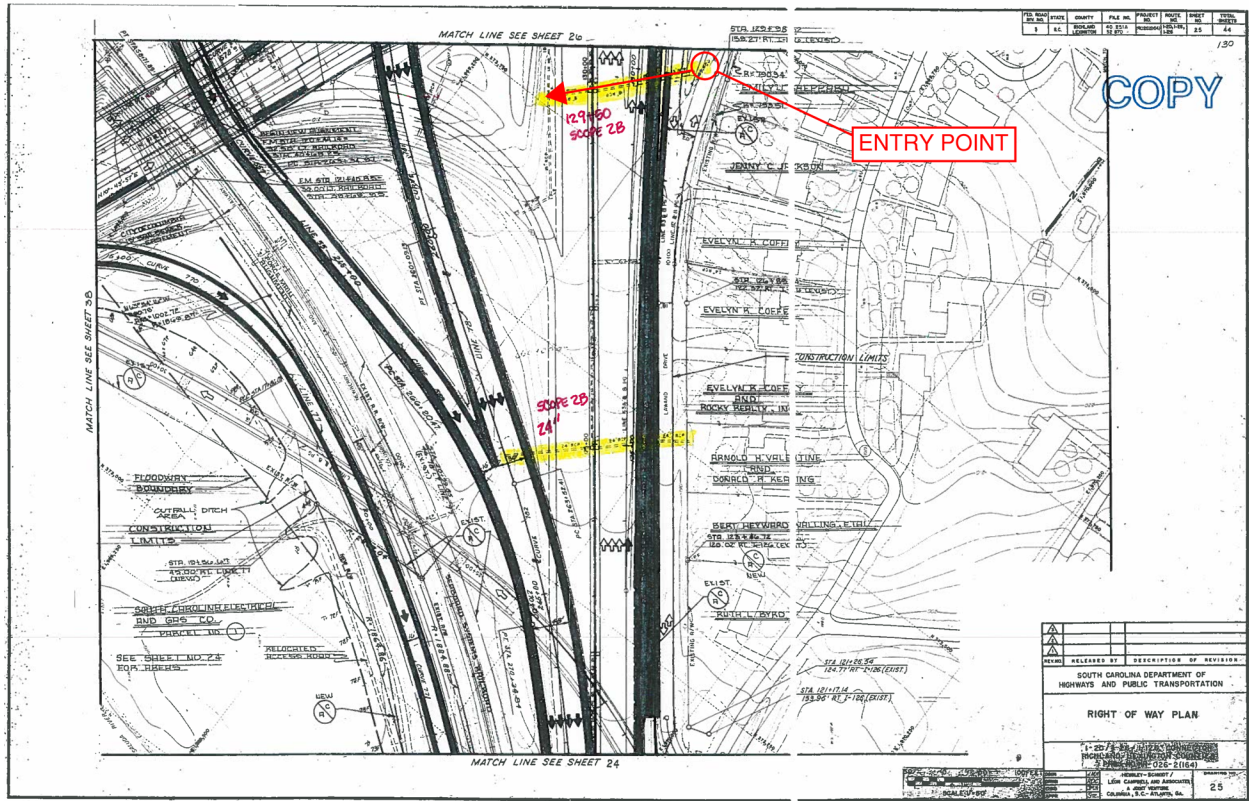
I-126 Station 129+50

- Dimensions: Verified 18-inch RCP, Approximately 400 LF
- Observations
 1. Joint at approximately 26-feet (South of entry)-chipped
 2. From approximately 26-feet to 48-feet (South of entry)-sediment buildup
 3. Southbound pipe blocked by old grate and trash. Pipe needs to be cleaned to continue.
- Recommendations
 1. Clean pipe.
 2. Further recommendations cannot be made as entire pipe was not able to be inspected.

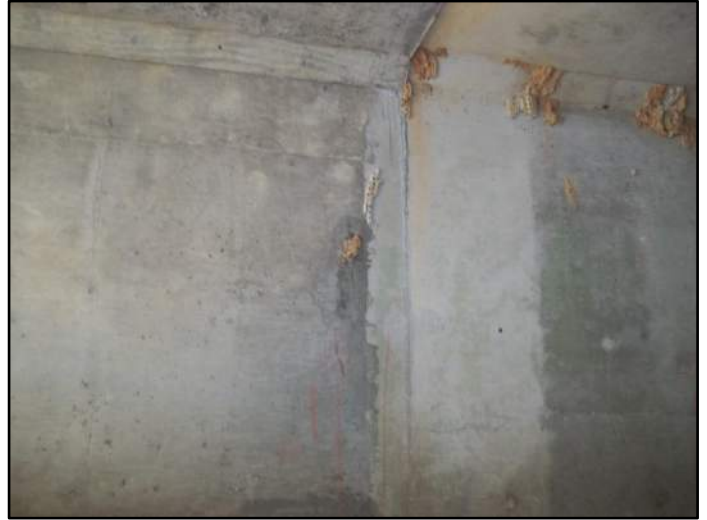
15' – Lt side
Transverse Cracking

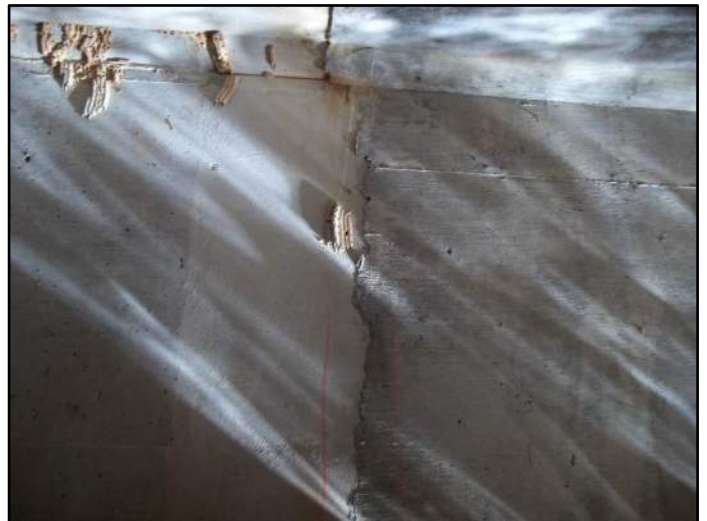
15' – Rt side
Transverse Cracking

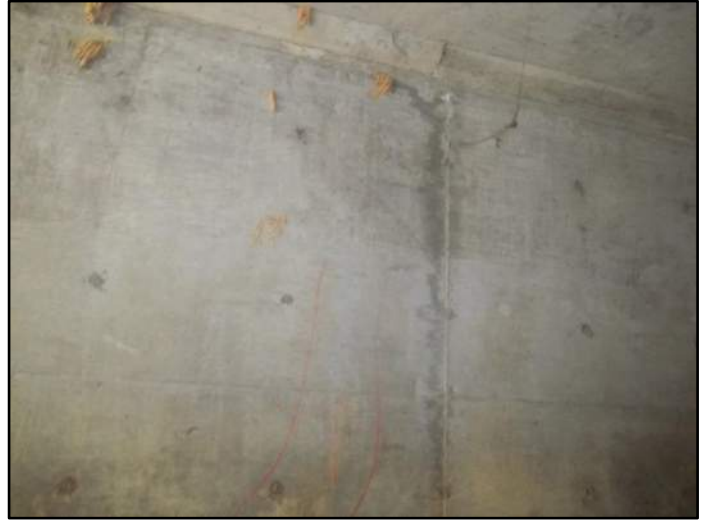
30' – Lt side
Transverse Cracking

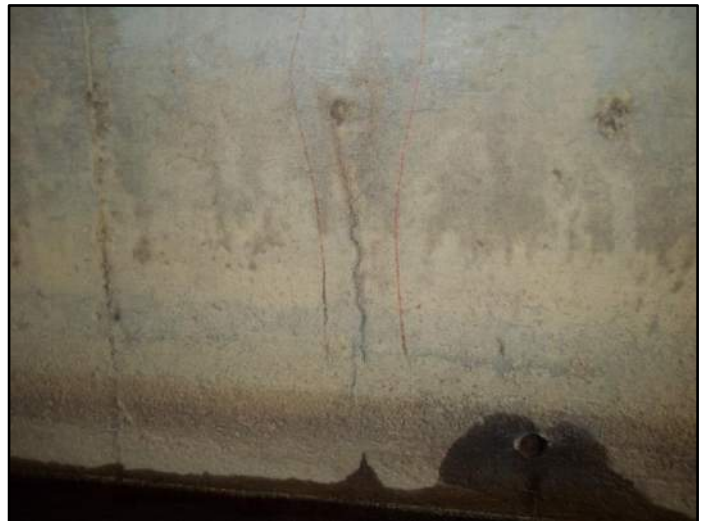
30' – Lt side
Transverse Cracking

30' – Rt side
Transverse Cracking

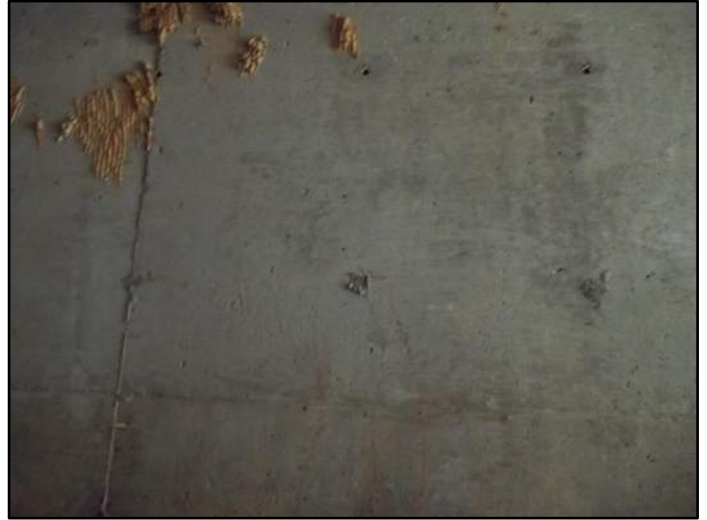
30' – Rt side
Transverse Cracking

40' – Rt side
Transverse Cracking

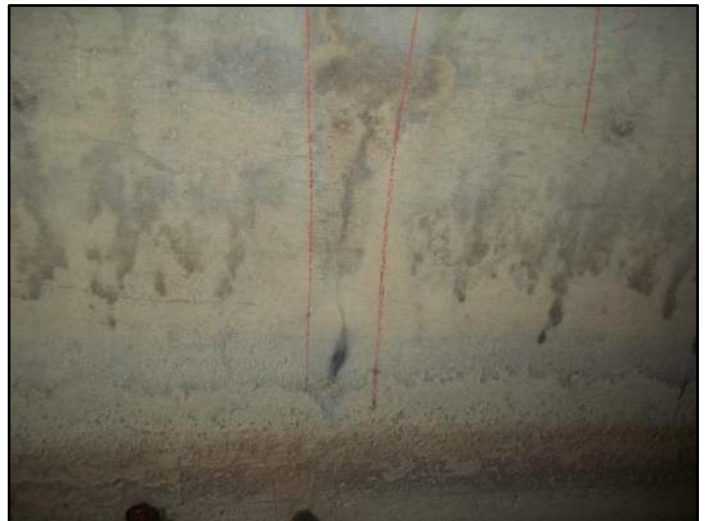
40' – Rt side
Transverse Cracking

43' – Lt side
Transverse Cracking

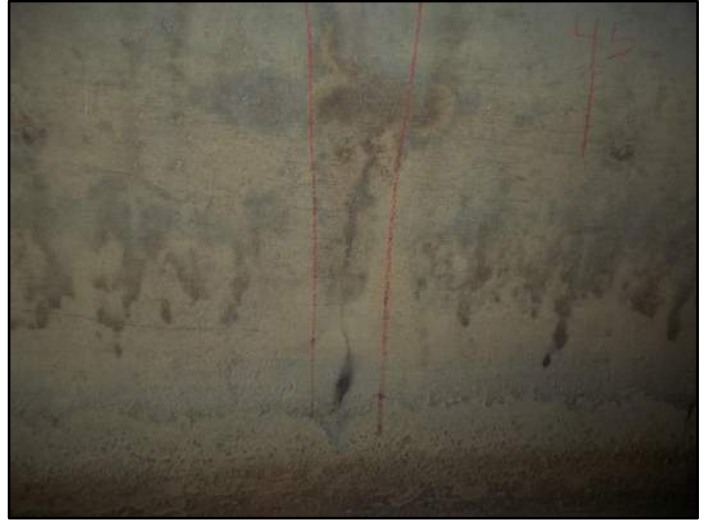
100_5509

43' – Lt side
Transverse Cracking

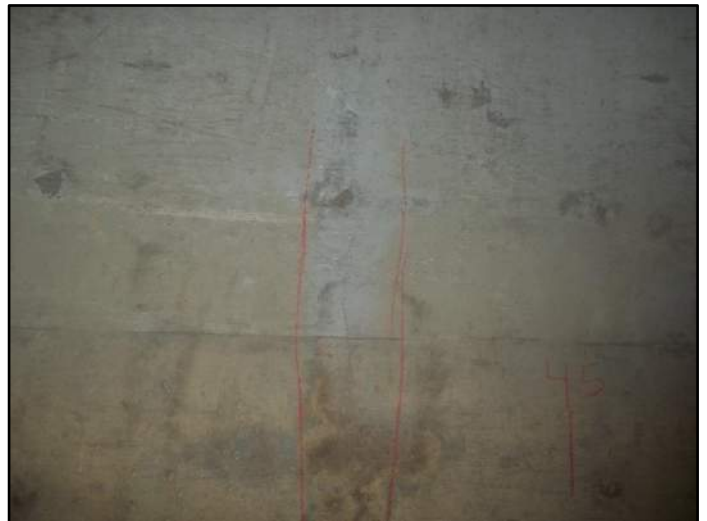
100_5511

43' – Lt side
Transverse Cracking

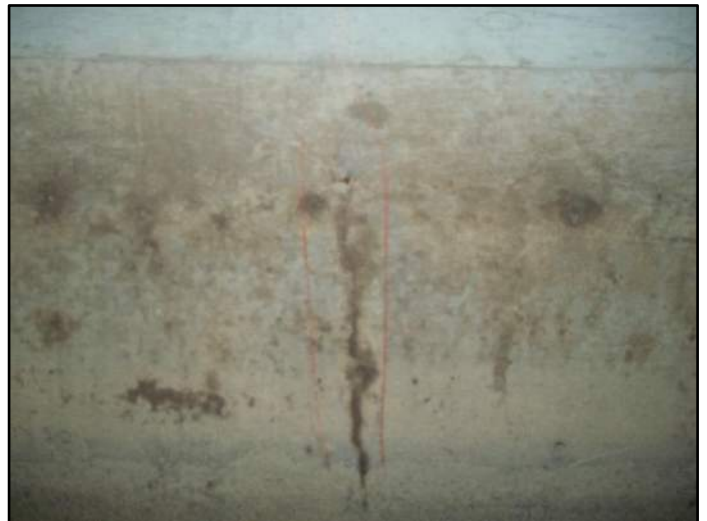
66' – Lt side
Separation at joint

91' – Rt side
Transverse Cracking with exposed rebar

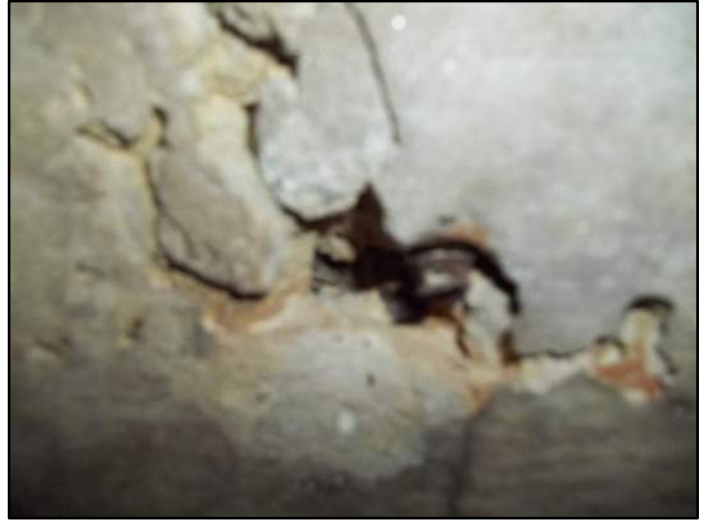
91' – Rt side
Transverse Cracking with exposed rebar

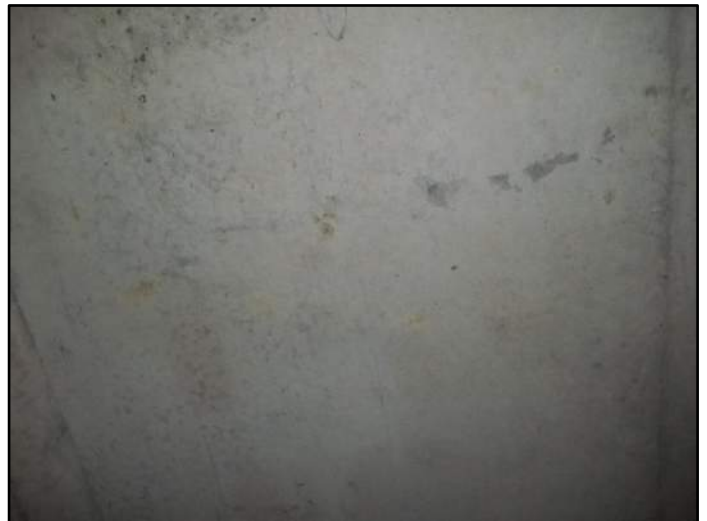
91' – Rt side
Transverse Cracking with exposed rebar

93' – Top
Transverse Cracking

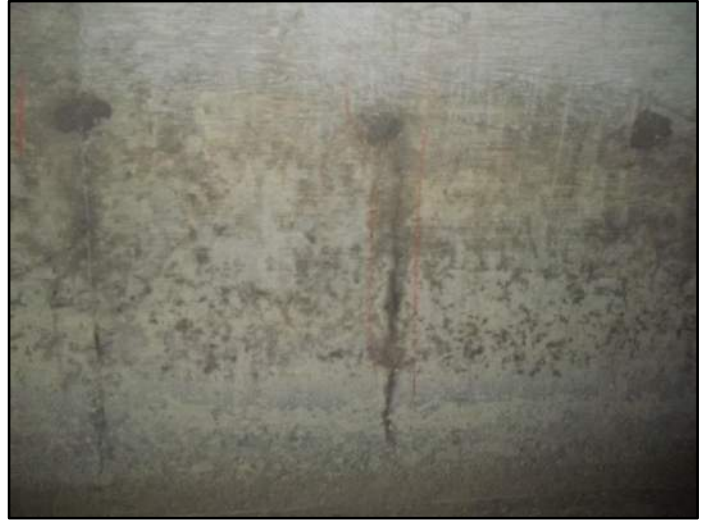
93' – Top
Horizontal crack

97' – Lt side
Vertical crack

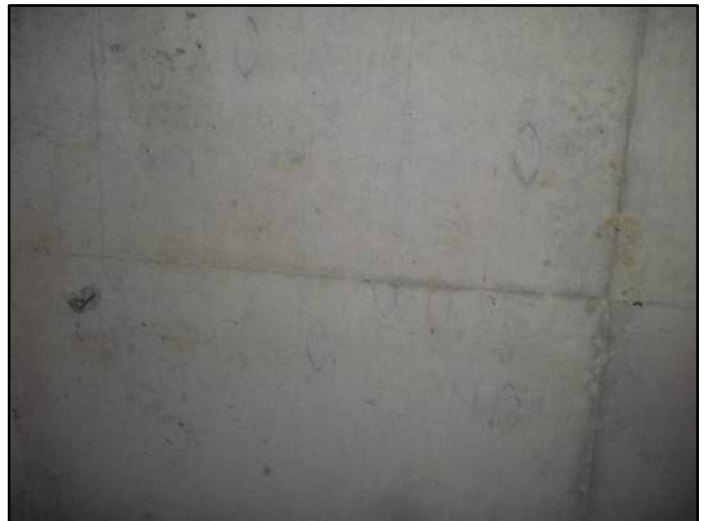
97' – Lt side
Transverse Cracking

97' – Top
Transverse Cracking

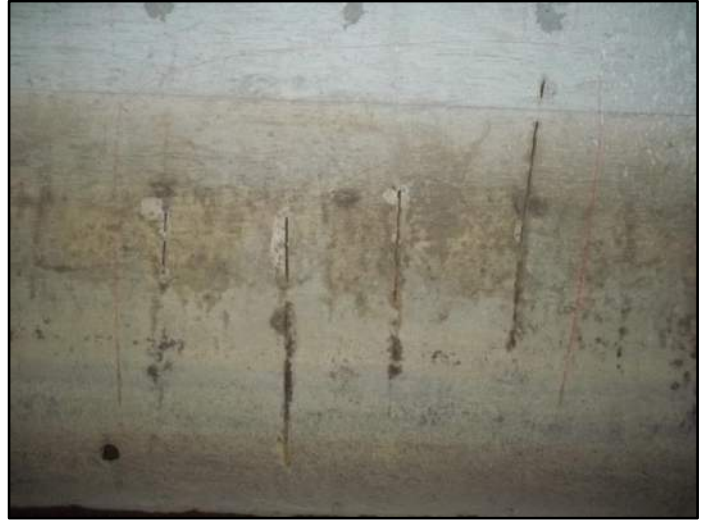
97' – Top
Transverse Cracking

98 – 102' – Rt side
Exposed rebar

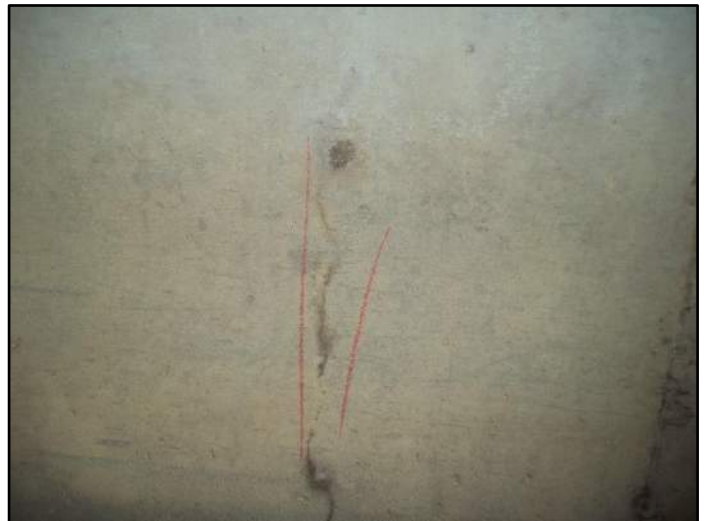
125' – Lt side
Separation at joint

139' – Rt side
Transverse Cracking

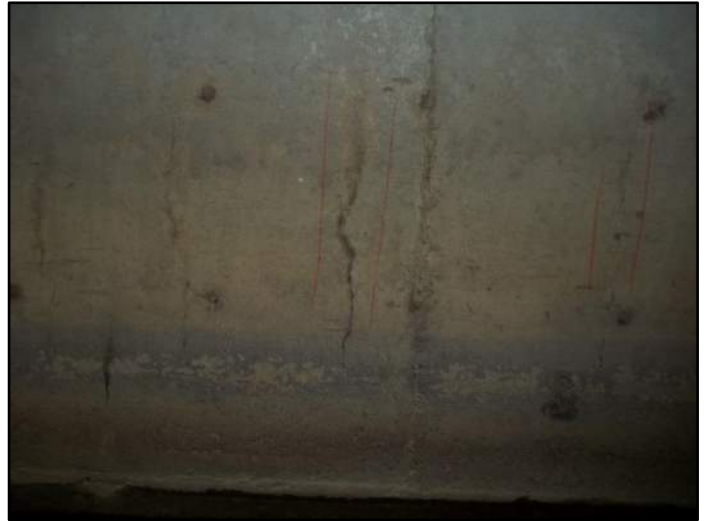
146' – Lt side
Transverse Cracking

146' – Rt side
Transverse Cracking

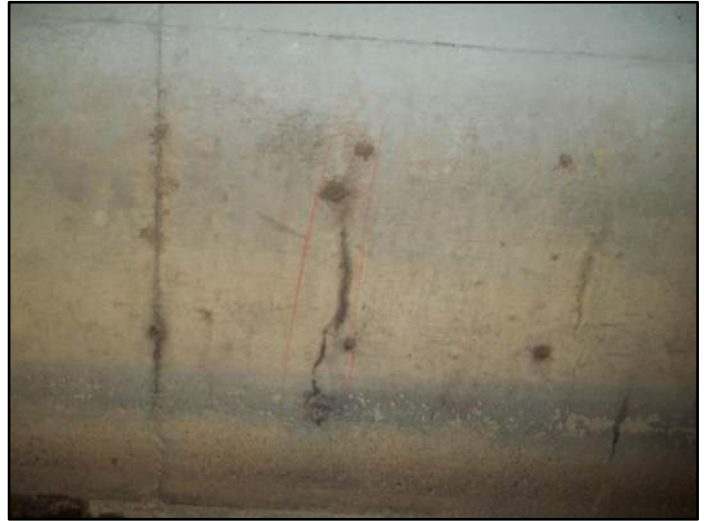
146' – Rt side
Transverse Cracking

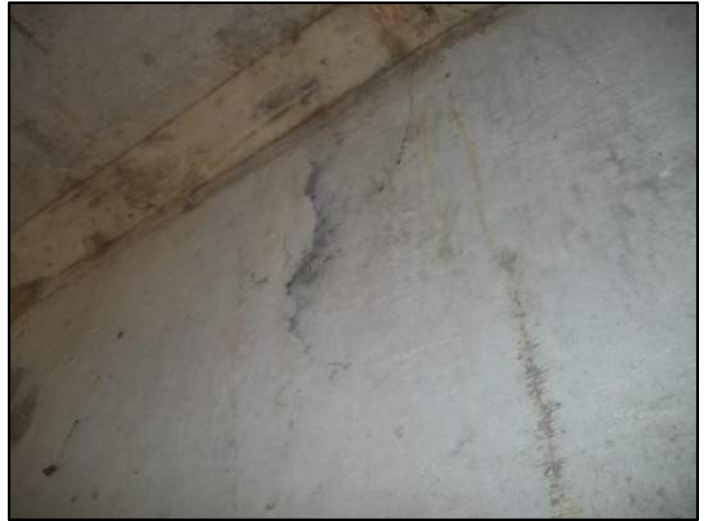
151' – Rt side
Spalling at top corner

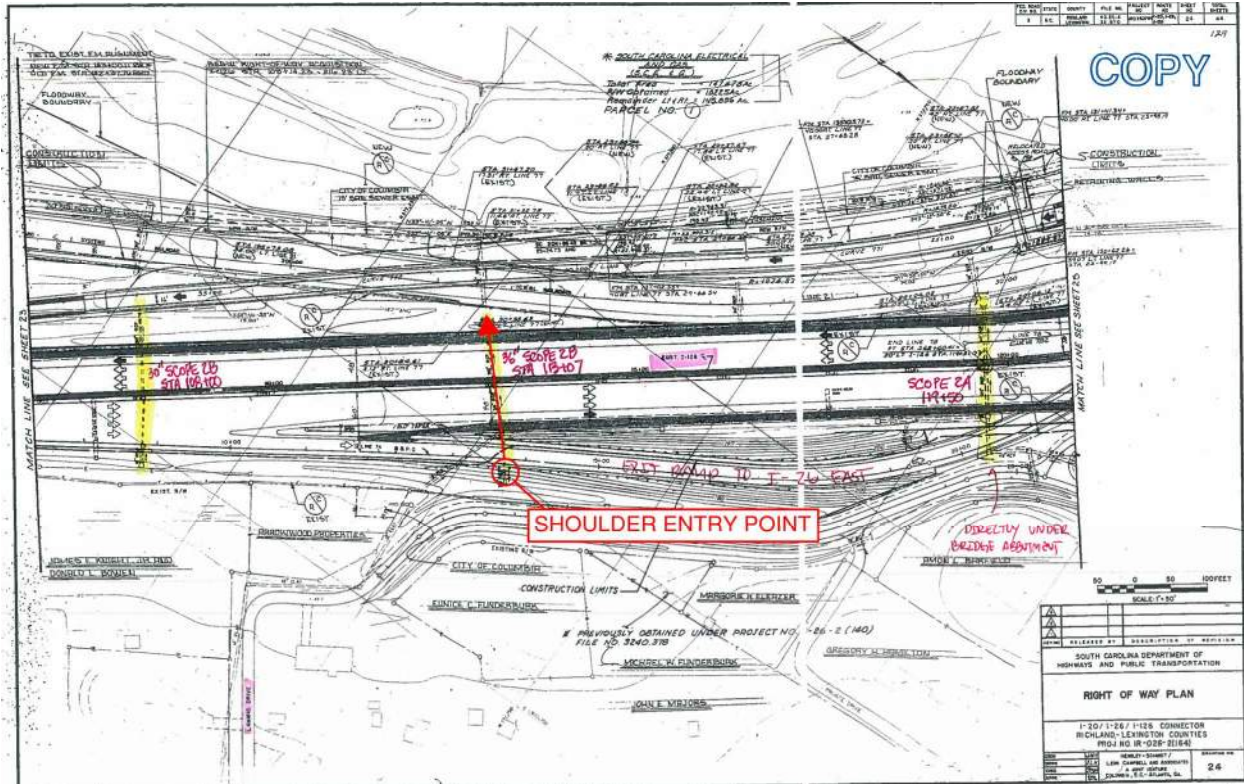
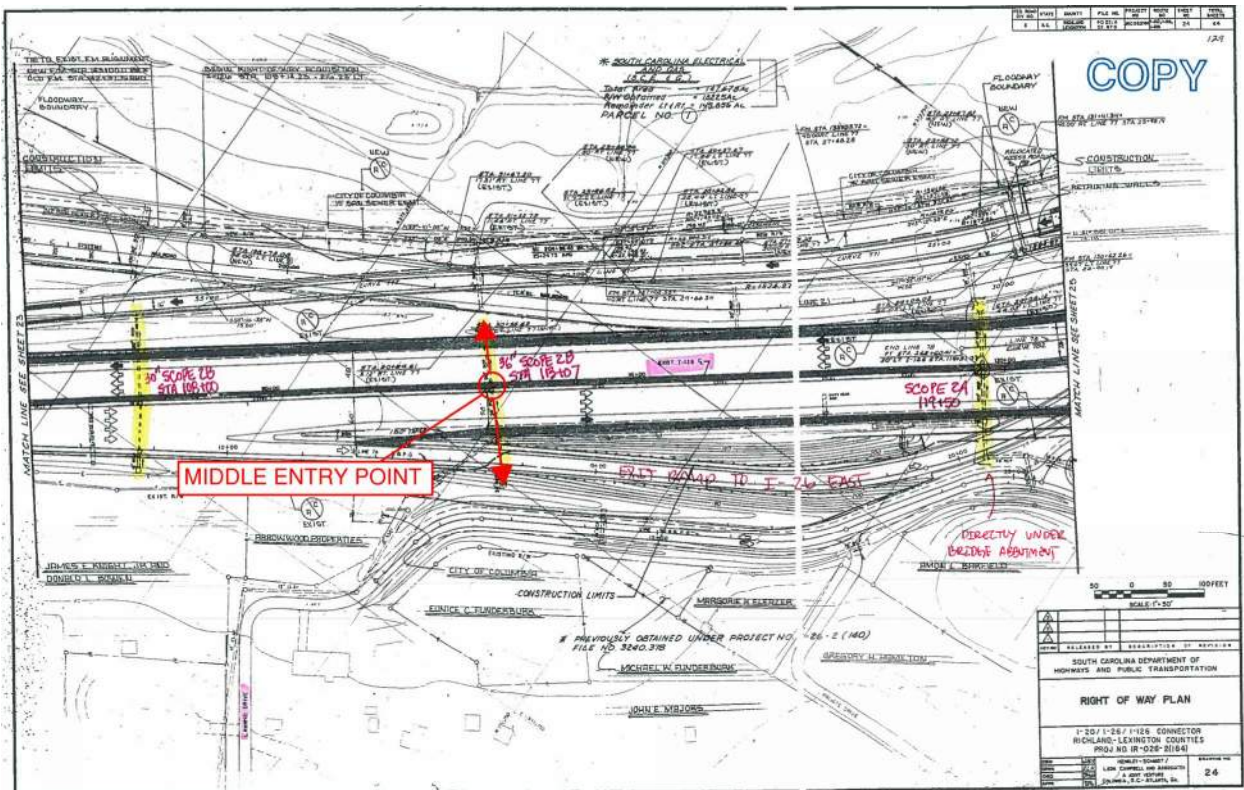
EP-4802

- Dimensions: Verified 36-inch RCP, Approximately 220 LF
- Observations
 1. Joint at approximately 10-feet (North of shoulder entry)-crack on side
 2. Joint at approximately 68-feet (North of shoulder entry)-chipped joint with some water seeping through
 3. Joint at approximately 48-feet (North of shoulder entry)-separated joint
 4. Joint at approximately 118-feet (South of middle entry)-severe separation, water has begun to undermine pipe.
- Recommendations
 1. Slipline or replace existing pipe.
 2. Determine if new backfill is needed under pipe where water is exiting through joint.

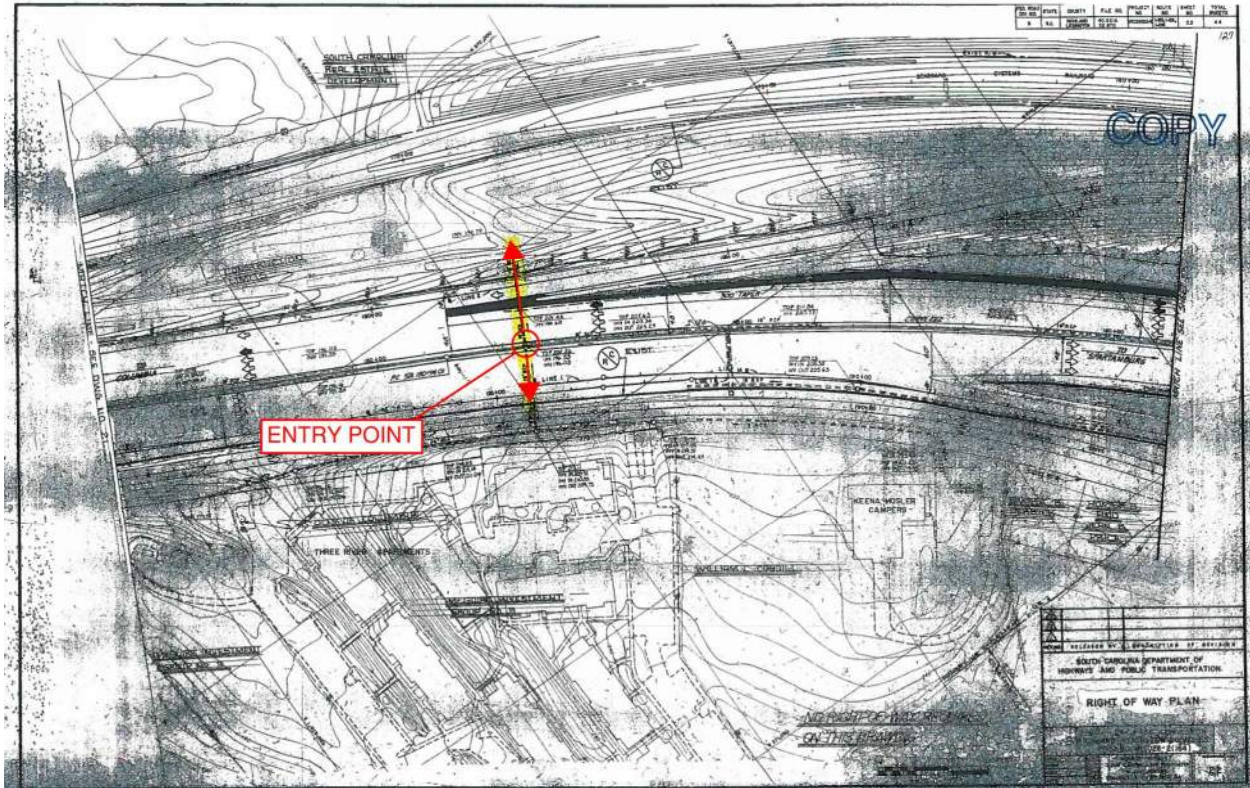
EP-5002

- Dimensions: Verified 18-inch RCP, Approximately 200 LF
- Observations
 1. North end of pipe appears to be blocked at entrance prohibiting water flow. Clean pipe in order to fix this issue.
- Recommendations
 1. Clean pipe.

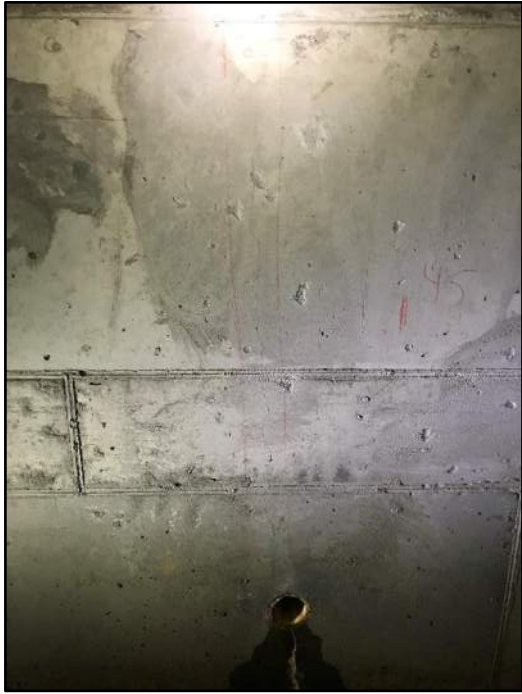
44' – Lt side
Transverse cracking

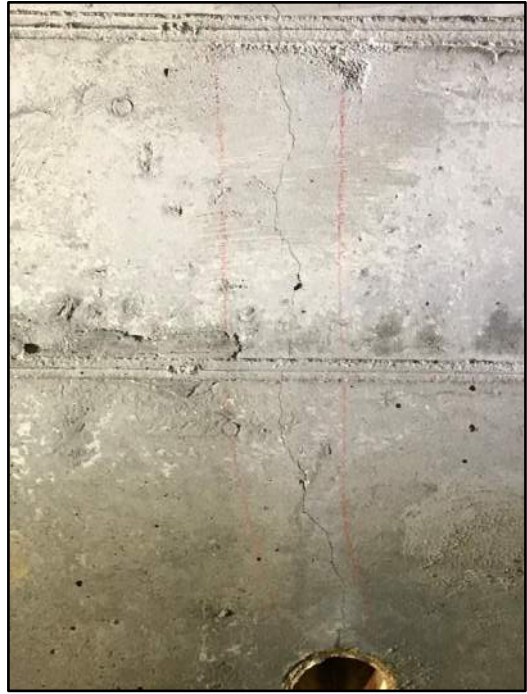
44' – Lt side
Transverse cracking

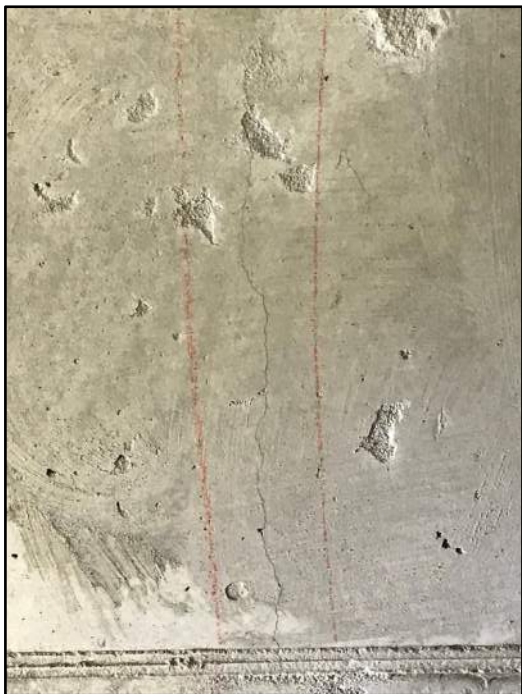
44' – Lt side
Transverse cracking

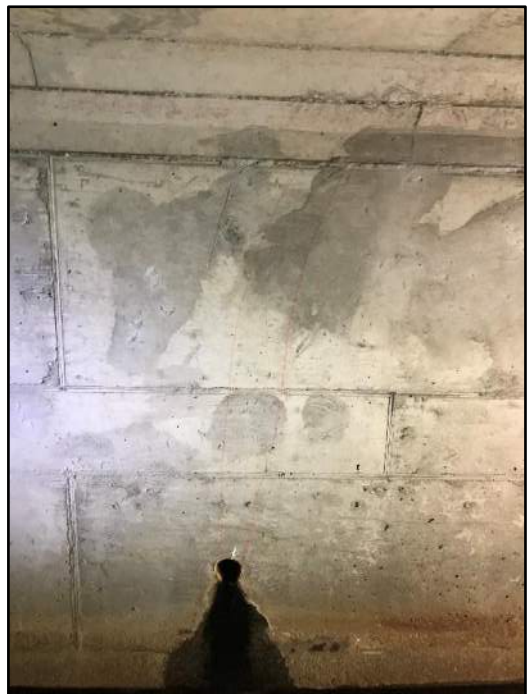
44' – Rt side
Transverse cracking

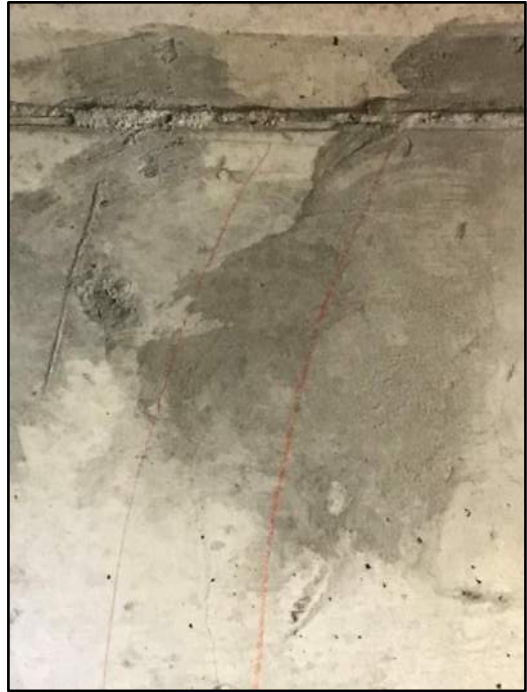
44' – Rt side
Transverse cracking

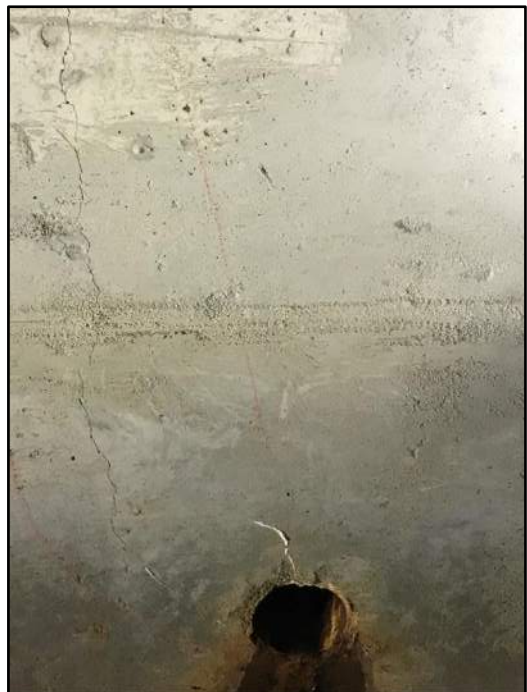
44' – Rt side
Transverse cracking

50' – Lt side
Transverse cracking

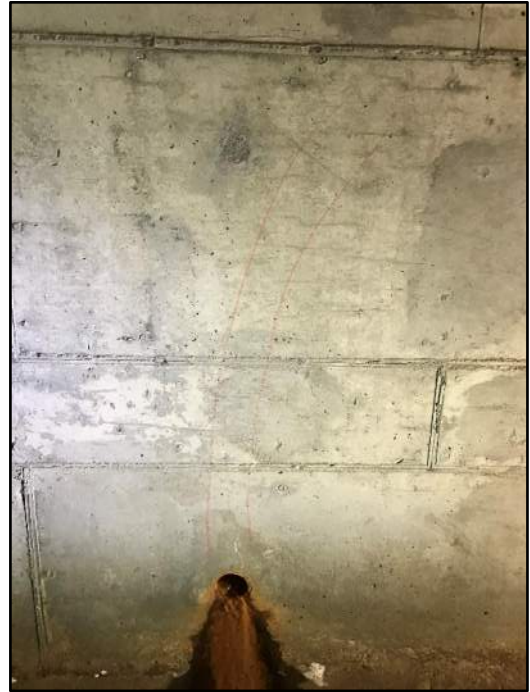
50' – Lt side
Transverse cracking

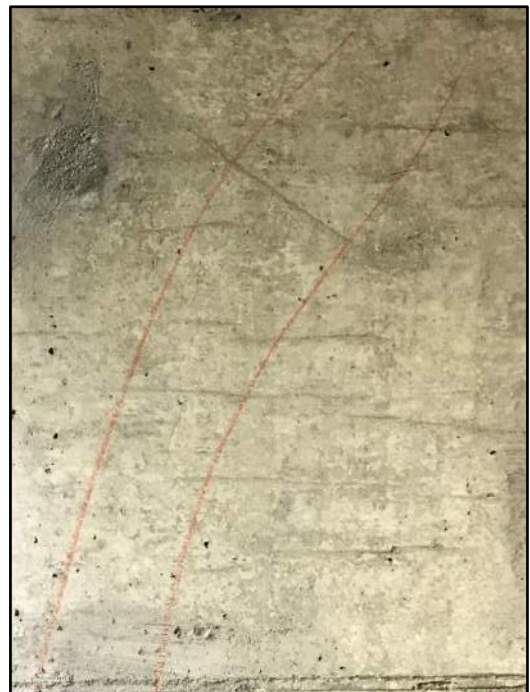
50' – Lt side
Transverse cracking

50' – Rt side
Transverse cracking

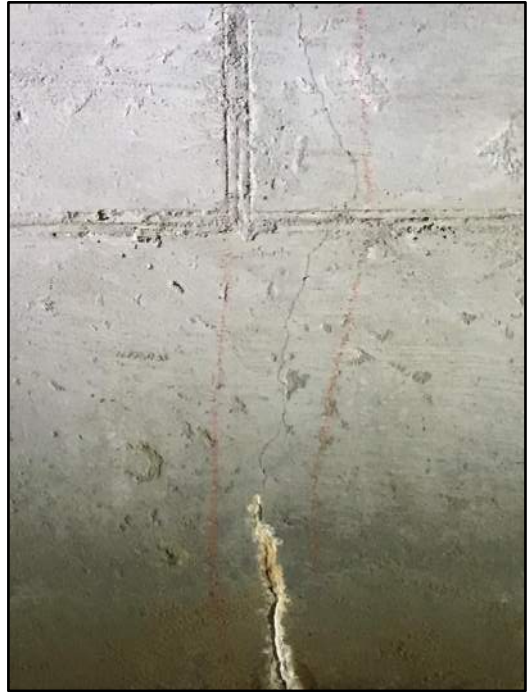
50' – Rt side
Transverse cracking

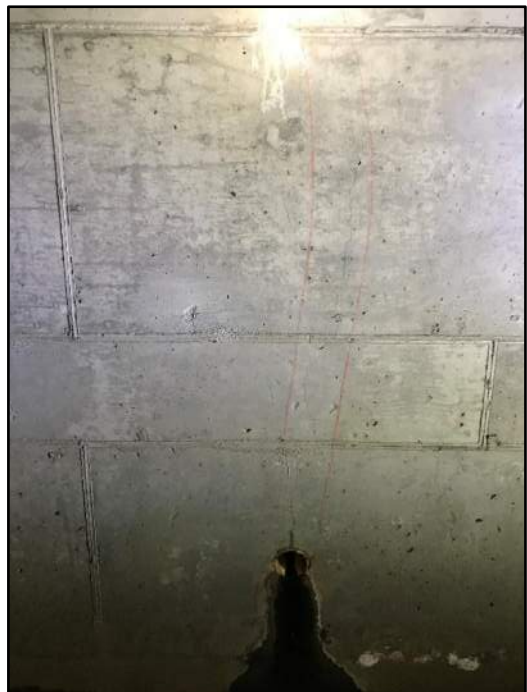
50' – Rt side
Transverse cracking

55' – Rt side
Transverse cracking

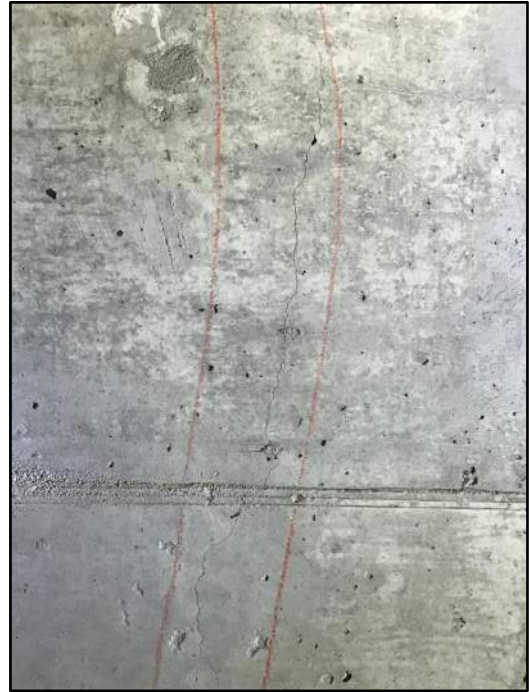
55' – Rt side
Transverse cracking

63' – Rt side
Transverse cracking

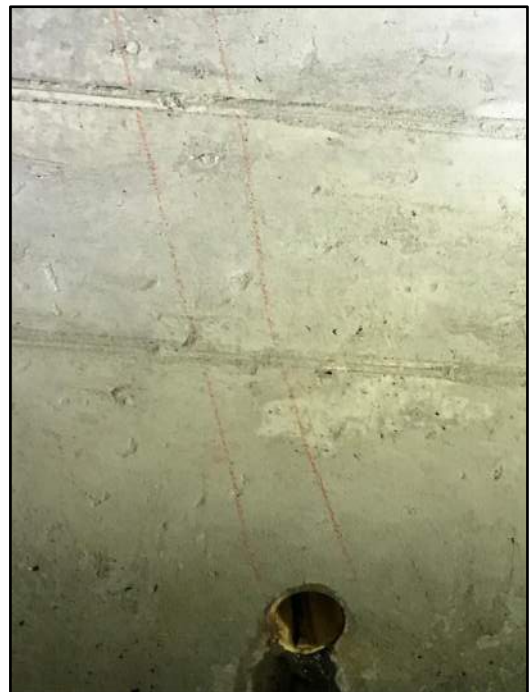
63' – Rt side
Transverse cracking

69' – Rt side
Transverse cracking

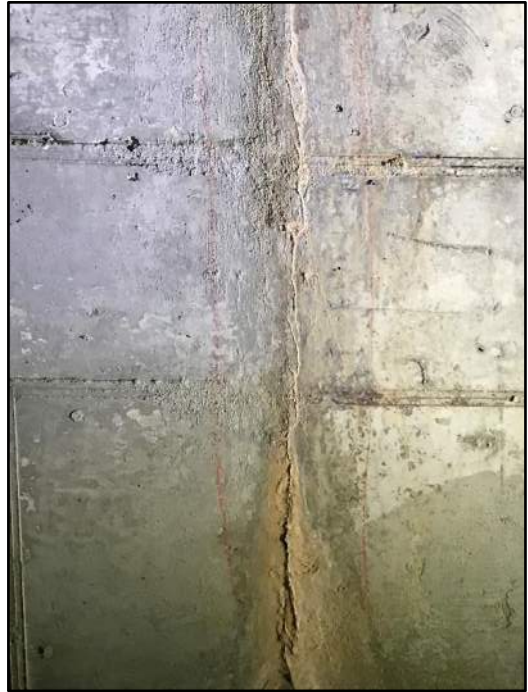
69' – Rt side
Transverse cracking

73' – Rt side
Transverse cracking

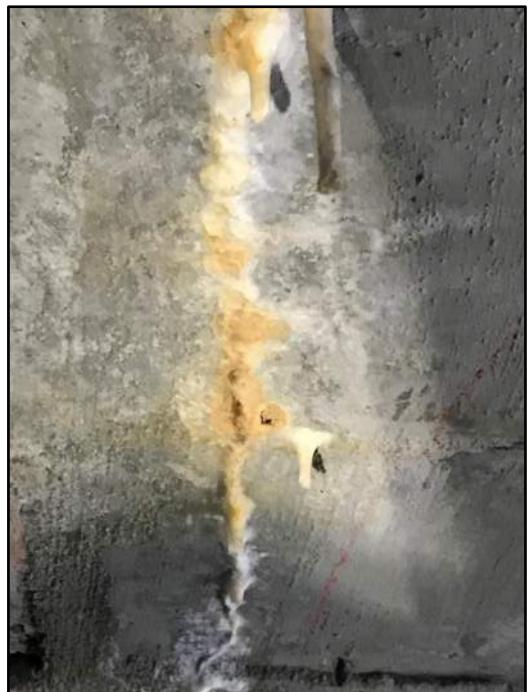
73' – Rt side
Transverse cracking

78' – Rt side
Transverse cracking

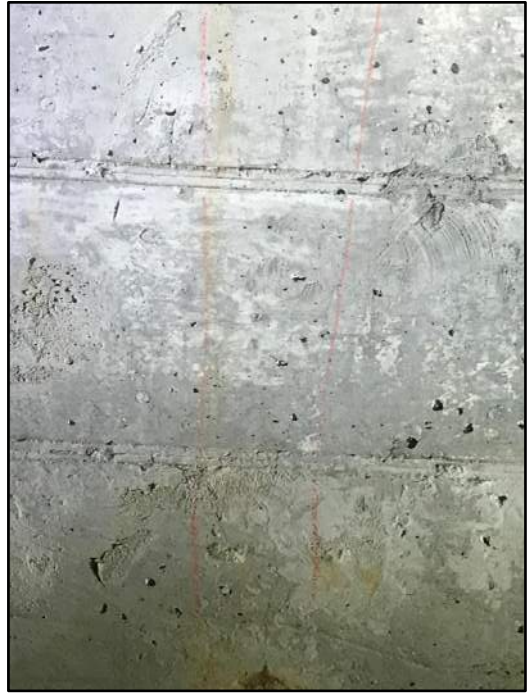
78' – Rt side
Transverse cracking

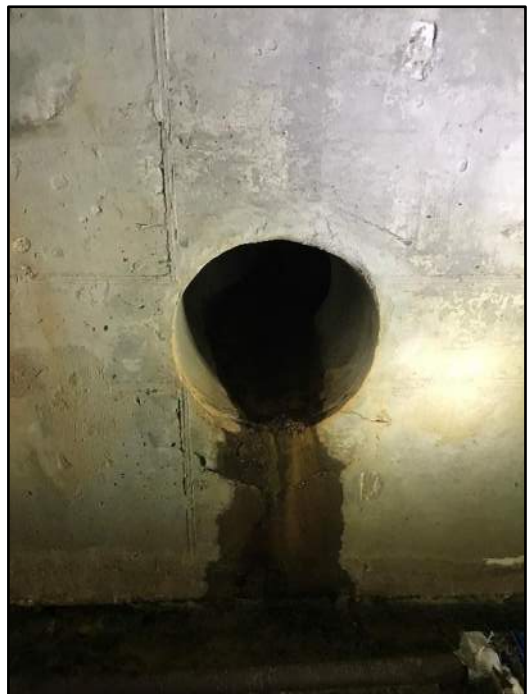
85' – Rt side
18" RCP cracking at tie interface

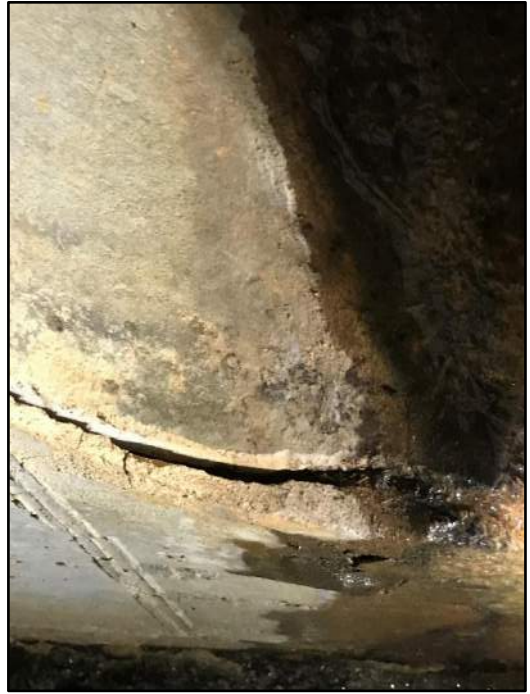
85' – Rt side
18" RCP cracking at tie interface

95' – Rt side
Transverse cracking

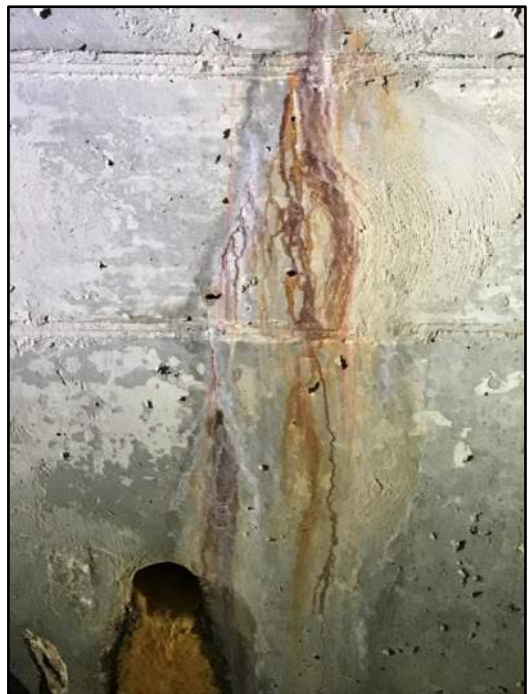
95' – Rt side
Transverse cracking

110' – Rt side
Transverse cracking

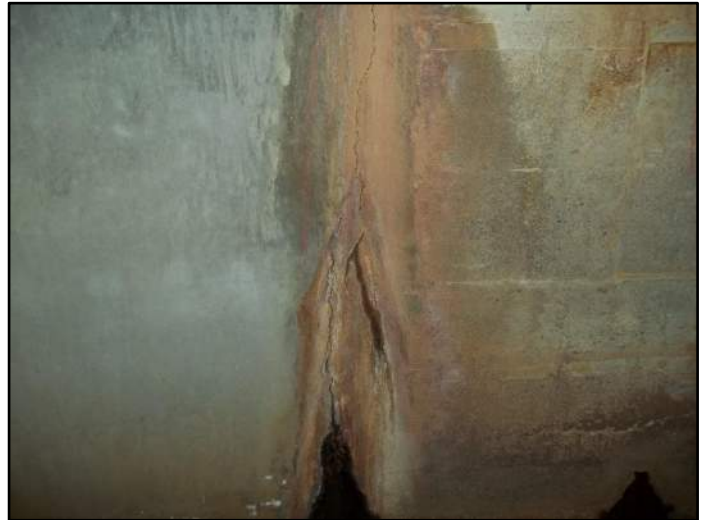
113' – Lt side
Transverse cracking

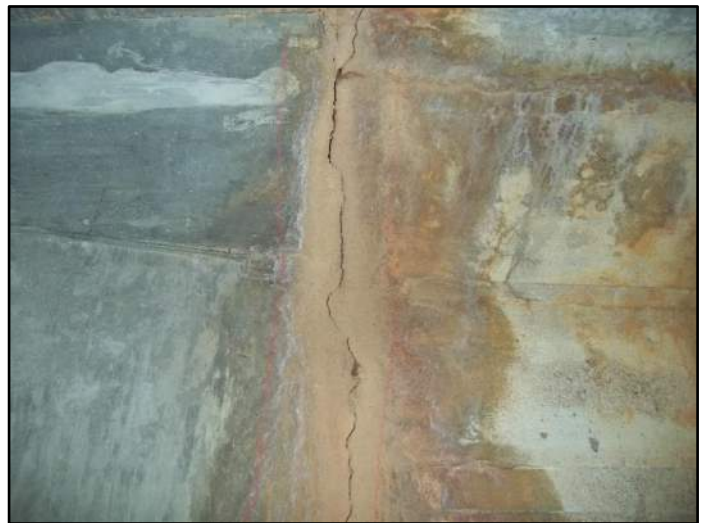
136' – Lt side
Transverse cracking

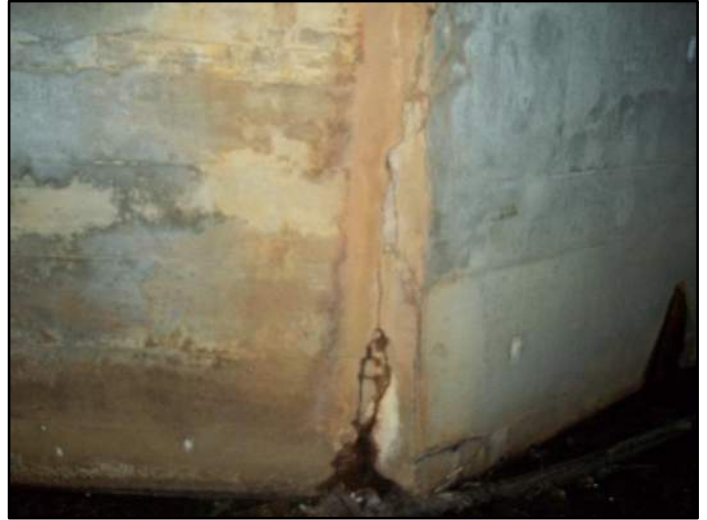
140' – Rt side
Transverse cracking

23' – Lt side
Transverse cracking

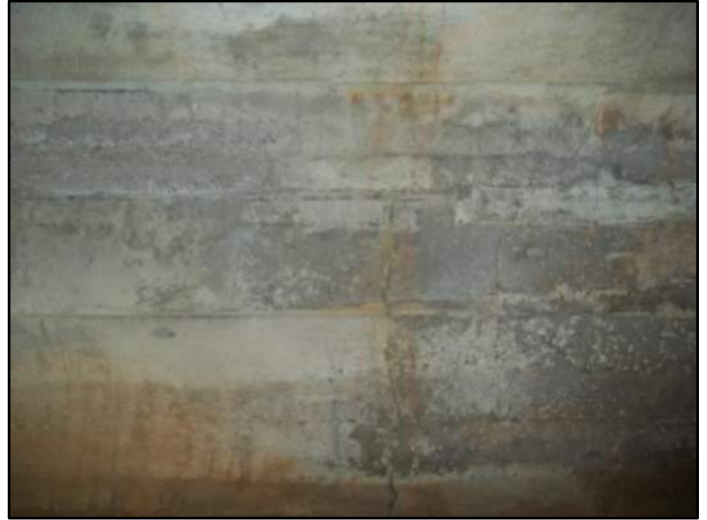
32' – Rt side
Transverse cracking

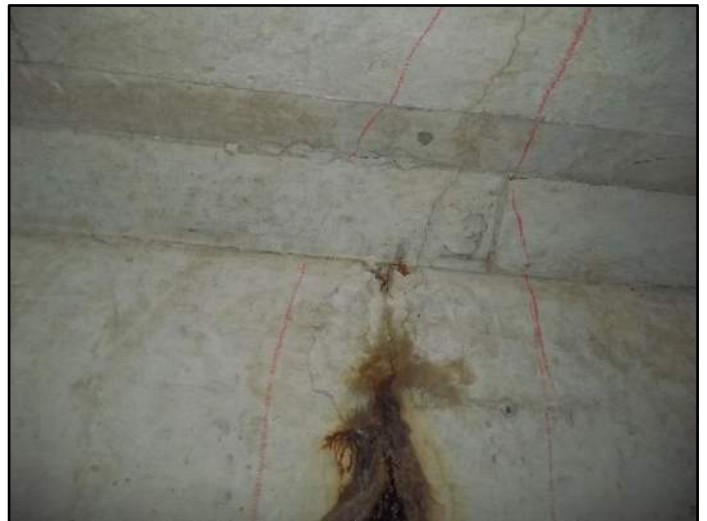
98' – Lt side and top
Transverse cracking

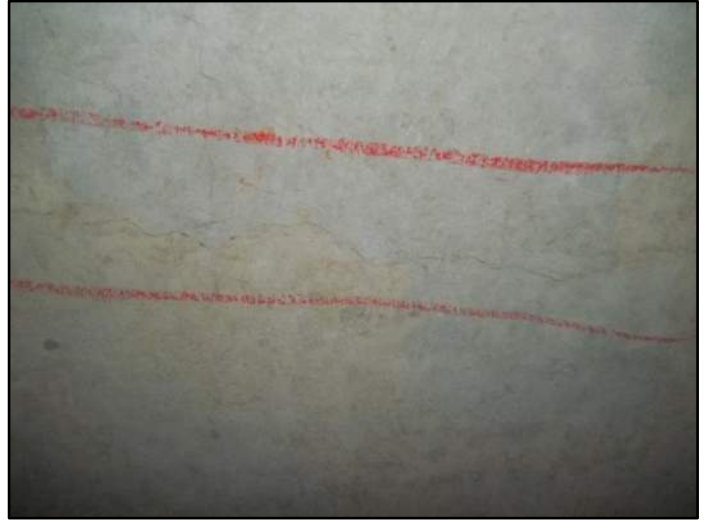
98' – Lt side and top
Transverse cracking

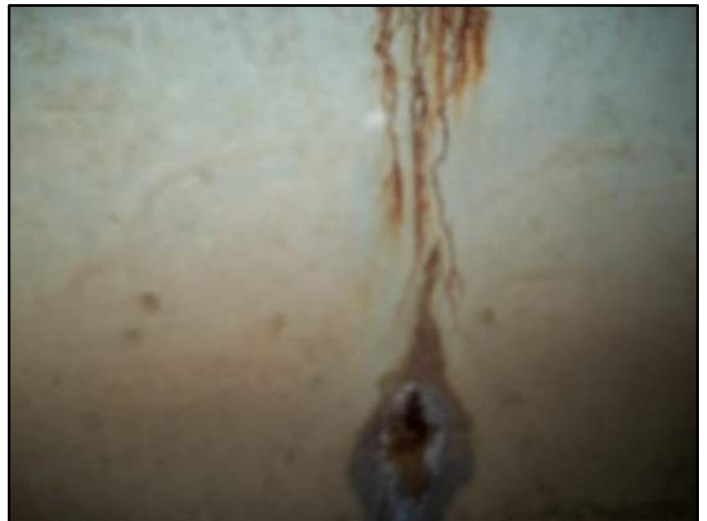
100' – Rt side
Transverse cracking

114' – Lt side
Transverse cracking

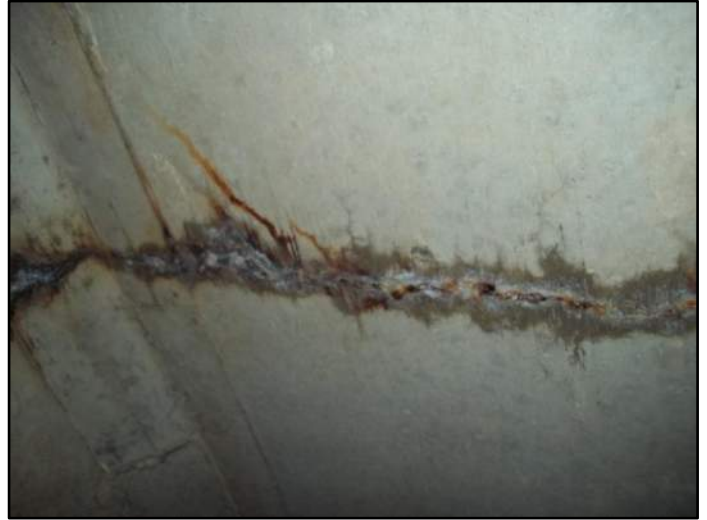
114' – Lt side
Transverse cracking

114' – Top side
Transverse cracking

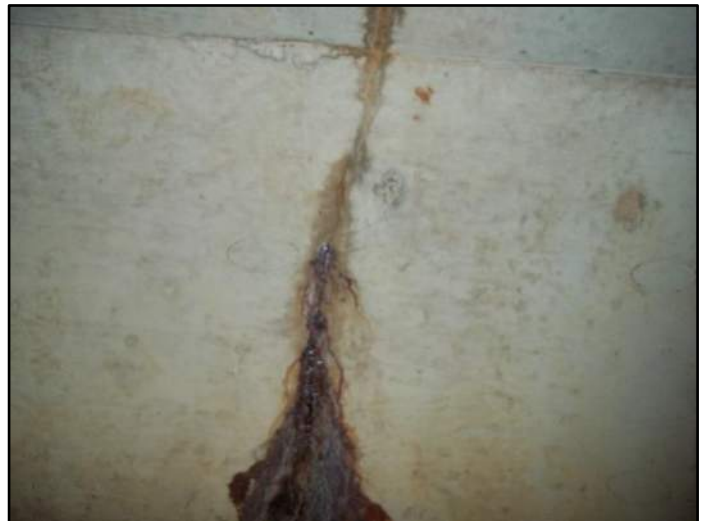
114' – Top side
Transverse cracking

114' – Rt side
Transverse cracking

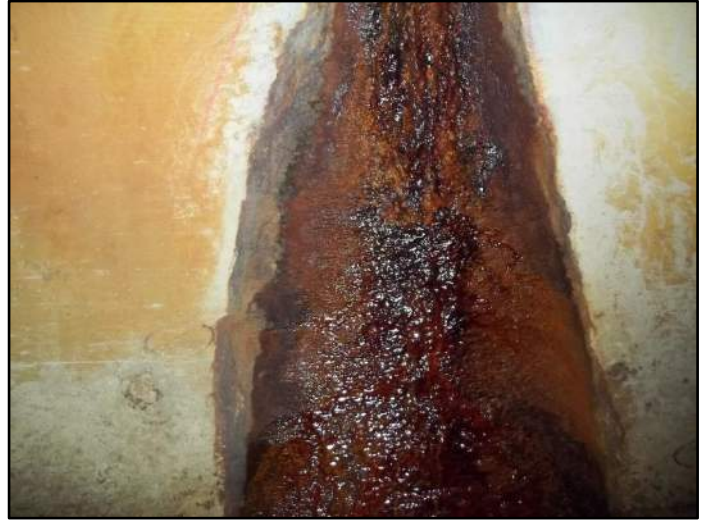
114' – Rt side
Transverse cracking

139.5' – Lt side
Separation at joint

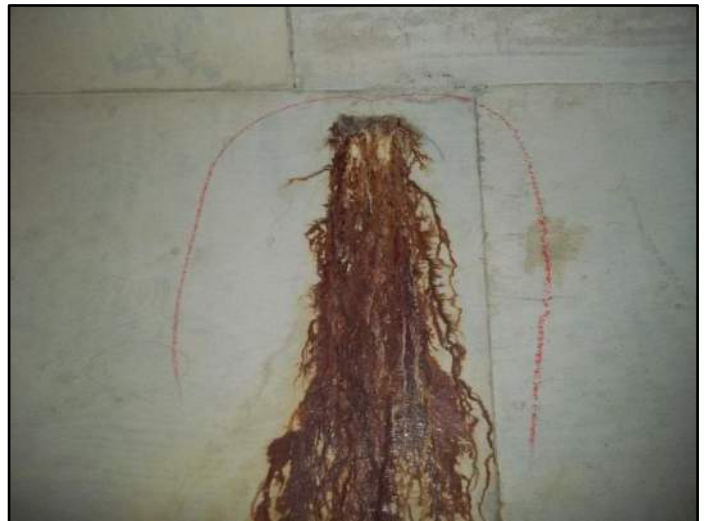
139.5' – Rt side
Separation at joint

143' – Rt side
weeping crack

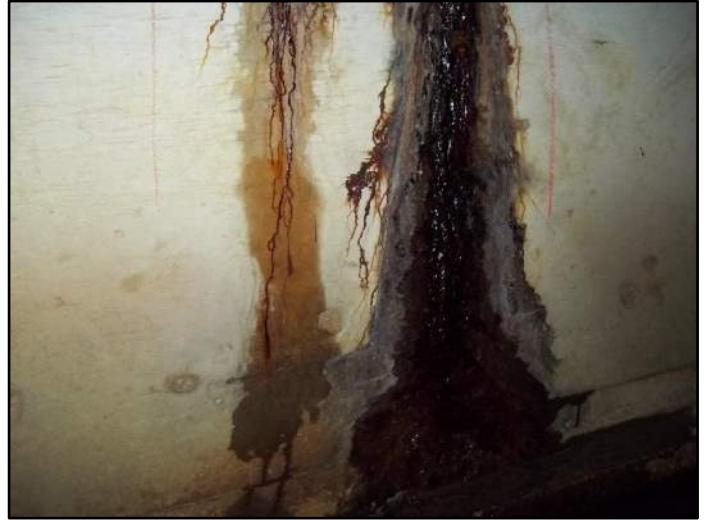
143' – Rt side
weeping crack

163' – Lt side
Transverse cracking

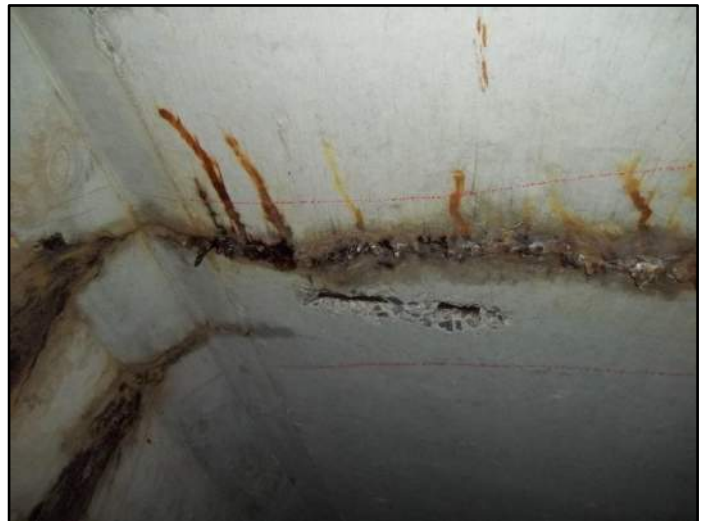
163' – Lt side
Transverse cracking

163' – Top
Transverse cracking with exposed rebar
