EC-2601

I-20/26/126 Corridor Improvement Project

6' x 6' RCB

Client: SCDOT

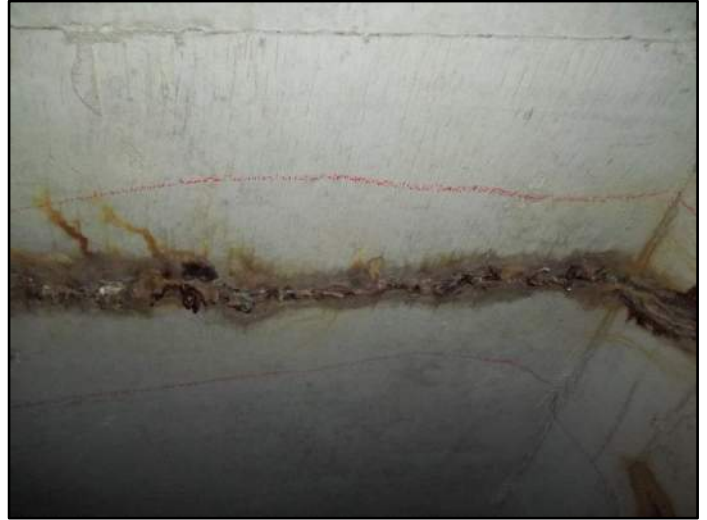
163' – Top
Transverse cracking crack and exposed rebar

163' – Top side
Transverse cracking

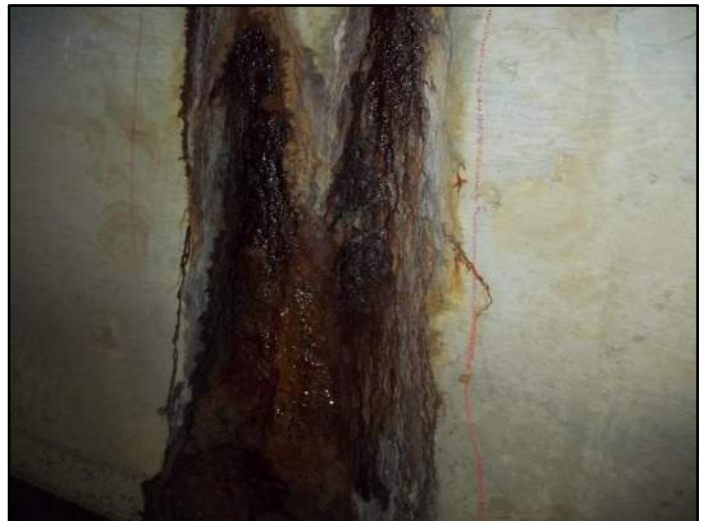
163' – Rt side
Transverse cracking

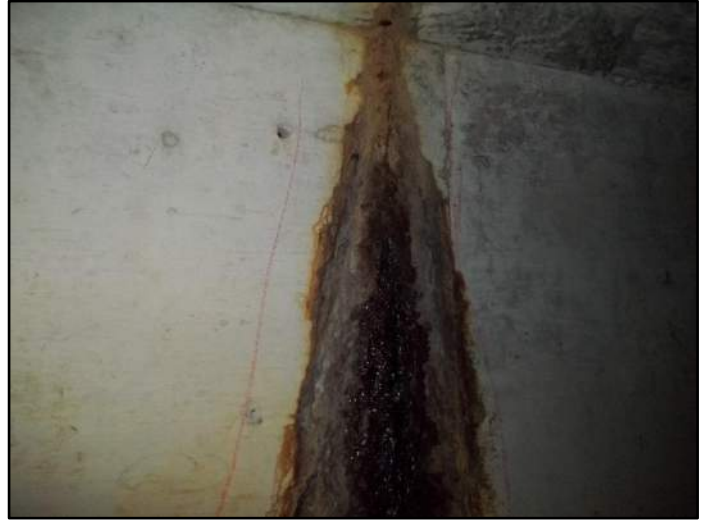
200' – Lt side
Transverse cracking

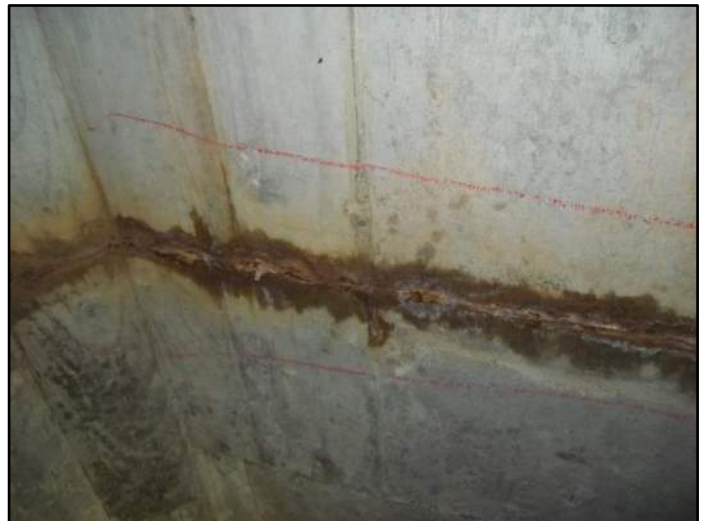
200' – Lt side
Transverse cracking

200' – Top side
Transverse cracking

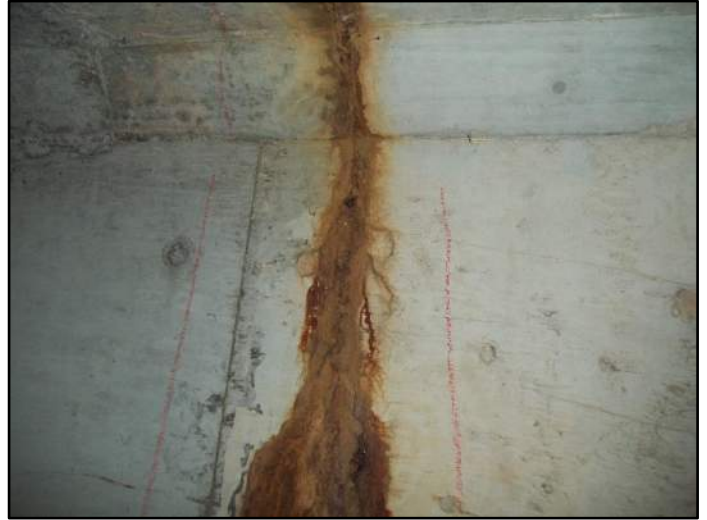
200' – Top side
Transverse cracking

200' – Rt side
Transverse cracking

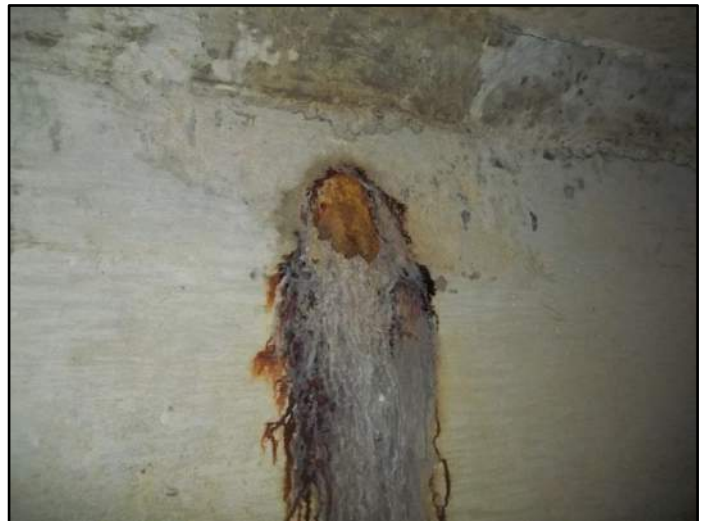
200' – Rt side
Transverse cracking

228' – Lt side
Weeping crack

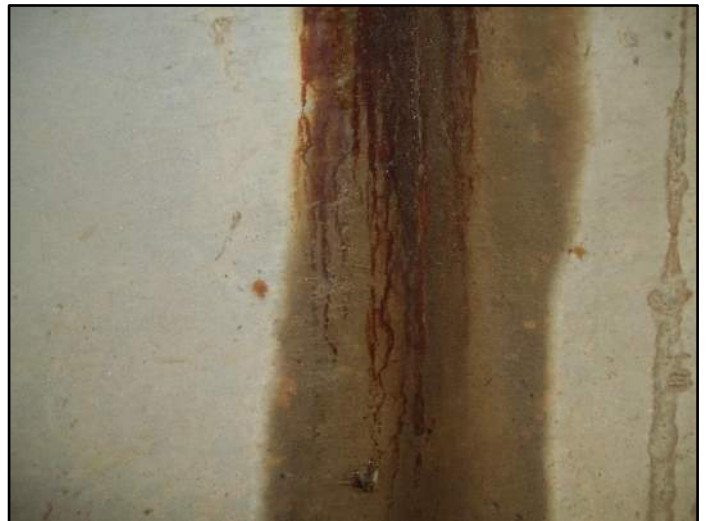
313' – Lt side
Transverse cracking
