## LEAD-BASED PAINT INVESTIGATION REPORT

COMMERCIAL STRUCTURE  
TRACT #402 – 500 LAWAND DRIVE  
COLUMBIA, SOUTH CAROLINA 29210  
TMS # R07302-05-01

November 17, 2020

FME Project No.: G5662.020

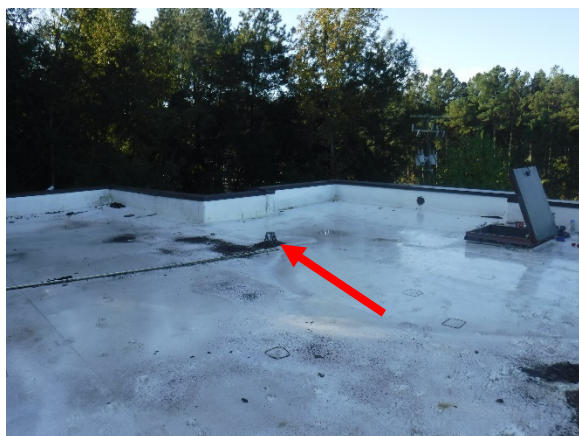
**Photo 1.** Lead Shielding Under Roofing Membrane at Roof Drains

Therefore, OSHA regulations and procedures should be followed when impacting these components. If possible, they should be removed in whole and disposed of properly. Also, SCDHEC disposal requirements for lead containing materials should also be followed.
