I-95 Southbound Bridge Over I-26  
Orangeburg County, South Carolina

Asbestos and Lead-Based Paint  
Survey Report

Structure # 381009530100  
ARM Project #16-318-22

October 14, 2022

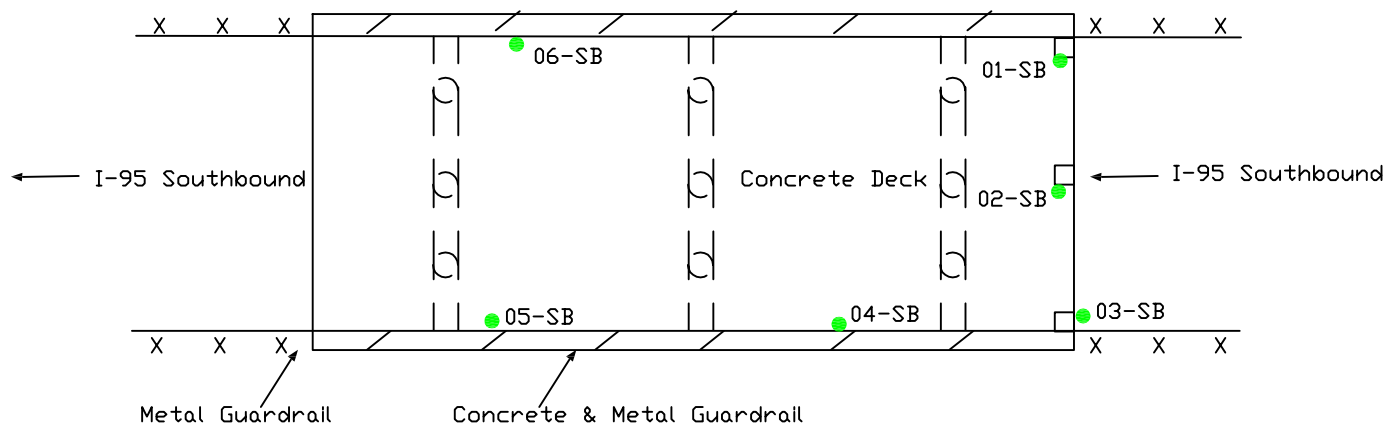
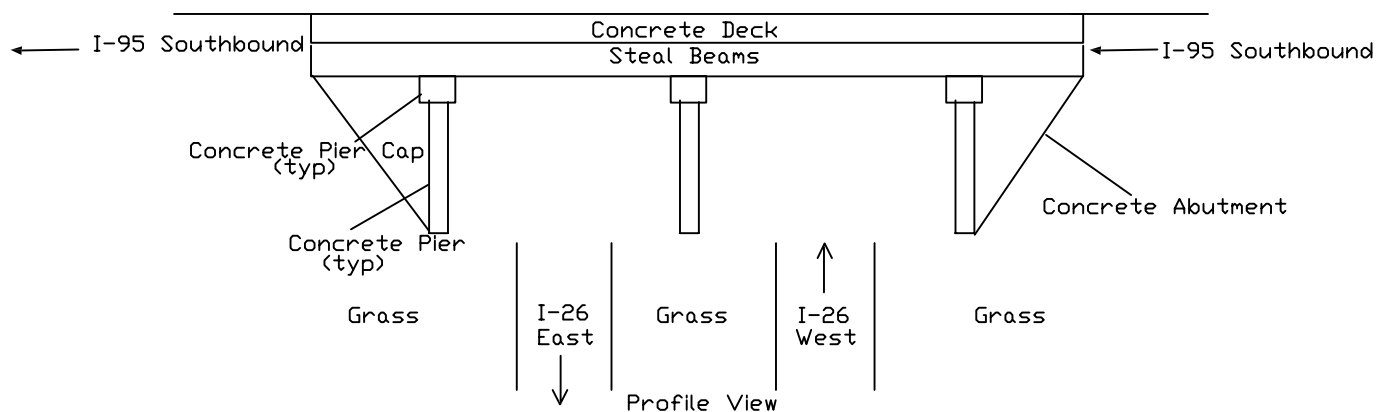
**FIGURE 2**

Sample Number	Material Description	Material Locations	Friable / Non-friable	Material Condition	Analytical Results*	Approx. Quantity
01-SB, 02-SB, 03-SB	Buffer Material at Steel Bridge Shoes	Between Concrete Pier Caps & Steel Bridge Shoes	Non-friable	Good	No Asbestos Detected	100 Square Feet
04-SB, 05-SB, 06-SB	Expansion Joint	Between Concrete Deck Sections	Non-friable	Good	No Asbestos Detected	225 Linear Feet

Site Plan Showing  
Sample Locations

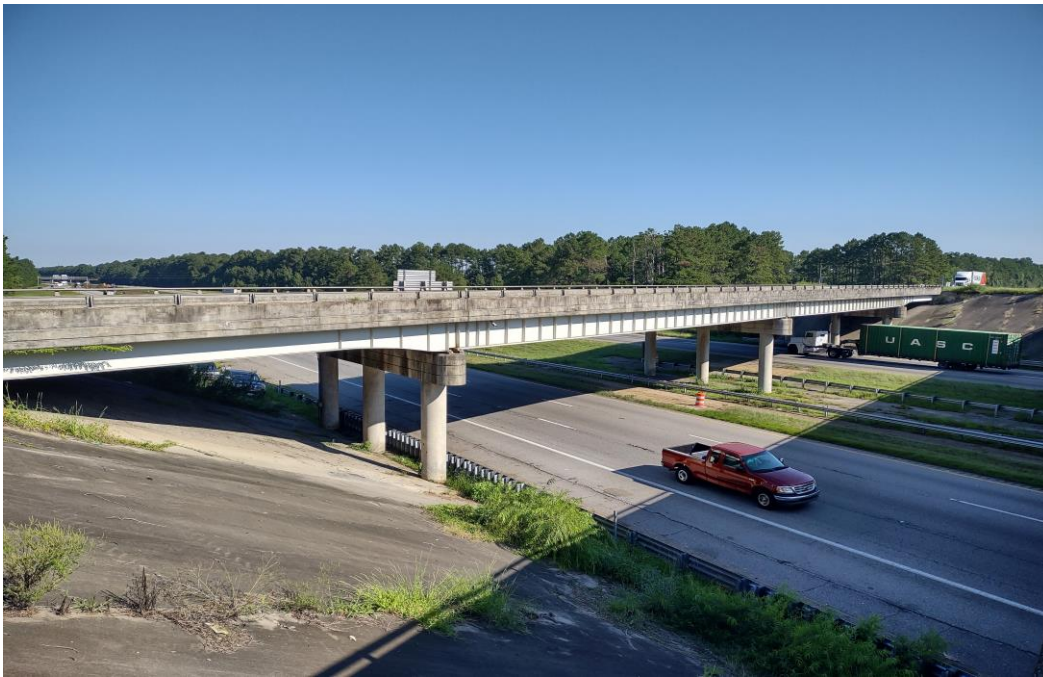
**Photograph 1**

A view of the I-95 southbound bridge over I-26 in Orangeburg County where an Asbestos and Lead-Based Paint Survey was performed by ARM Environmental.

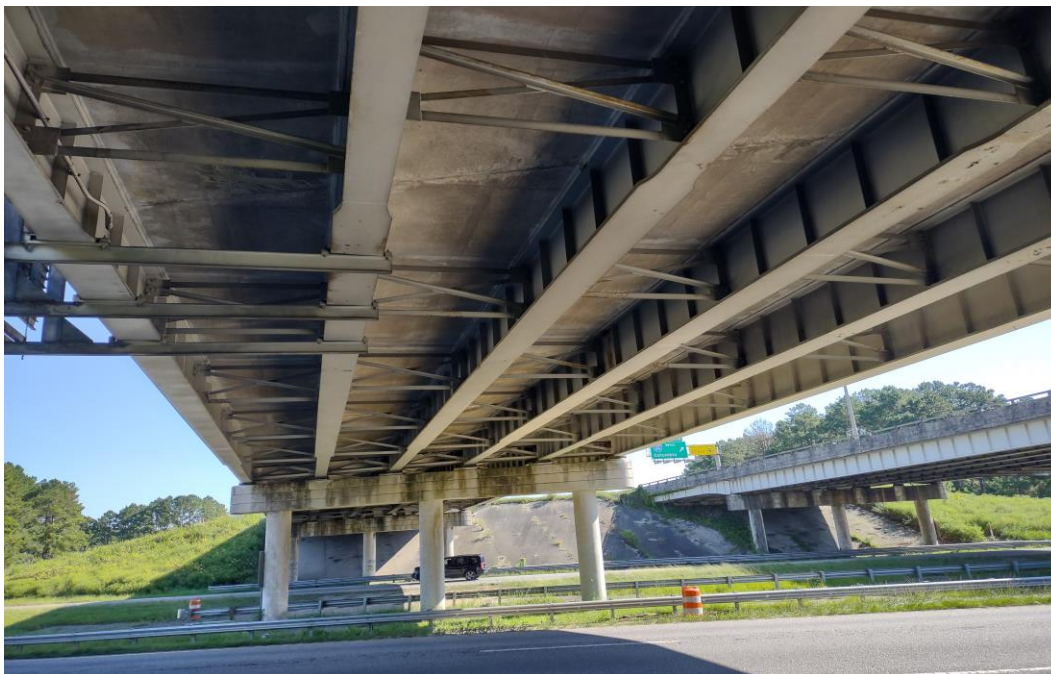
**Photograph 2**

A view of the underside of the I-95 southbound bridge over I-26 in Orangeburg County.
