Stormwater Management Design Report

I-77 Widening Design-Build Preparation On-Call

From Percival Road to Killian Road

May 2015

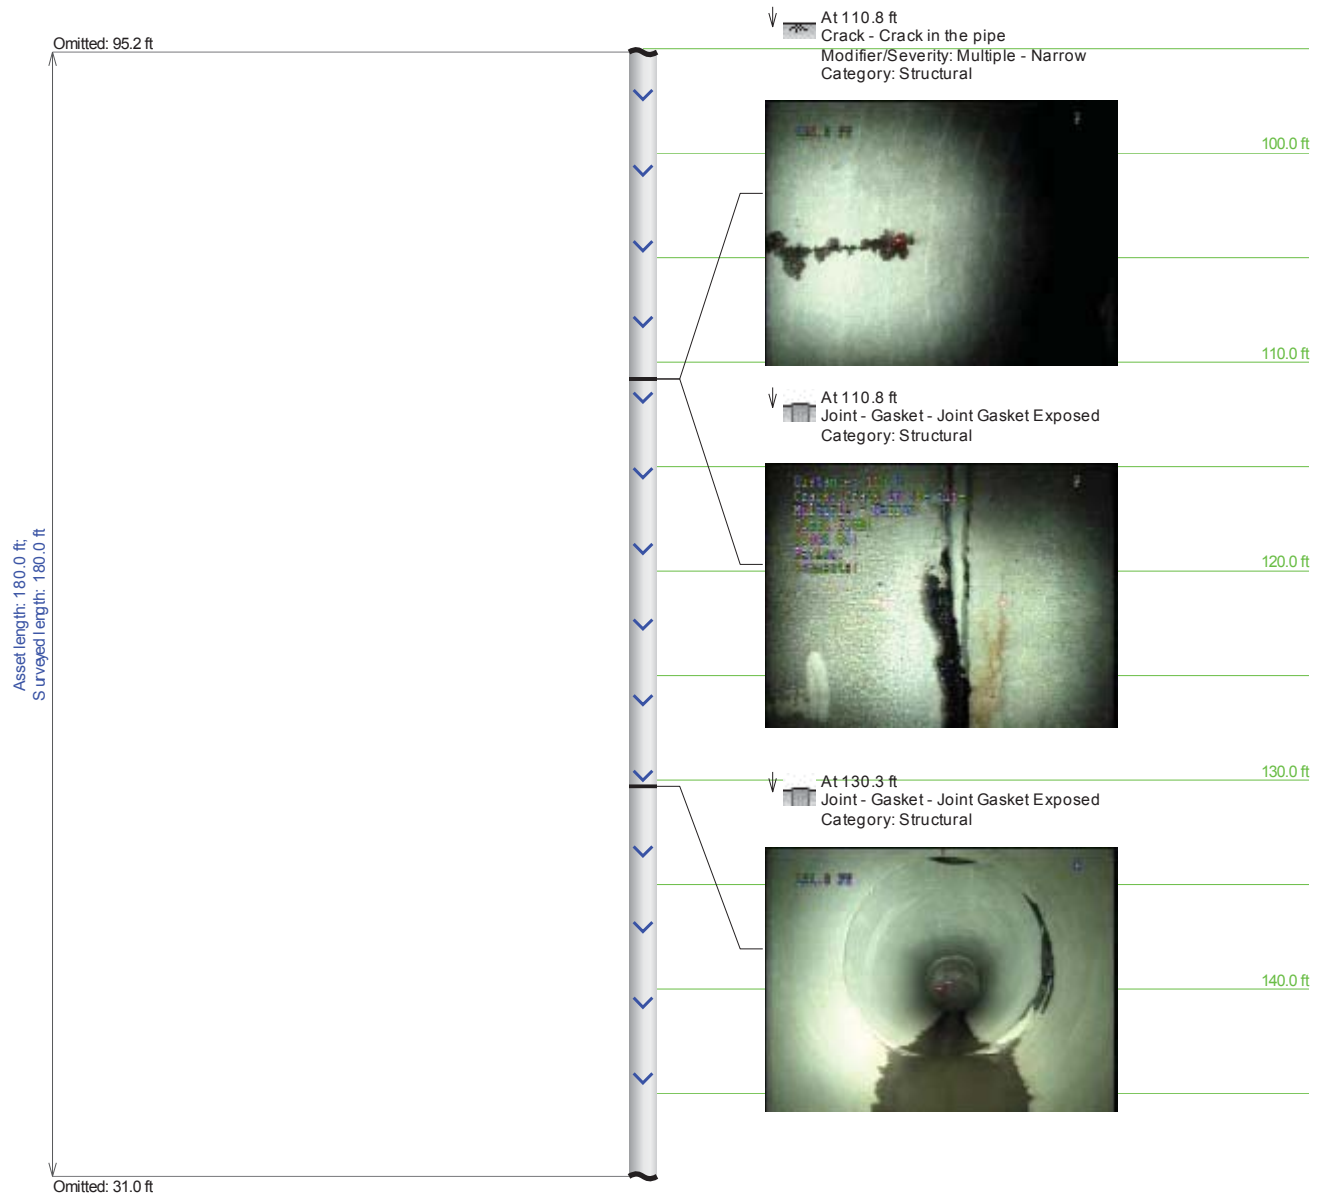
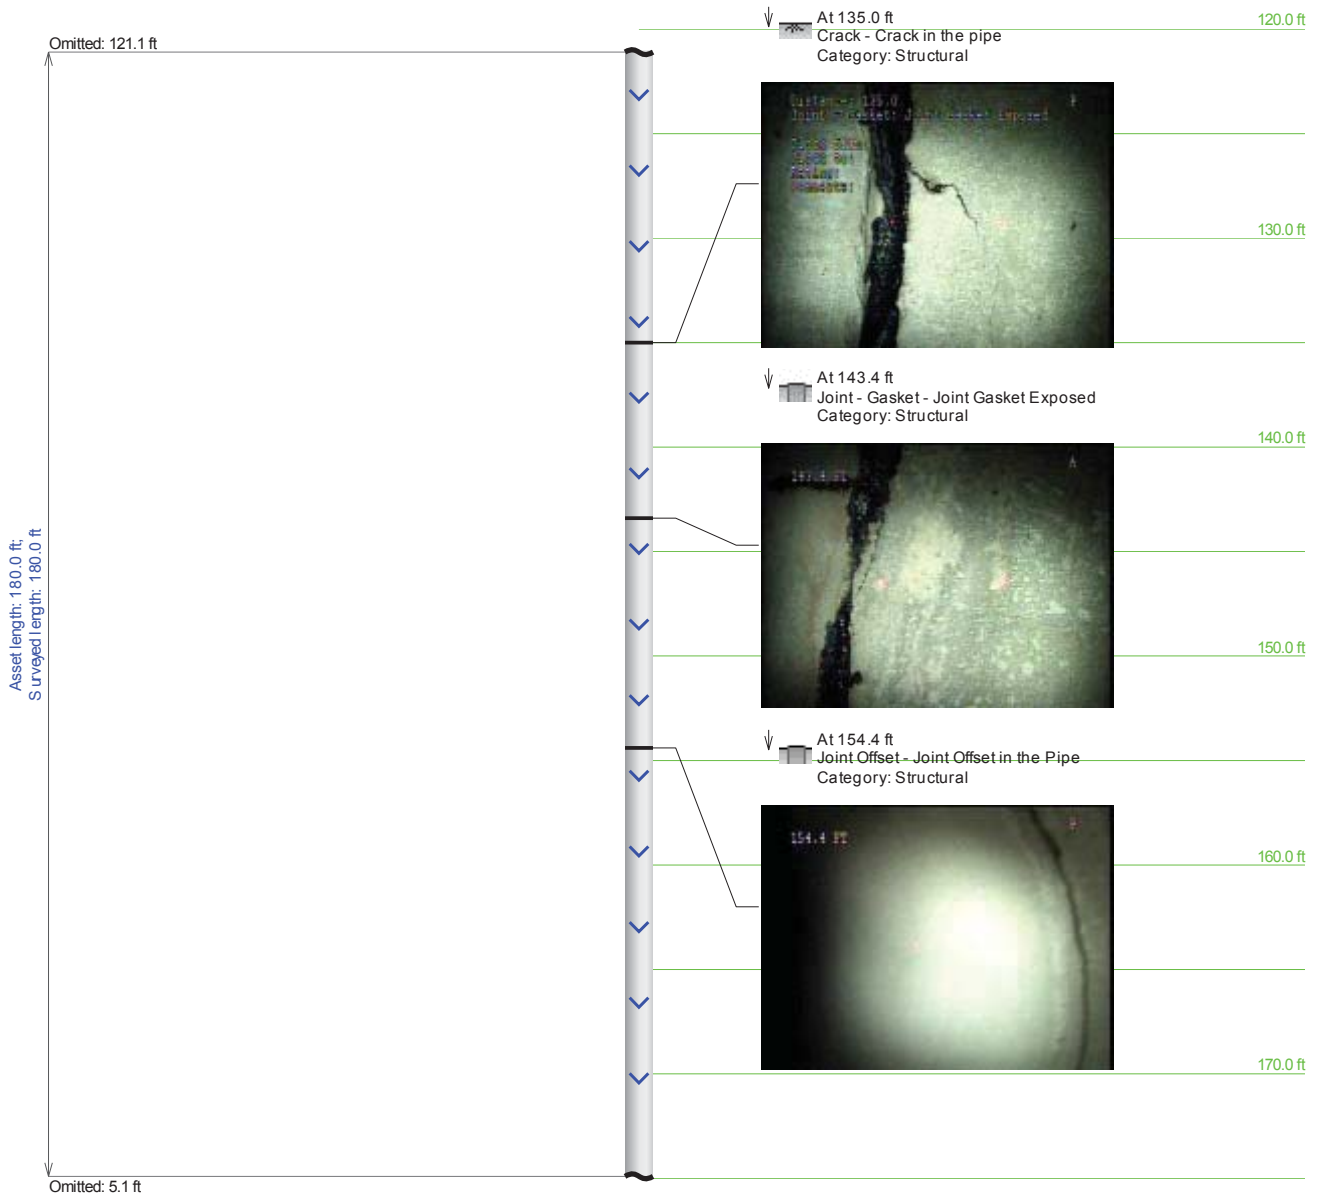
Project Name: I-77 exit 15-22	Mainline ID: EP0801	City: Columbia, SC	Address: I-77 North
Start date/time: 1/19/2015	Pipe width: 18	Pipe height: 18	Pipe type: Concrete Reinforced
			Surface condition: Asphalt
			Weather: Dry
Direction: Downstream	Surveyed footage: 180.0	Operator: Tina Watkins	Comments

Project Name: I-77 exit 15-22	Mainline ID: EP0801	City: Columbia, SC	Address: I-77 North
Start date/time: 1/19/2015	Pipe width: 18	Pipe height: 18	Pipe type: Concrete Reinforced
		Surface condition: Asphalt	Weather: Dry
Direction: Downstream	Surveyed footage: 180.0	Operator: Tina Watkins	Comments
