**ASBESTOS & LEAD-BASED PAINT  
ASSESSMENT REPORT  
I-85 Widening MM80-96  
SC 18 BRIDGE OVER I-85  
STRUCTURE NO. 1140001800400  
GAFFNEY, SOUTH CAROLINA  
S&ME Project No. 1426-14-161**

**Reference: Asbestos and Lead-Based Paint Assessment Report**  
SC 18 Bridge on Shelby Highway over I-85  
Structure No. 1140001800400  
Gaffney, South Carolina  
S&ME Project No. 1426-14-161

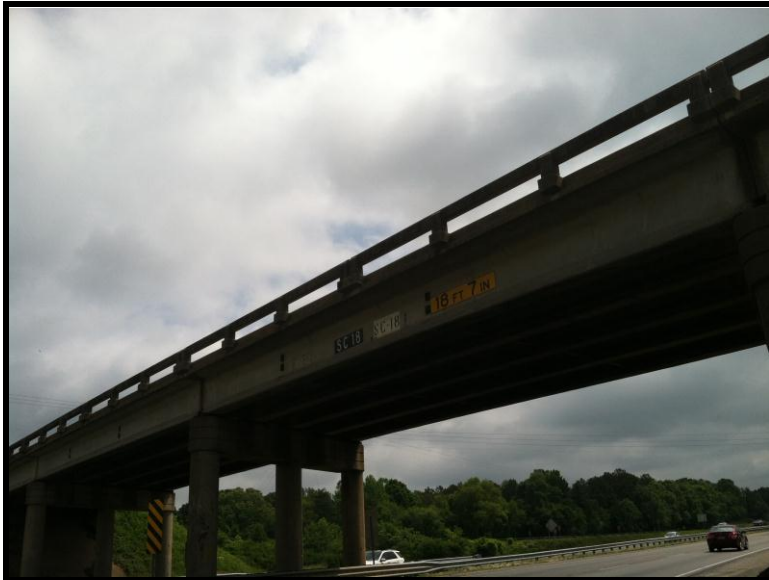
1 Bridge SC-18 on Shelby Road over I-85  
General view from I-85

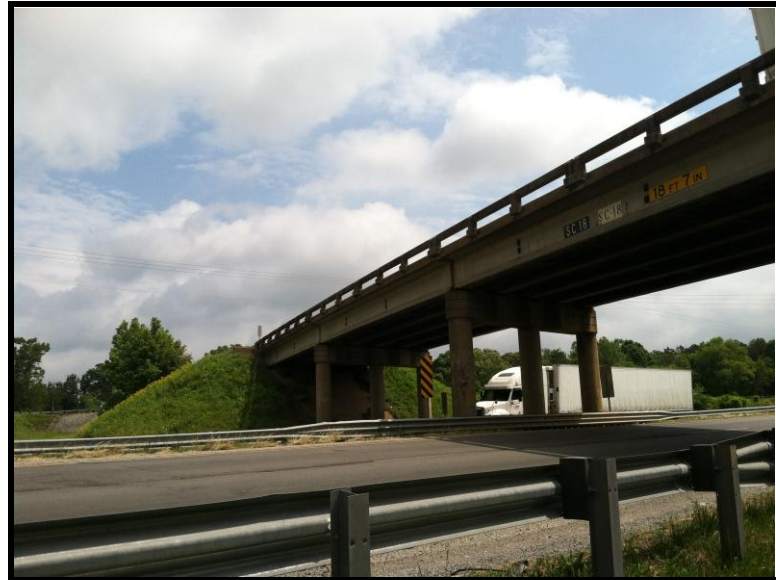
2 General view from I-85

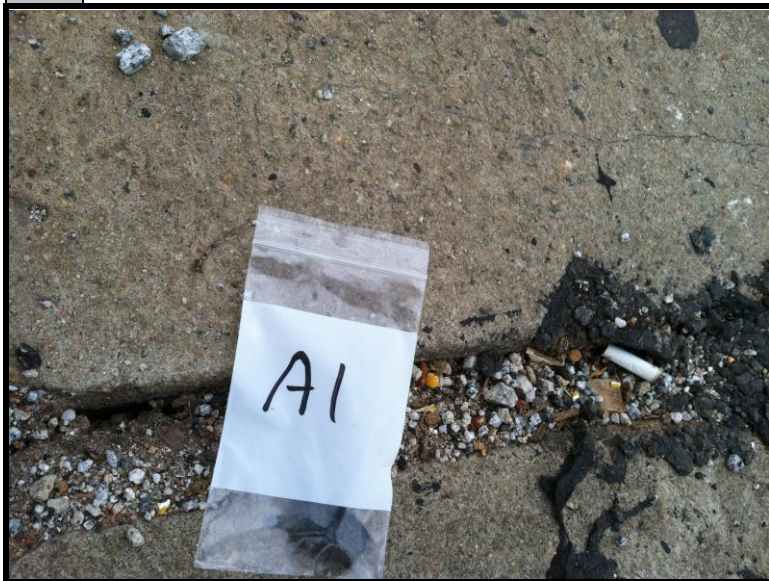
- Tar expansion material, and
- Asphalt expansion material.

The asbestos assessment conducted on the SC 18 Bridge on Shelby Highway over I-85 in Gaffney, South Carolina, **did not** identify asbestos-containing materials. If additional suspect materials are discovered during the planned renovation activities, bulk samples must be collected and analyzed for asbestos content prior to continuation of work. A copy of this report should be provided to the contractor(s) to assist with compliance with applicable State and Federal regulations.

3 Tar expansion material on top deck  
Sample A -

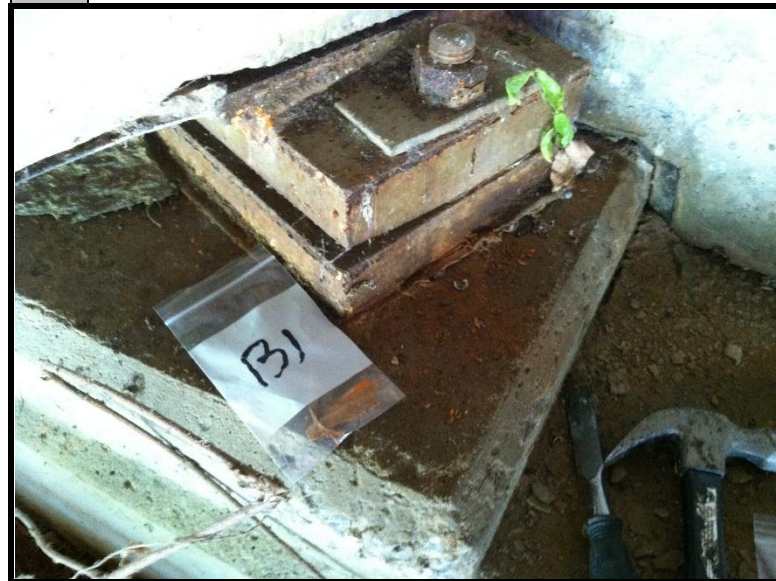
4 End abutment bearing pad  
Sample B -

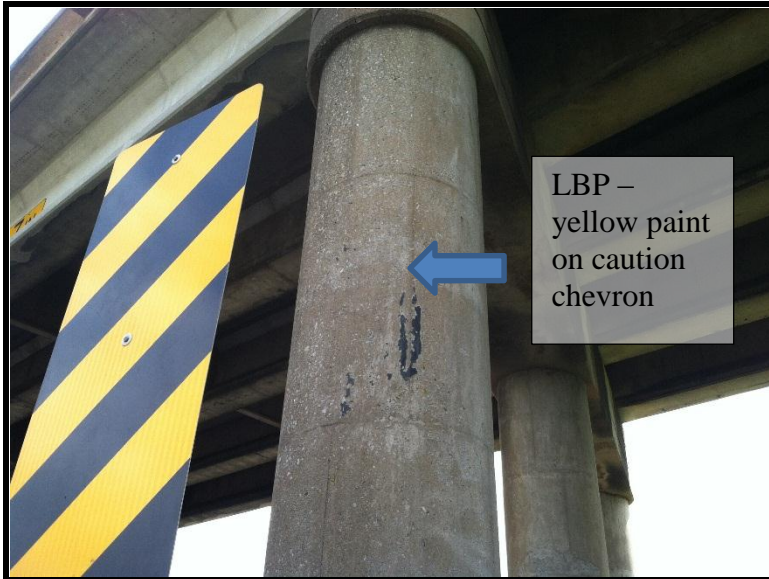
The **yellow painted caution chevrons on piers** were identified as containing lead levels exceeding the SCDHEC disposal limit of 0.7 mg/cm<sup>2</sup>. Destructive actions (sanding, burning, demolition, component removal, paint preparation) to the lead-containing paint surfaces will require the contractor to comply with the standards of SCDHEC and OSHA, including but not limited to proper disposal, initial exposure monitoring, the use of personal protective equipment, and medical surveillance. If additional painted components are discovered during renovation activities, the paint should be tested prior to any destructive actions (sanding, burning, demolition, component removal, paint preparation) or disposal.

**5** Lead sample from caution chevron on piers

SCDHEC Regulation 61-107.19 permits demolition materials painted with lead-based paint ( $\geq 0.7$  mg/cm<sup>2</sup>) to be disposed in a permitted Class Two (C&D) or Class Three Subtitle D, Municipal Solid Waste (MSW) landfill. However, accumulations of paint waste (chips, dust, or flakes) from the identified areas of lead-based paint may be classified as hazardous waste, which requires disposal in a Subtitle C (hazardous waste) landfill. The hazardous waste regulations include Title 40 Code of Federal Regulations parts 260 through 272. A sample of accumulated paint waste should be collected for analysis via Toxicity Characteristic Leaching Procedure (TCLP) to determine the waste's lead content and hazardous waste characteristics.

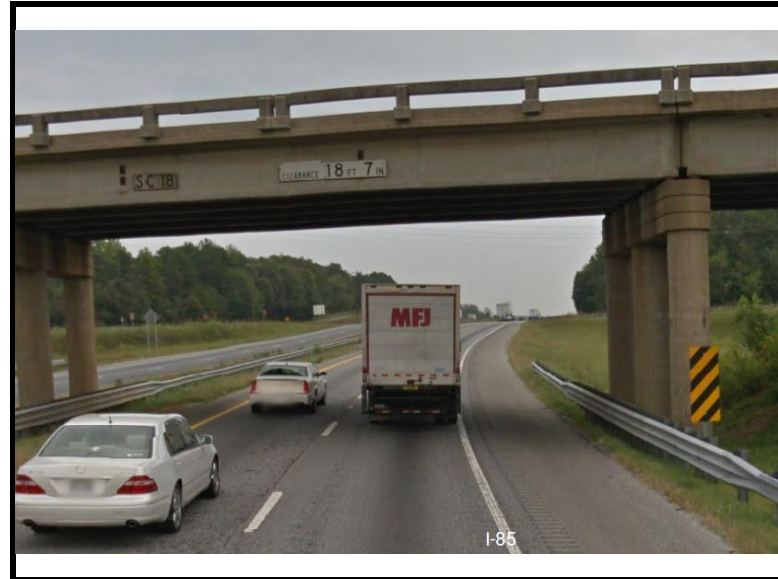
**6** General view from I-85
