## MEMORANDUM

**RE:** I-85 Spartanburg MM 77-96 Pavement Investigation Summary

On the nights of July 13<sup>th</sup>, August 9<sup>th</sup>, and December 15<sup>th</sup> 2015, OMR collected 67 cores and conducted Falling Weight Deflectometer (FWD) testing. This was done in order to assess the current condition of the pavement and make recommendations for pavement rehabilitation and widening. 6 of these cores were from the shoulder. The remaining 61 cores were all collected from or near the right wheel path of the right (outside, high truck traffic) lane. The following is a summary of our observations from these cores.

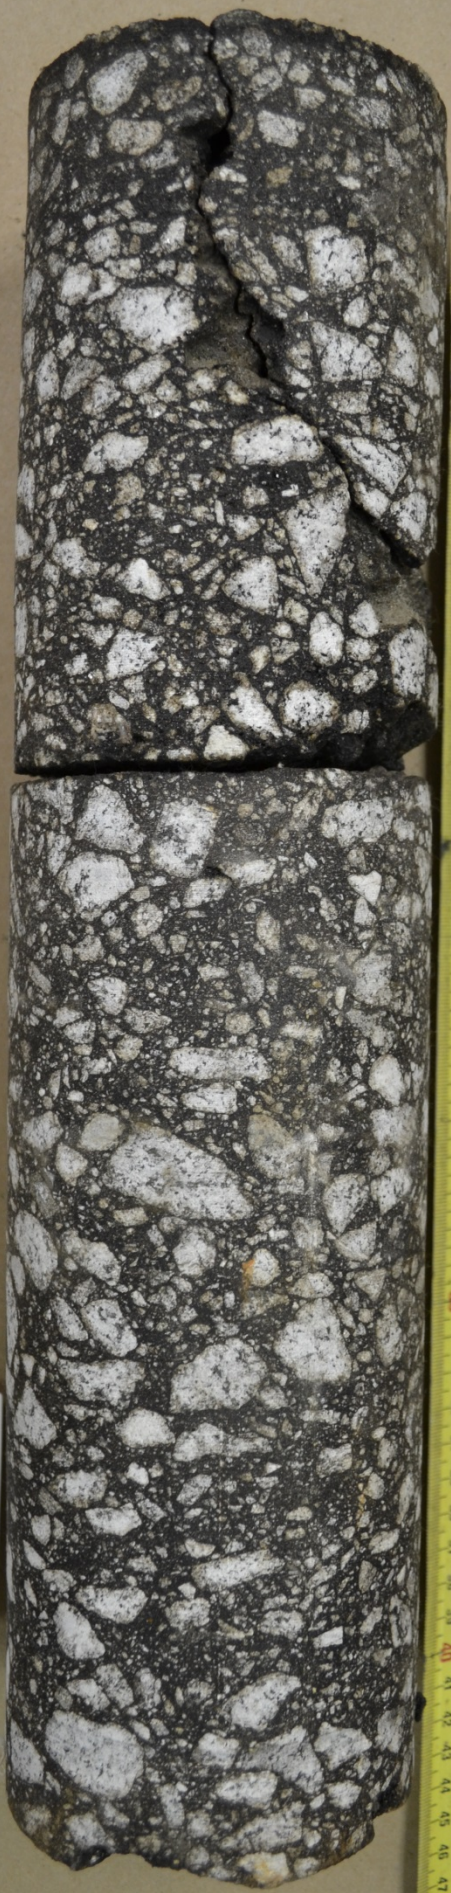
3

11 of 11 cores encountered cracking within the near surface HMA. The average depth of cracking was 4.5 inches varying from 2 to 6 inches with the exception of 2 locations where cracking extended to 10 and 13 inches. 5 of 11 cores exhibited debonding at or near the termination of cracking. In general, the mixtures are in relatively good condition. Poor mixture conditions (high void contents, stripping) were only encountered at 1 location existing between 2.75 to 4.25 inches below the surface. The base is in relatively good condition with only 2 locations exhibiting slight stripping near the bottom and 1 location with poor mixture quality in a relatively thin zone. Reference pictures of locations #3 and #8 for typical cores that exhibit cracking and debonding. Reference pictures of location #5 for typical cores that exhibit cracking only.

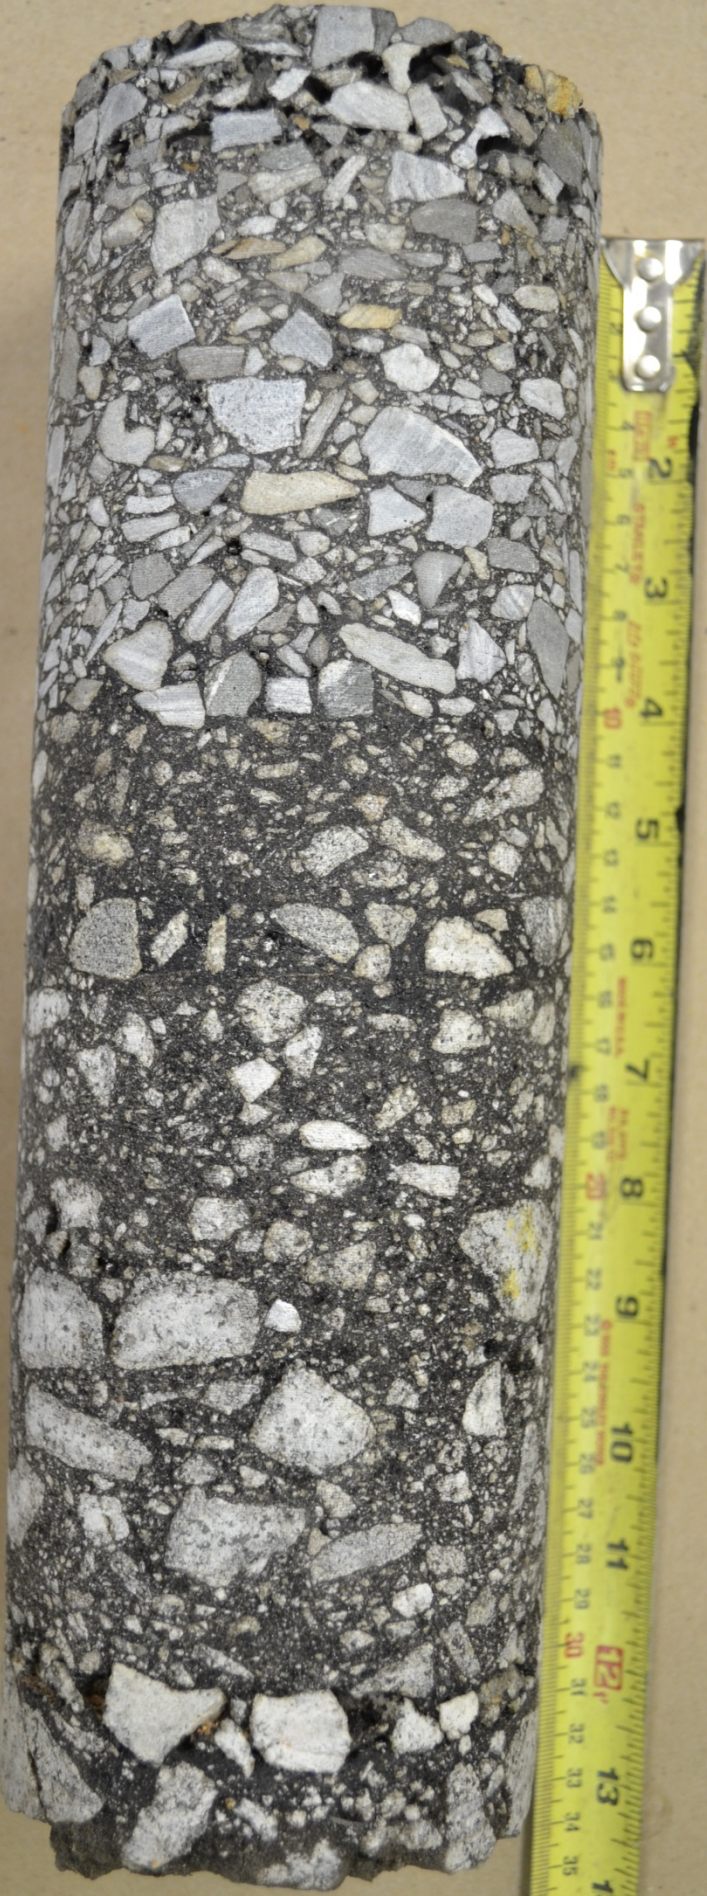
**1**

2 of 23 cores from 80 to 96 encountered cracking within the near surface HMA. Cracking was very slight and depth was hard to assess. In general, the mixtures are in relatively good condition. Variations in mixture conditions (void contents, stripping) were only encountered at 2 locations (paired with cracking) at approximately 3 inches below the surface and appeared to be isolated and low severity. The HMA base is in relatively good condition with 7 locations exhibiting low to moderate severity isolated stripping and voids near the bottom. The pavement is supported by a Macadam Base that appears to be in relatively good condition.

Reference pictures of locations #1, #8, #15 and #22 for typical variations in mixture quality.

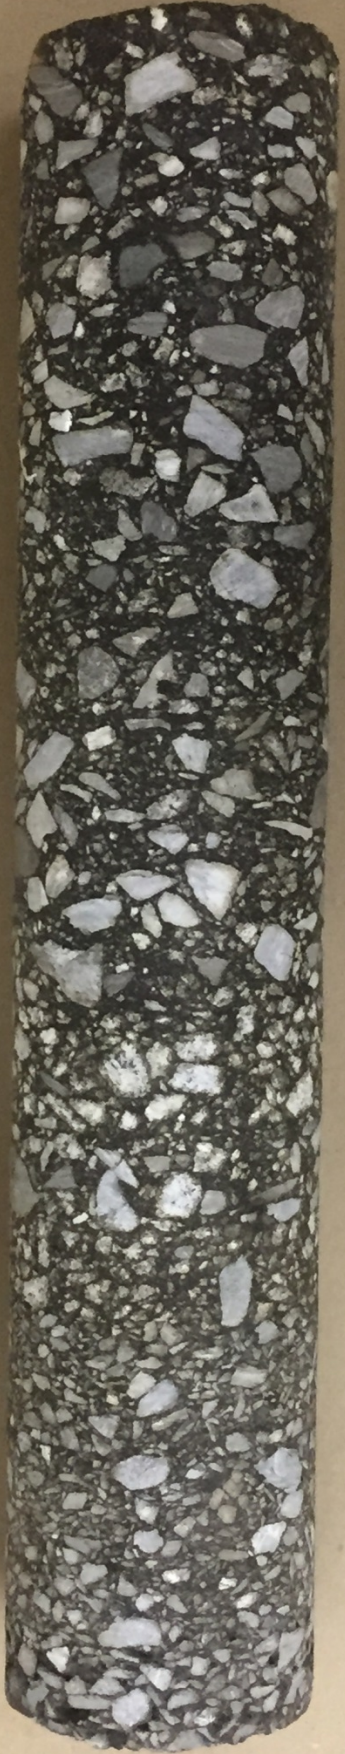
**1**

No cores were taken to investigate the depth of cracking at joints or along the center of lane cracking. It is assumed that this cracking is limited to the upper structure due to location. All of the 27 cores were taken within the right lane right wheel path. While the surface conditions North Bound and South Bound were similar, the cores indicated different underlying conditions. 17 of 27 cores South Bound encountered debonded layers with an average approximate depth of 6 inches below the surface, ranging from 4.5 to 14.25 inches. These debonded layers are typically located within a layer or layers of mixture that is of questionable quality. The layers are characterized as being rich in liquid AC that is relatively soft or resembling stripping. The AC typically stripped somewhat from the aggregate matrix during coring and in some cases could be indented by pressing with a fingernail. An extraction test was conducted to measure the binder grade. This test indicated results somewhat lower than expected for aged AC. The conditions of these layers varied from fair to poor and ranged from 1.5 to 16.5 inches below the surface. The presence of these questionable mixtures and debonded layers appears to be more prevalent between mile markers 93 to 80.

Reference pictures of locations #1, #9, #11, #17, #20, #24 and #25 for a representation of typical variations in mixture quality.
