**ASBESTOS CONTAINING MATERIAL SURVEY
AND
LEAD BASED PAINT SURVEY REPORT**

SC 277 Northbound Over I-77 Bridge Replacement
Richland County, South Carolina

F&R PROJECT NUMBER: 65V-0109

SCDOT PROJECT ID: P030487

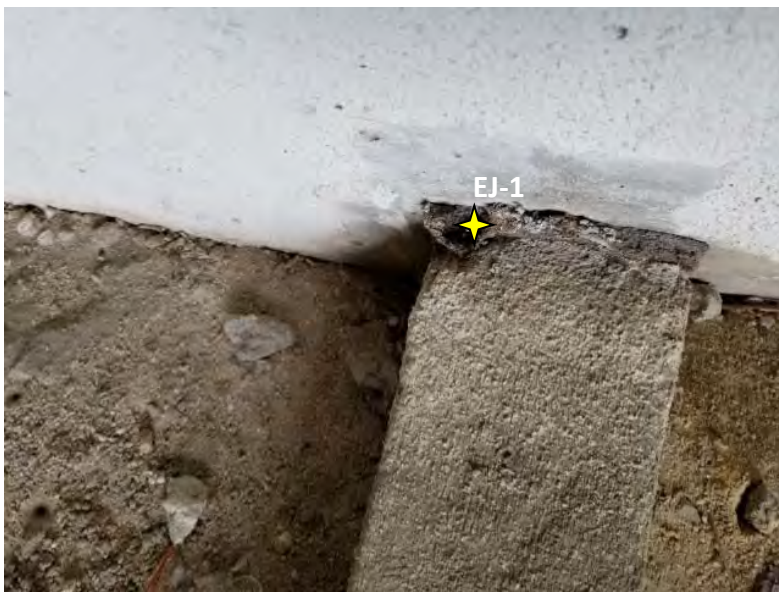
**VIEW OF EXPANSION JOINT
SAMPLING POINT AT THE INTERFACE
OF THE SOUTH ABUTMENT WALL
AND WING WALL**

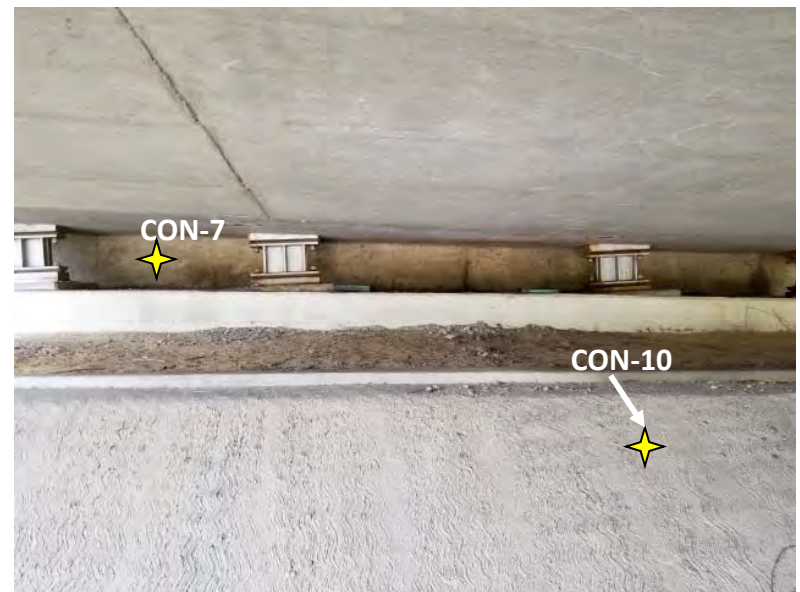
**VIEW OF CONCRETE SAMPLING
POINT ON THE SOUTH
ABUTMENT WALL AND ON THE
SOUTH WING WALL**

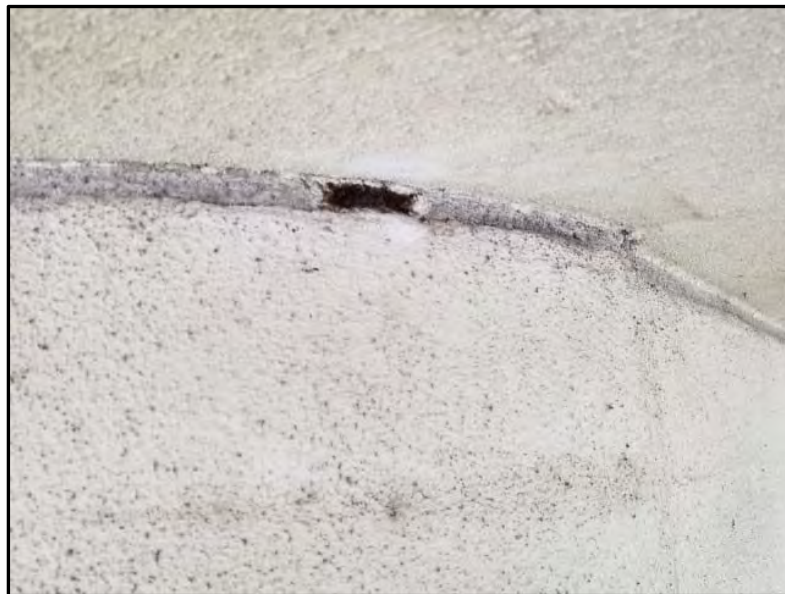
Photograph 6: View of expansion joint sampling point at the top of Bent 3 (None Detected).

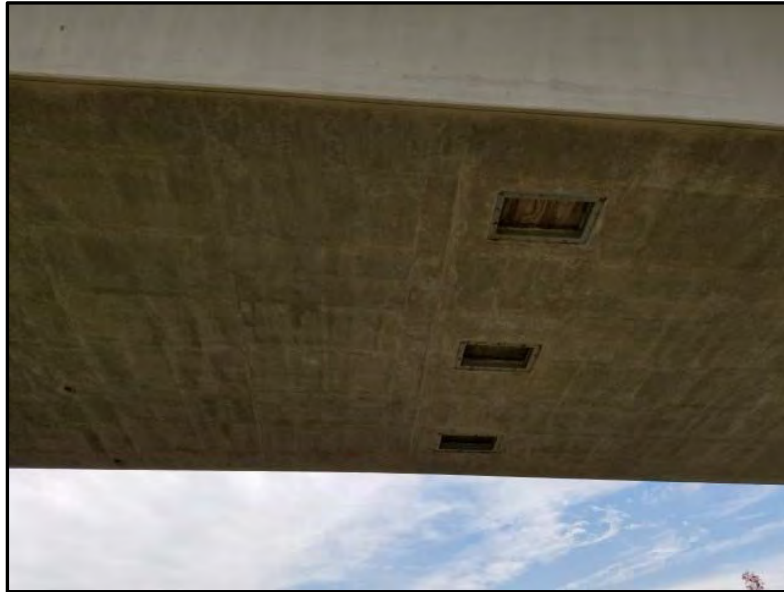
- Silver painted metal access hatch frames located along the perimeter of access ports to the interior of the hollow concrete girder
- Silver painted metal access hatch covers located at select access ports to the interior of the hollow concrete girder
- Silver painted metal support columns located between the bridge girder and pier footings and abutments
- Yellow striping located between the two northbound lanes on the concrete bridge roadway

Photograph 7: View of access hatches to the hollow concrete box girder. The silver painted metal access hatch frames and access hatches are coated with Lead Based Paint.

F&R recommends that all workers disturbing painted (or coated) surfaces as part of this project receive OSHA Lead in Construction Awareness training and that engineering controls and hygiene practices described in 29 CFR 1926.62 be followed during the disturbance of painted (or coated) surfaces.

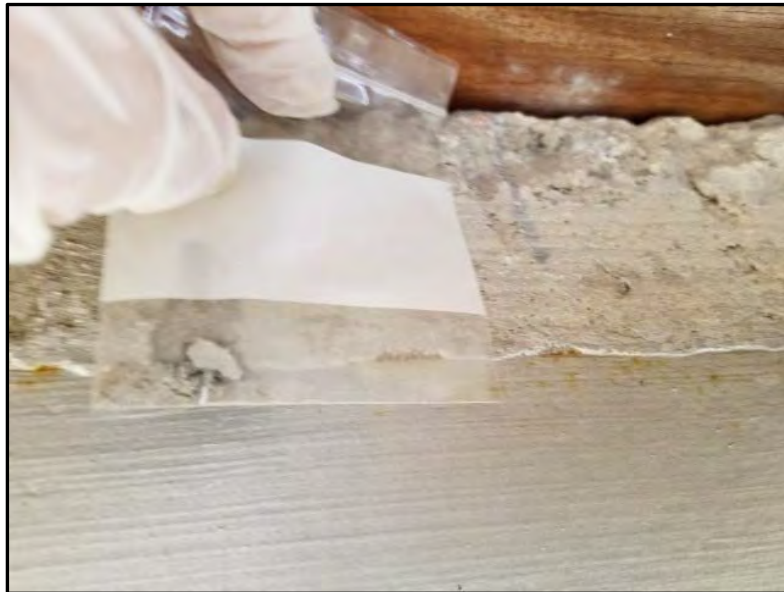
Photograph 8: View of concrete sampling point adjacent to an access hatch on the bottom of the concrete girder (None Detected).

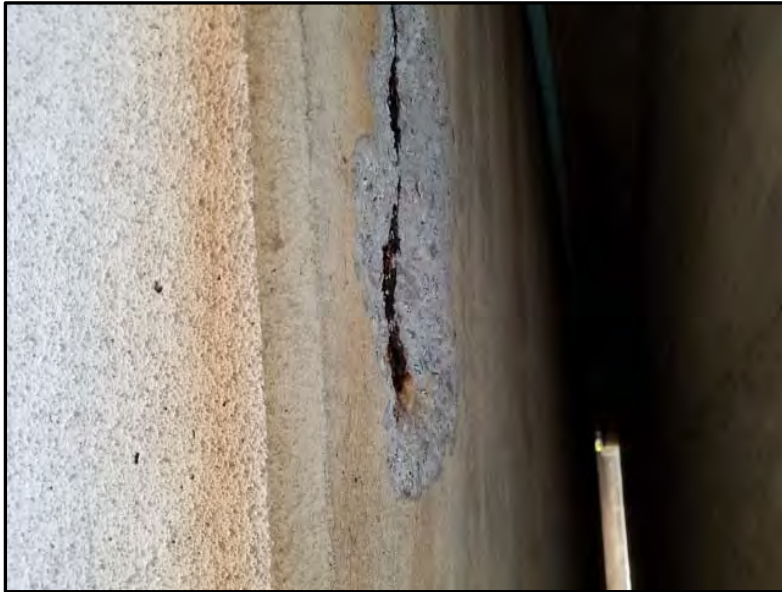
Photograph 9: View of concrete sampling point at the end of the girder adjacent to the abutment wall (None Detected).

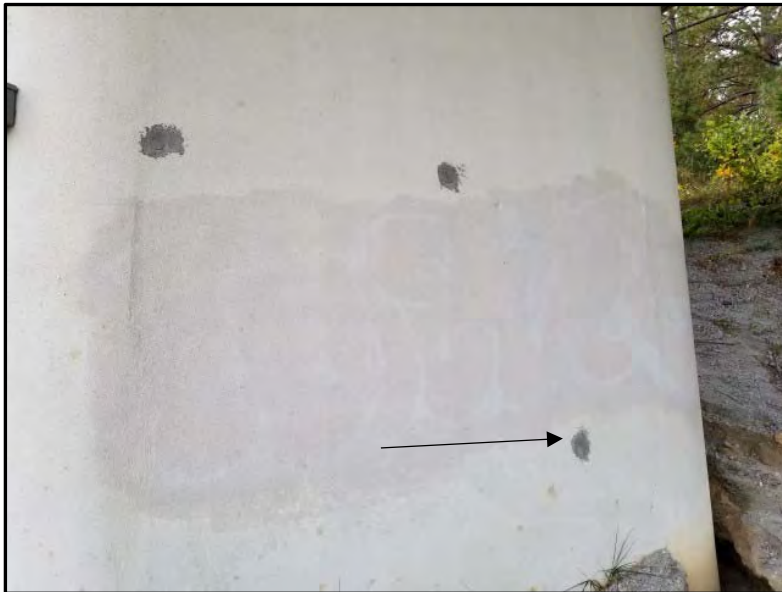
Photograph 10: View of gray cementitious material located at isolated areas on the bents and abutment 2. Bent 1 is pictured in this photo (None Detected).

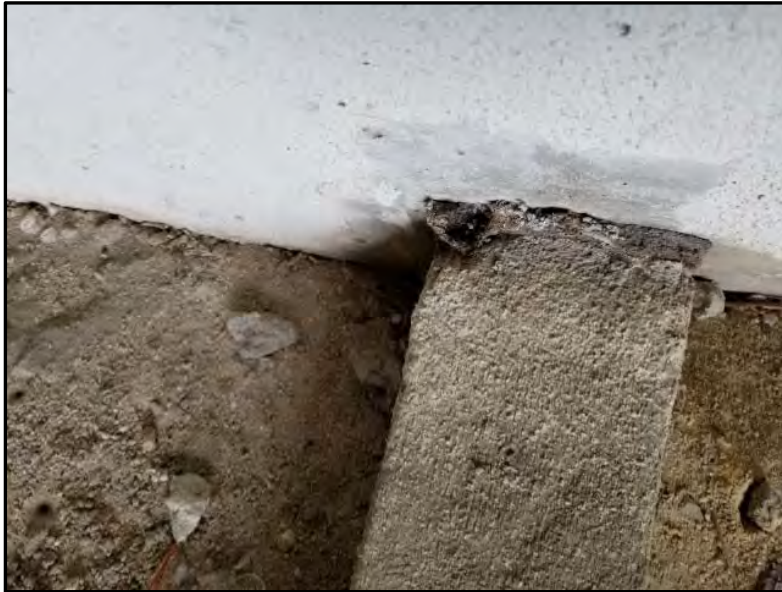
Photograph 11: View of expansion joint sampling point at the interface of the wing wall and the abutment wall (None Detected).

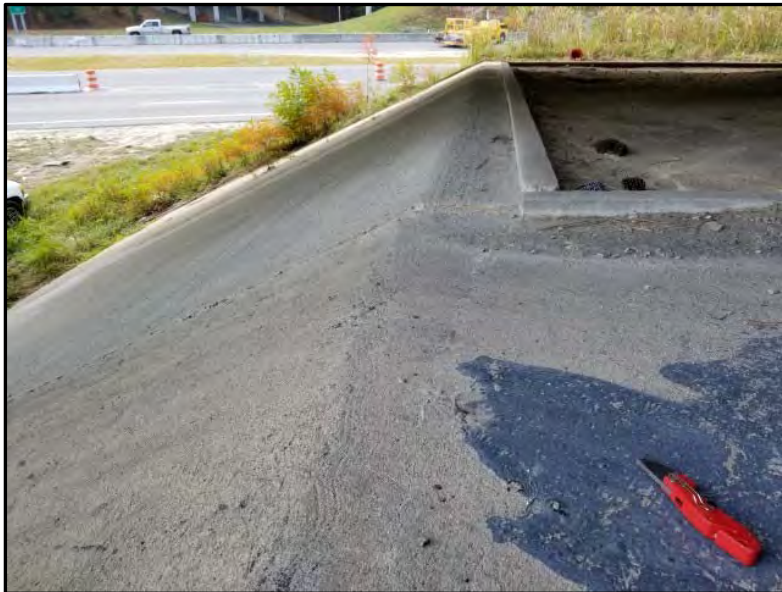
Photograph 12: View of gray mastic sampling point located at the top of the eastern wing wall (None Detected). This material was an isolated spill area at the top of the eastern wing wall.

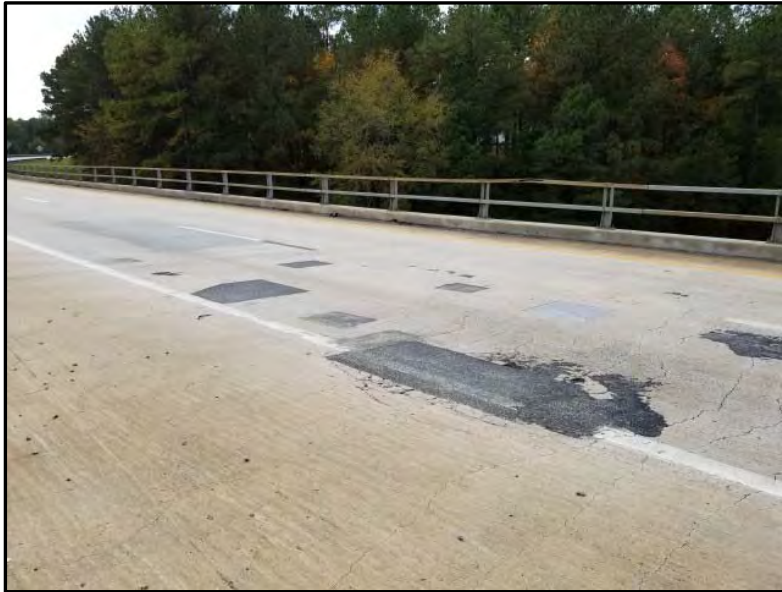
Photograph 13: View of asphalt patching of repaired areas along the bridge deck (None Detected).

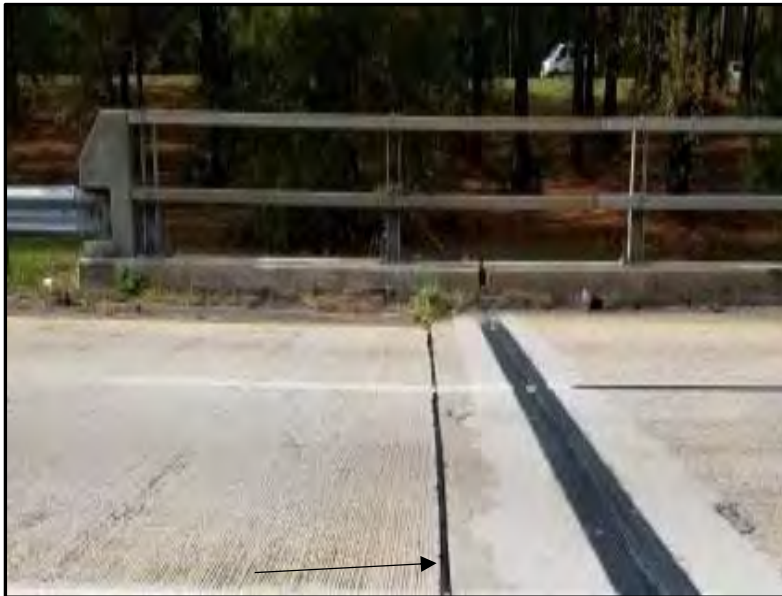
Photograph 14: View of black sealant sampling point located at the interface of the roadway and bridge approach (None Detected).

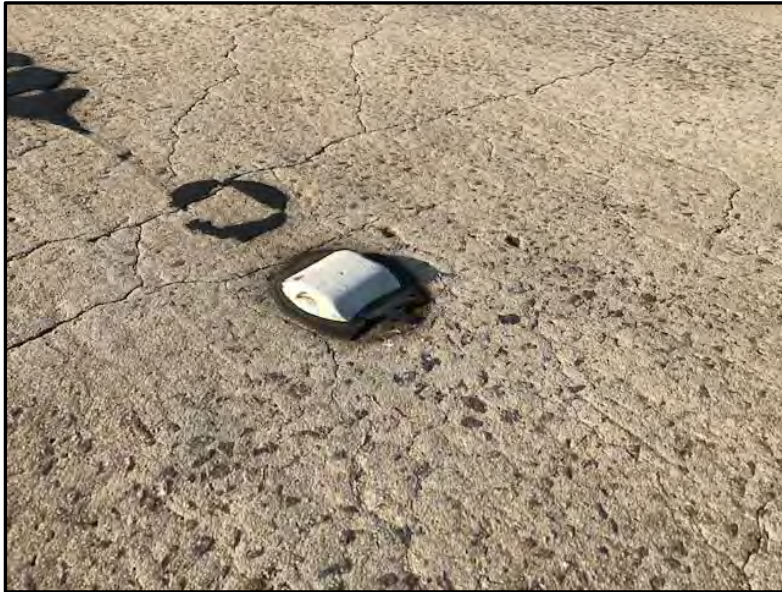
Photograph 15: View of black mastic sampling point associated with reflectors that are located along the center of the concrete bridge roadway (None Detected).

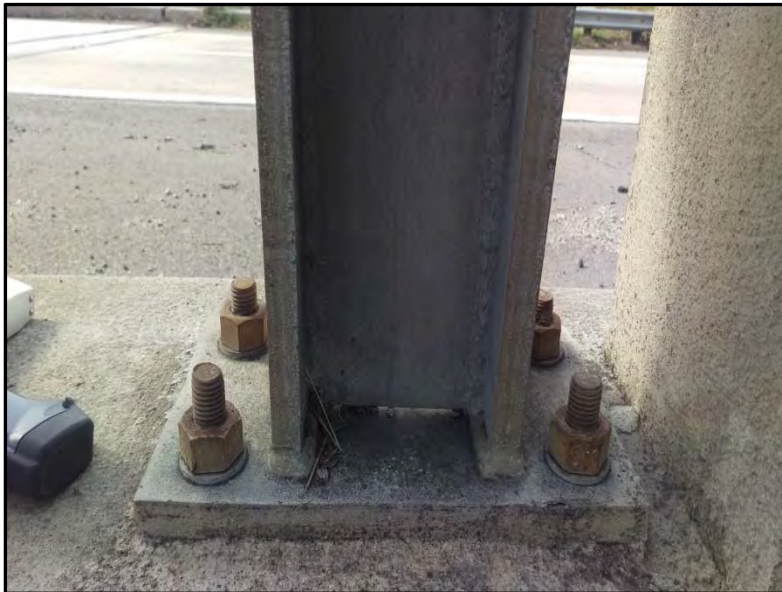
Photograph 16: View of silver painted steel support column located between the bridge girder and the abutment. The silver paint is lead based.

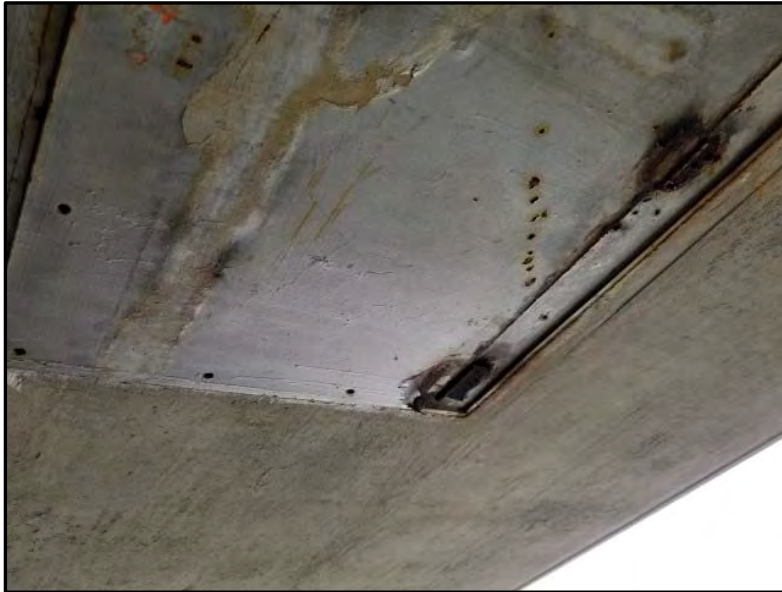
Photograph 17: View of lead based silver paint located on select painted access hatches on the underside of the concrete girder.

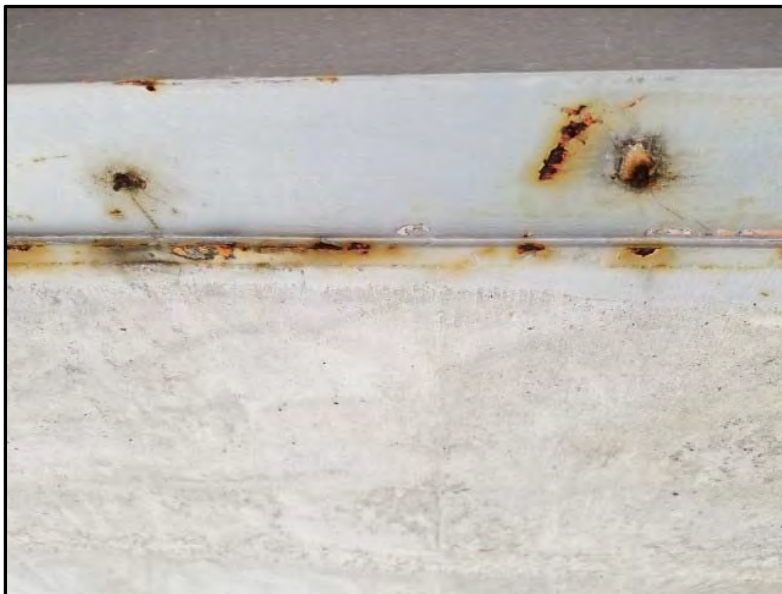
Photograph 18: View of lead based silver paint coated metal access hatch frame located at access hatches on underside of the concrete girder.
