**I-85 / I-385 Interchange Pipe Inventory Summary**

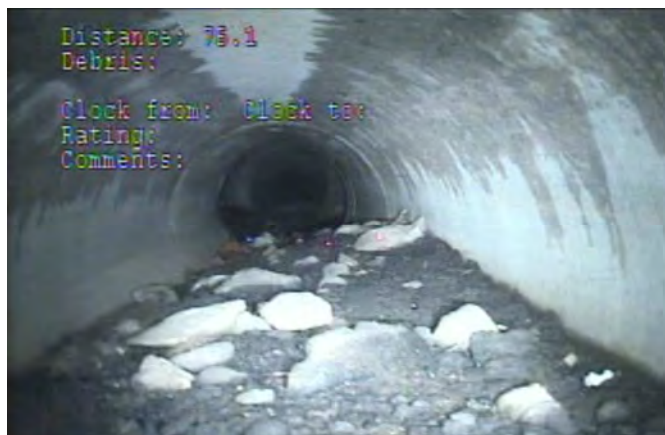
Debris at 75 ft

Based on the Video Pipe Inspection, Pipe A1 should be cleaned and retained.

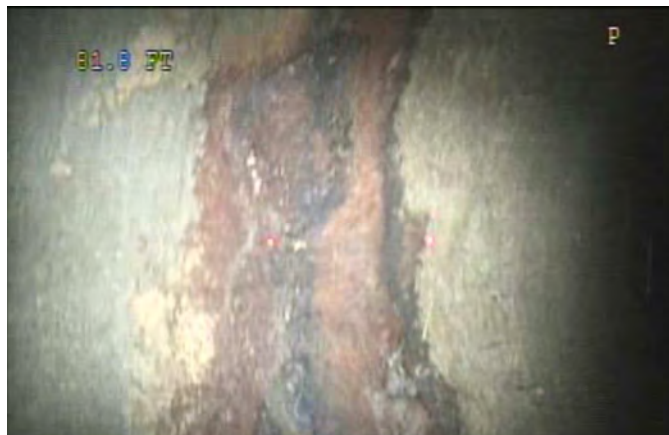
Joint - Separated at 82 ft

Based on Video Pipe Inspection and Hydraulic Information, Pipe A5 should be retained.

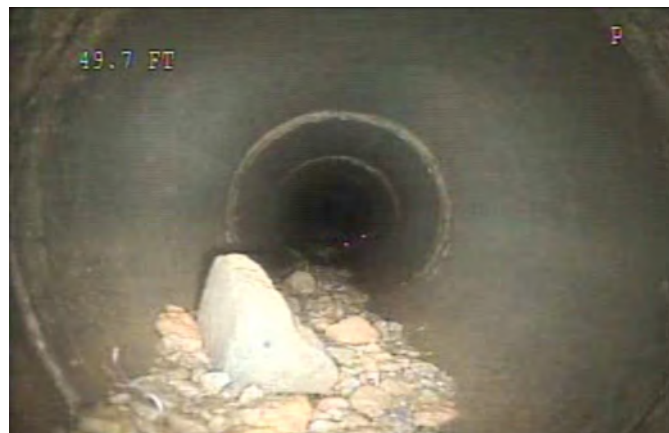
Debris at 50 ft

Based on Video Pipe Inspection and Hydraulic Information, Pipe A6 should be cleaned and retained.

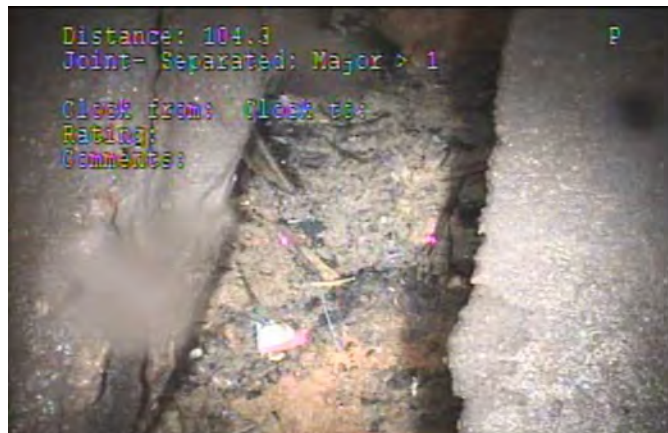
Joint - Separated at 104 ft

Based on Video Pipe Inspection and Hydraulic Information, retain 100' of the existing pipe from the median catch basin. Replace the last 24', which is affected by the two areas of joint separation.

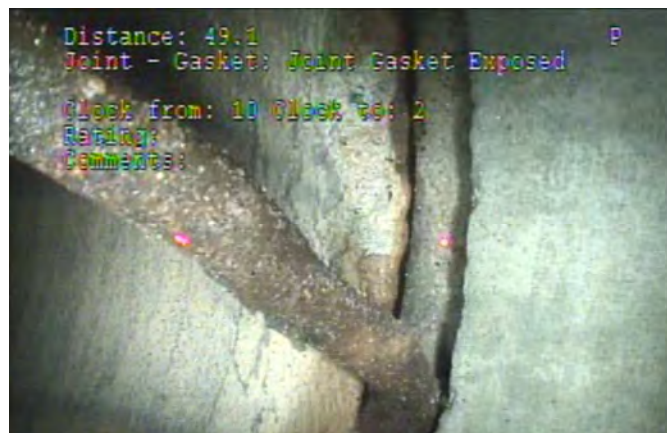
Joint - Gasket at 49 ft

Based on Video Pipe Inspection and Hydraulic Information, Pipe A11a should be retained.

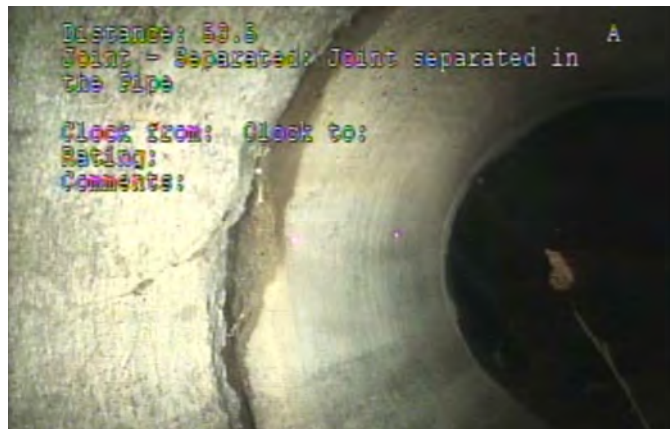
Joint - Separated at 53 ft

Based on Video Pipe Inspection and Hydraulic Information, retain 50' of the existing pipe from the median catch basin. Replace the last 8', which is affected by the joint separation.

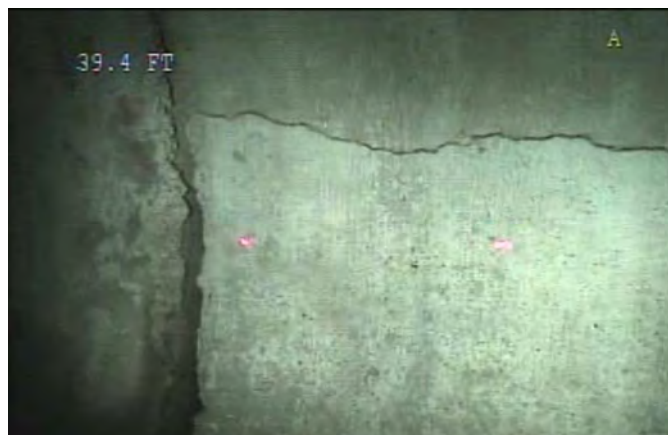
Joint - Separated at 8 ft and 40 ft; Crack - Multidirectional at 40 ft;  
Obstruction (debris) at 40 ft; VPI incomplete

Joint - Separated and Multidirectional crack at 40 ft

Based on Hydraulic Information, Pipe A18 should not be used. Concept Plans replace the existing 18" R.C. Pipe with a 24" Smooth Wall Pipe.

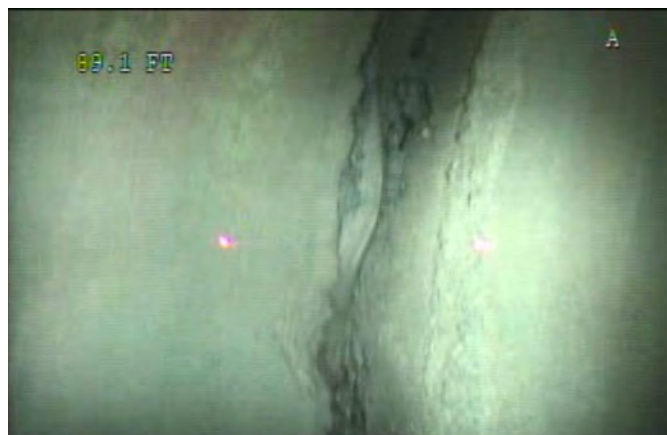
Joint - Separated at 89 ft

Based on Hydraulic Information, Pipe A19 should not be used. Concept Plans replace the existing 18" R.C. Pipe with a 24" Smooth Wall Pipe.

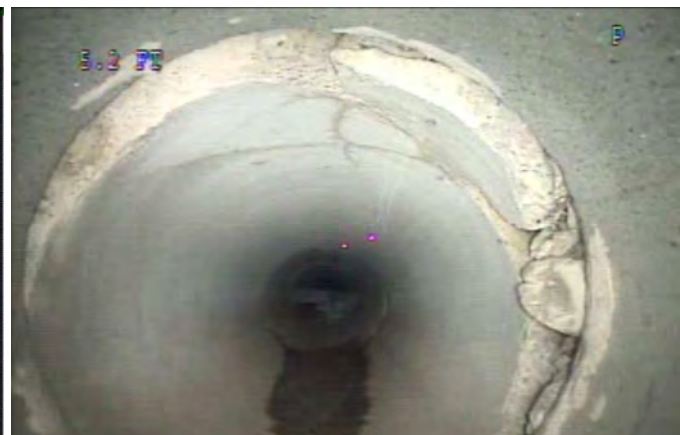
Crack - Multidirectional at 4 ft and 8 ft; Joint - Separated at 8 ft and 88 ft;  
Debris at 22 ft

Joint - Separated and Multidirectional crack at 8 ft

Based on the Video Pipe Inspection, Pipe B2 should be slip lined if retained due to deficiencies. Capacity should be verified with slip lined pipe. Concept Plans remove the existing 18" R.C. Pipe.

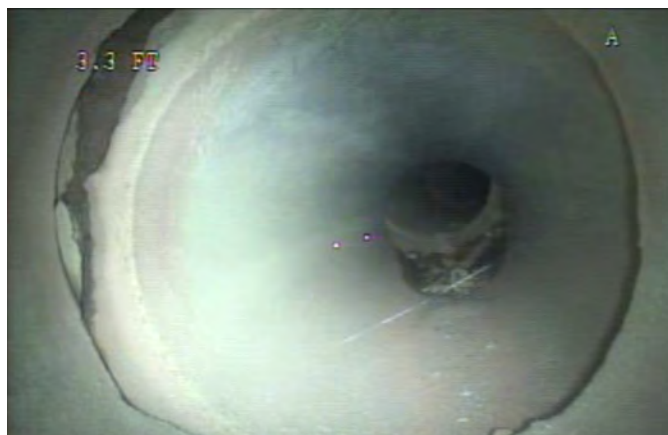
Pipe not connected at 6 ft; All joints major offset as far as camera will zoom

Based on the Video Pipe Inspection, Pipe B3 should not be used due to deficiencies. Concept Plans plug and abandon the existing 18" R.C. Pipe.

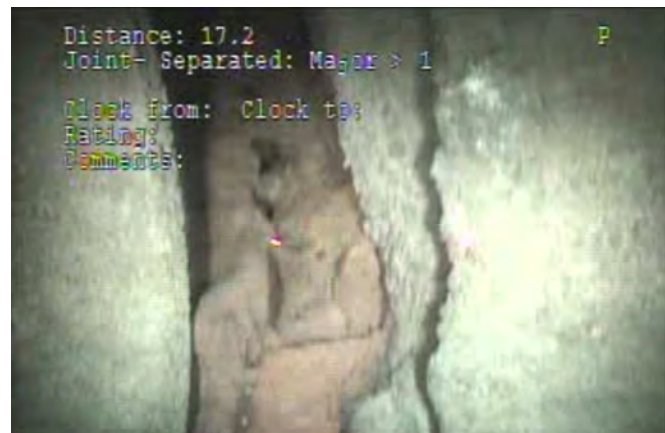
Joint - Separated at 4 ft (left) and 17 ft (right); other joint separations similar

Based on the Video Pipe Inspection, Pipe B5 should be slip lined due to deficiencies. Capacity should be verified with slip lined pipe.

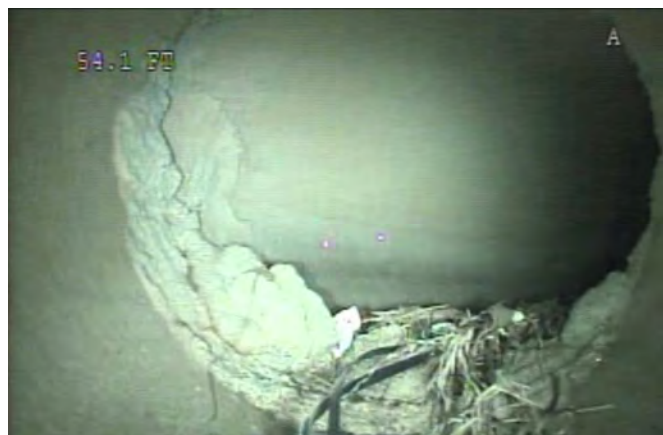
Joint - Separated and Joint - Angular at 58 ft

Based on the Video Pipe Inspection, Pipe B6 should be slip lined due to deficiencies. Capacity should be verified with slip lined pipe. Concept Plans plug and abandon the existing 18" R.C. Pipe.

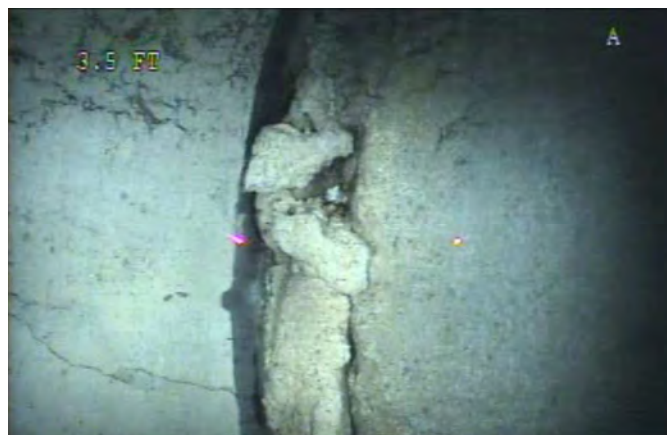
Joint - Separated at 4 ft

Based on the Video Pipe Inspection and Hydraulic Information, Pipe B7 should be retained. Concept Plan will eliminate the joint separation at 4' by removing 6' of existing pipe.

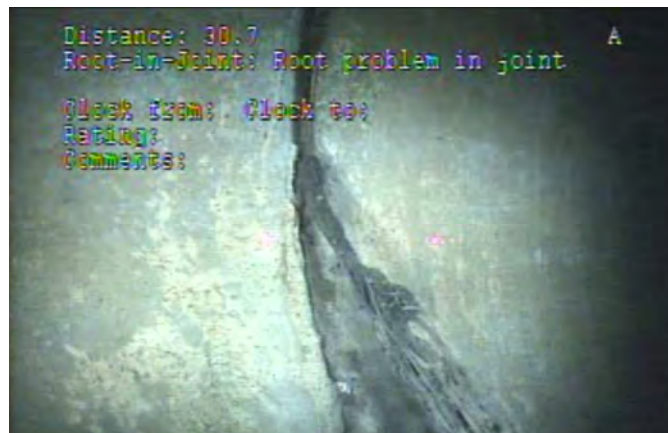
Root in joint at 31 ft

Based on the Video Pipe Inspection and Hydraulic Information, Pipe B9 should be retained.

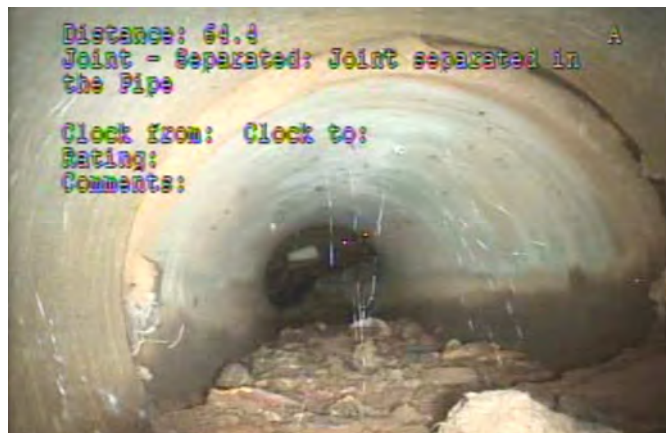
Joint - Separated at 64 ft

Based on Video Pipe Inspection and Hydraulic Information, clean and retain 60' of the existing pipe from the median catch basin. Replace the last 15', which is affected by joint separation, but is not located under the travelway.

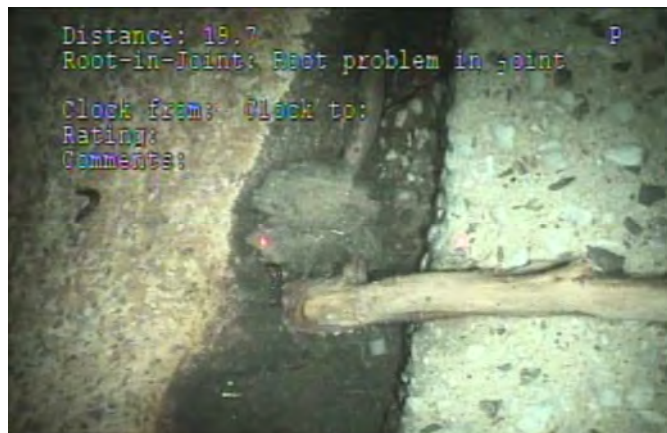
Root in joint at 19 ft

Based on the Video Pipe Inspection, 61' of Pipe B11 from the median catch basin can be retained. Replace the last 25', which is affected by joint offset, but is not located under the travelway. Concept Plans remove pipe B11.

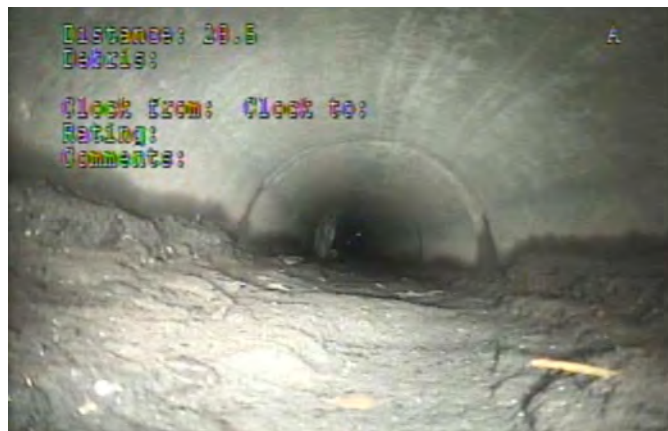
Debris at 29 ft

Based on Video Pipe Inspection and the Hydraulic Information, Pipe B12 should be cleaned and retained.

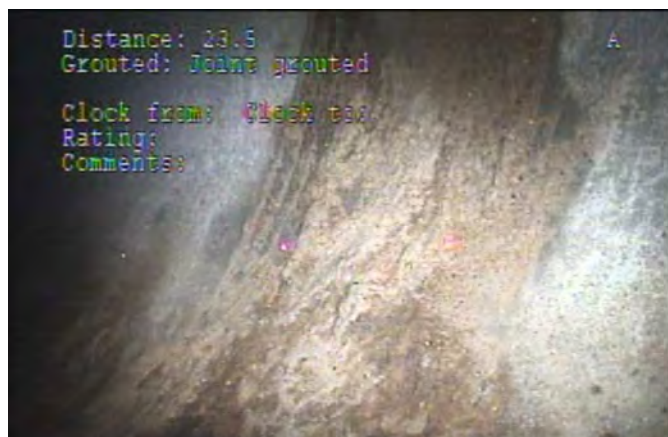
Grouted at 24 ft

Based on the Video Pipe Inspection, Pipe B13 could be retained. The Concept Plan replaces B13.

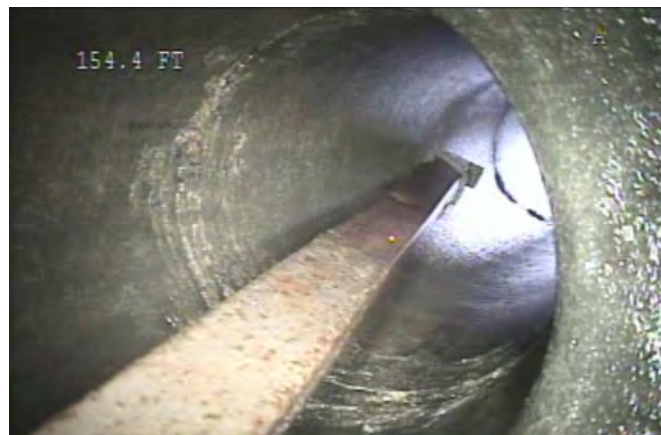
Debris at 154 ft (Left: looking ahead; Right: looking up)

Based on the Video Pipe Inspection, it appears as though the obstruction is located at the median CB and should be able to be removed. Also up until 154', the pipe appears to be in good shape. Remove obstruction at catch basin, clean and retain pipe.

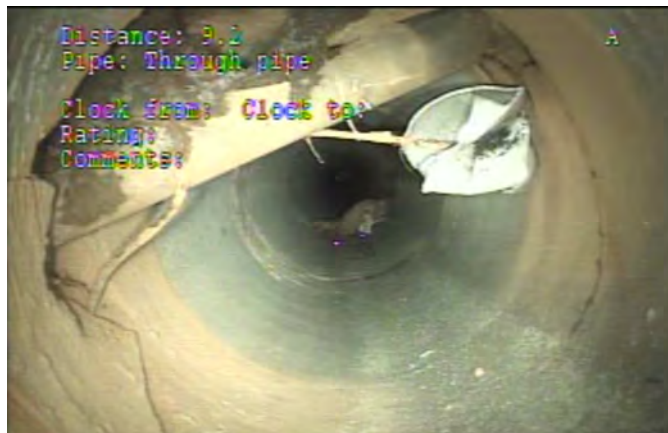
Utility conduit through pipe (broken) at 9 ft

Utility conduit through pipe at 9 ft

Based on Video Pipe Inspection, replace 12' of pipe at the outlet (to fix the broken pipe).

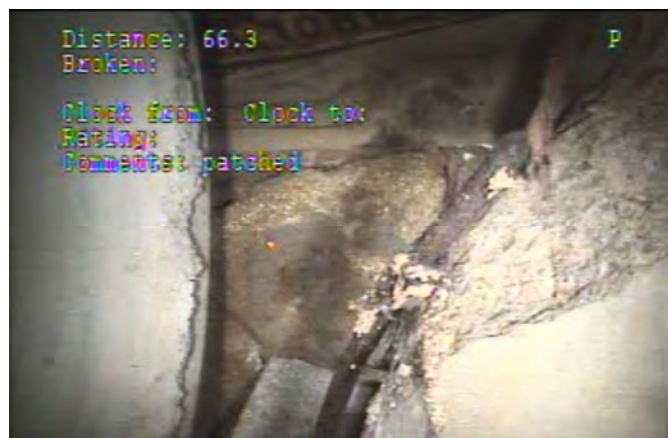
Broken (patched) at 66 ft; Crack at 75 ft

Broken at 66 ft

Based on the Video Pipe Inspection, Pipe B17 should be slip lined due to  
defficiencies. Capacity should be verified with slip lined pipe.

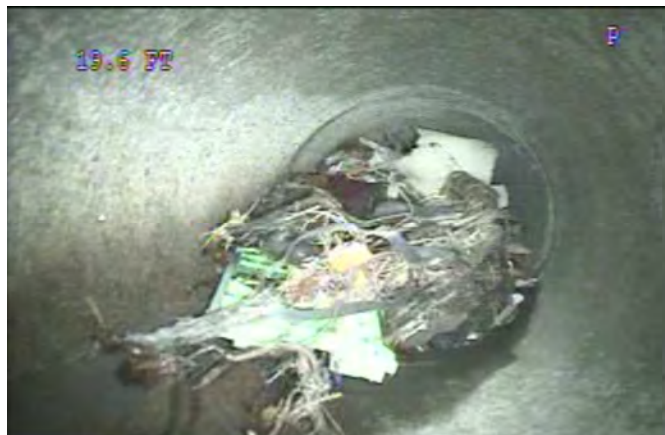
Debris at 22 ft

Based on the Video Pipe Inspection and the Hydraulic Information, Pipe B18 should be cleaned and retained.

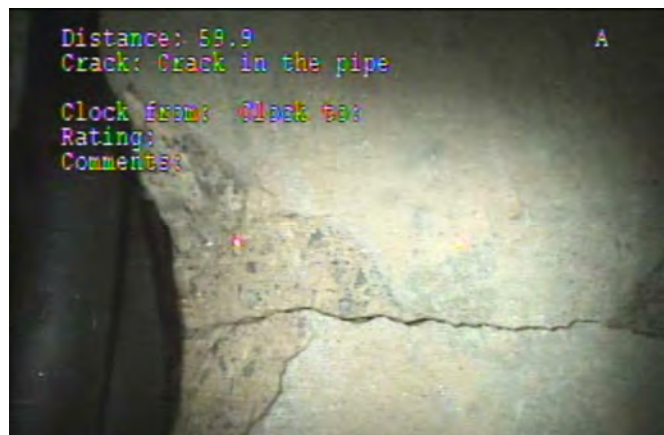
Joint - Gasket at 43, 47, and 57 ft; Crack at 60 ft

Crack at 60 ft

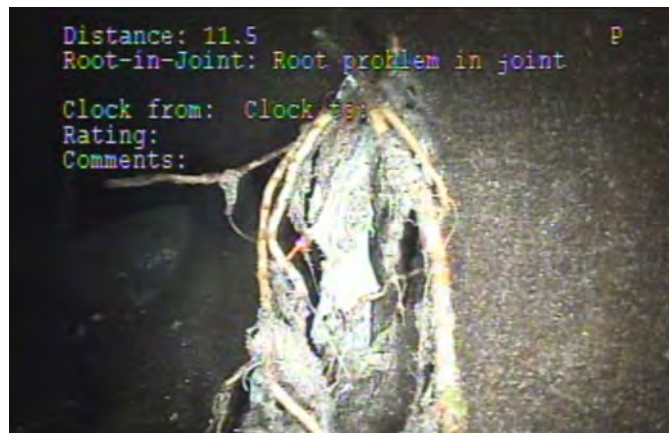
Root in joint at 12 ft

Based on Video Pipe Inspection and Hydraulic Information, Pipe B25 should be cleaned and retained.

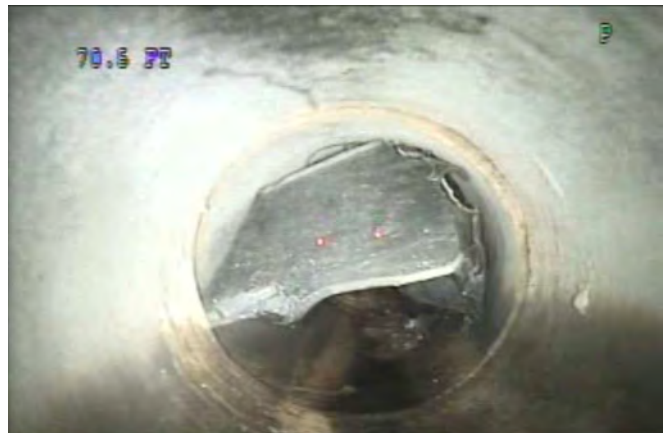
Joint Offset at 13 ft; Grouted at 20 ft; Debris at 72 ft;  
Crack at 74 ft; VPI incomplete

Crack (above) and debris at 72 ft

Based on Video Pipe Inspection and Hydraulic Information, 68' from the median catch basin could be cleaned and retained. Replace the last 13', which is affected by the joint offset and not located below the travelway.

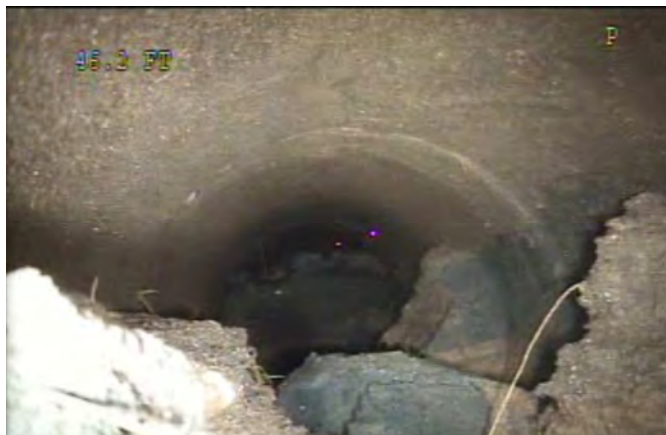
Debris at 46 ft

Based on Video Pipe Inspection and Hydraulic Information, Pipe B30 could be cleaned and retained.

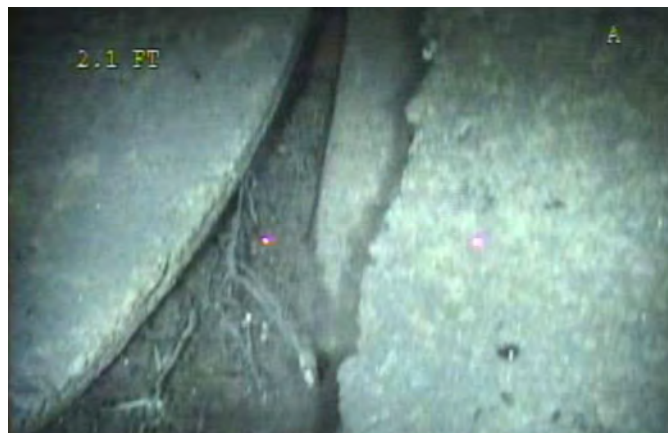
Joint - Separated at 2 ft

Based on the Video Pipe Inspection and Hydraulic Information, Pipe B31 should be slip lined due to deficiencies. Capacity should be verified with slip lined pipe.

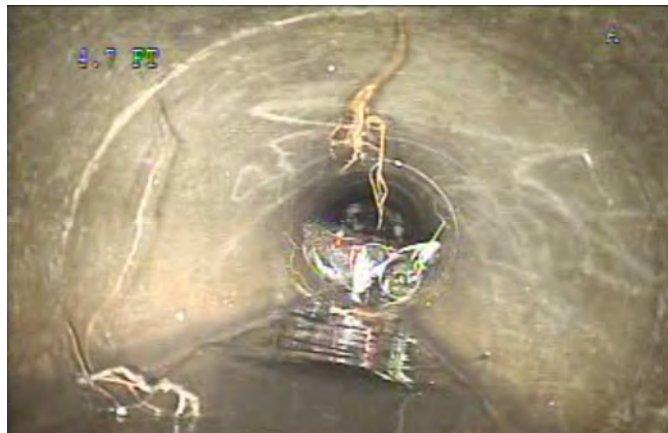
Root in joint at 6 ft; Debris ahead

Based on Video Pipe Inspection and Hydraulic Information, Pipe B32 could be cleaned and retained.

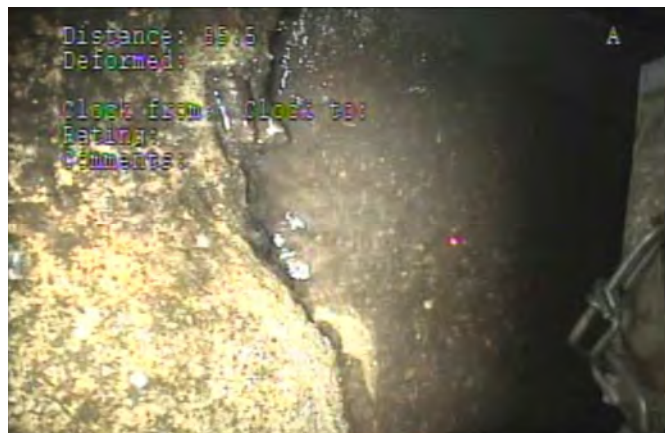
Deformed at end adjacent to junction box

Based on the Video Pipe Inspection and Hydraulic Information, Pipe B34 could be retained.

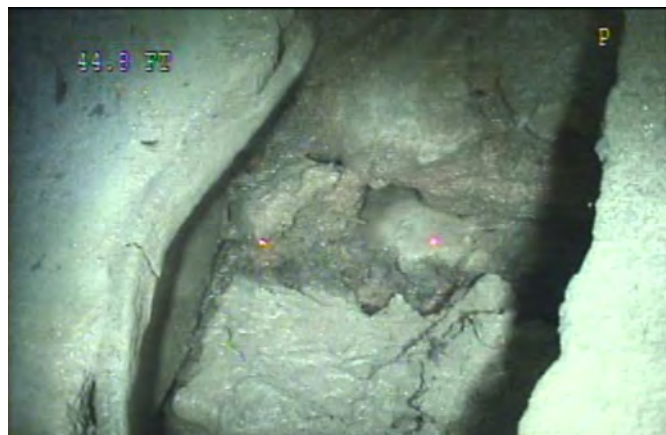
Joint Offset at 2 ft at 8 ft; Joint - Separated at 4 ft and 13 ft; Broken at 45 ft;

Broken at 45 ft

The pipe is no longer in use, but based on the video inspection of the pipe, there are large deficiencies under the travelway that could cause future problems. Also, Field surveys noted the presence of large amounts of sediment in the down stream catch basin. Pipe B36 should be removed or plugged & abandoned.

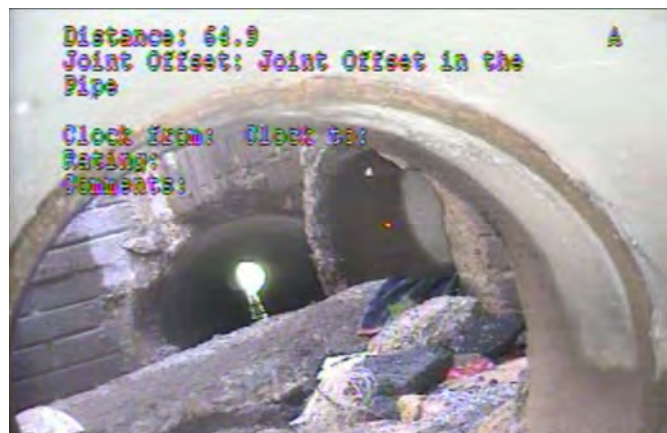
Joint Offset at 65 ft; Also looking at debris in CB

Based on Video Pipe Inspection and the Hydraulic Information, Pipe B38 could be retained.

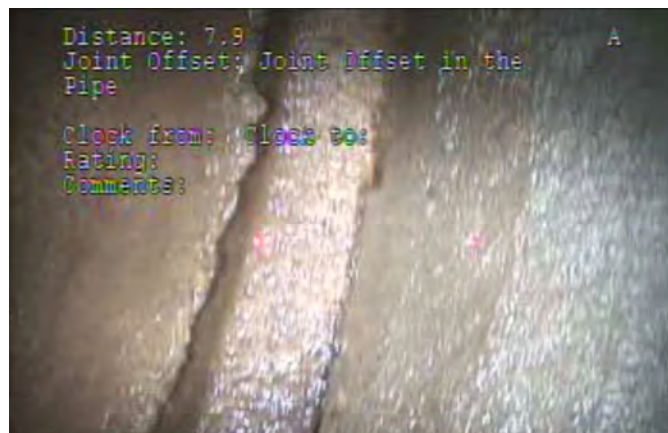
Joint Offset at 8 ft

Based on Video Pipe Inspection and the Hydraulic Information, Pipe B39 could be retained.

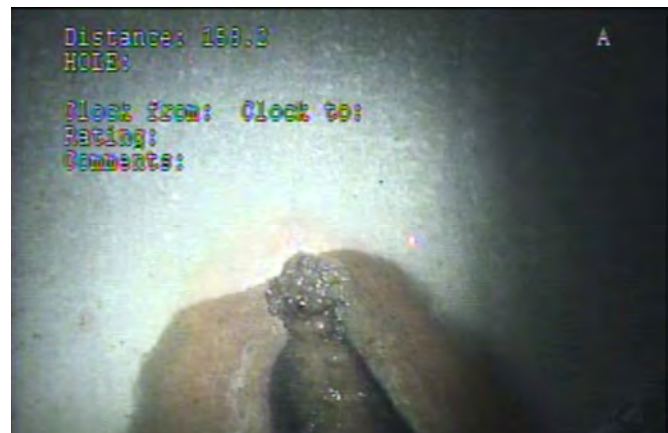
Crack - Longitudinal at 17, 48, 90, and 105 ft; Joint Offset at 154 ft;

Hole at 158 ft

Based on the Video Pipe Inspection, Pipe C2 should be slip lined due to deficiencies. Capacity should be verified with slip lined pipe.

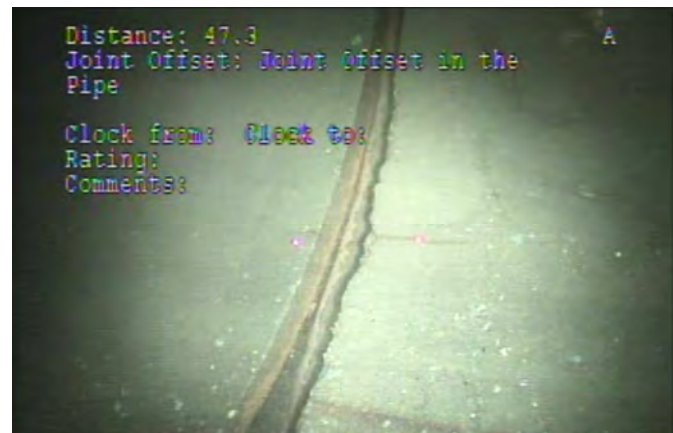
Crack - Longitudinal at 20 ft; Joint Offset at 47 ft

Joint Offset at 47 ft

Based on the Video Pipe Inspection and Hydraulic Information, retain 80' of the existing pipe from the median catch basin. Replace the last 47', which is affected by joint offset.

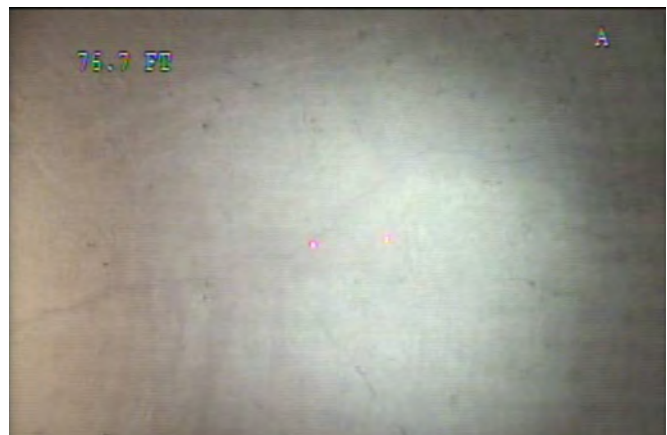
Crack - Longitudinal at 6 ft and 55 ft; Joint Offset at 28 ft and 76 ft;  
Crack - Multidirectional at 77 ft

Multidirectional crack at 77 ft

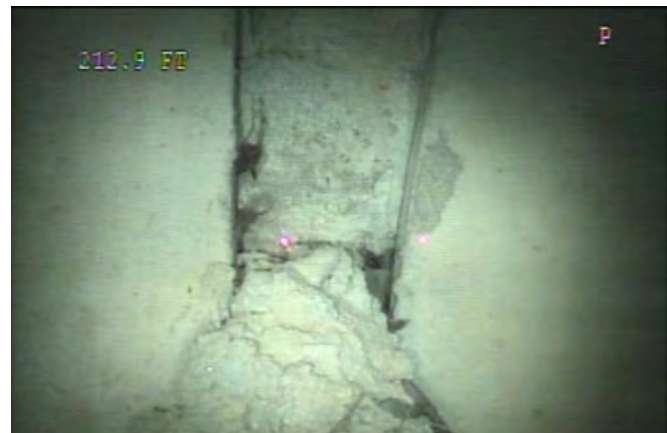
Joint Offset at 8, 25, 66, 98 and 132 ft; Crack - Longitudinal at 8, 49, and 95 ft;  
Crack - Circumferential at 61 ft and 95 ft; Crack - Multidirectional at 104 ft and 132 ft; Joint - Separated at 123, 156, 164, and 213 ft

Joint - Separated at 213 ft

Based on Video Pipe Inspection, Pipe C5 should be slip lined due to deficiencies. Capacity should be verified with slip lined pipe. The Concept Plan only retains the section of C5 between 24' and 94' in the VPI which shows minimum deficiencies and could be retained.

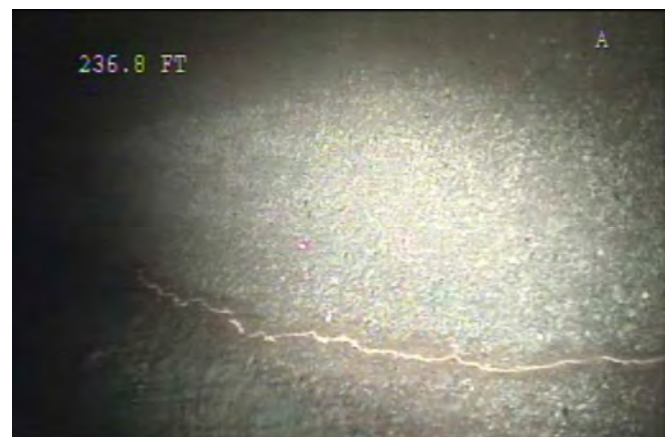
Crack - Longitudinal at 20, 232, 237, 270, and 344 ft; Joint Offset at 34, 82, 124,  
164, 213, and 302 ft; Crack - Circumfrenclal at 103 ft; Joint - Alignment at 107  
and 172 ft; Joint - Separated at 286 and 360 ft

Longitudinal crack at 237 ft

Based on the Video Pipe Inspection, Pipe C7 should be slip lined due to  
deficiencies. Capacity should be verified with slip lined pipe. The Concept  
Plans plug & abandon the existing 30" R.C. Pipe.

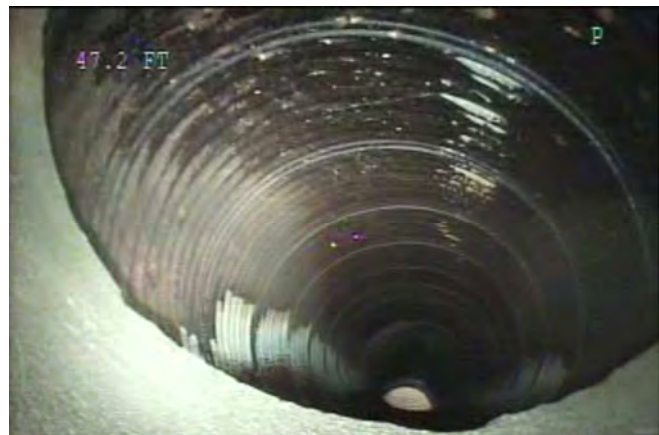
All joints offset; Broken at 7 ft;  
Change from RCP to corrugated pipe at 49 ft - Joint Failure; VPI incomplete

Change from RCP to CMP at 49 ft

Based on Video Pipe Inspection and Hydraulic Information, Pipe C8 should be replaced and should not be used.

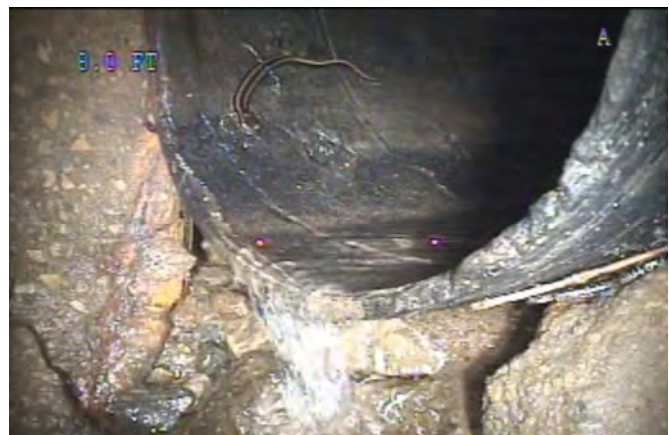
Lateral at 8.0 ft

Based on Video Pipe Inspection, Pipe C10 should not be used. Concept Plans replace the existing 18" R.C. Pipe.

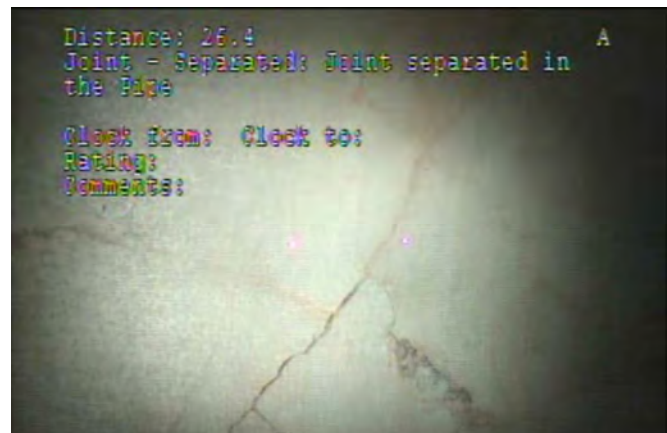
Joint - Separated and Multidirectional crack at 26 ft

Based on Video Pipe Inspection, Pipe C12 could be retained. Concept Plans remove the existing 24" R.C. Pipe.

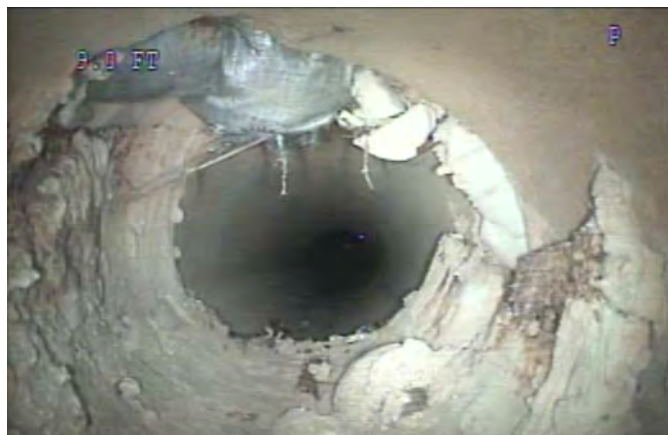
Broken at 9 ft

Based on the Video Pipe Inspection, Pipe D2 should not be used due to deficiencies.

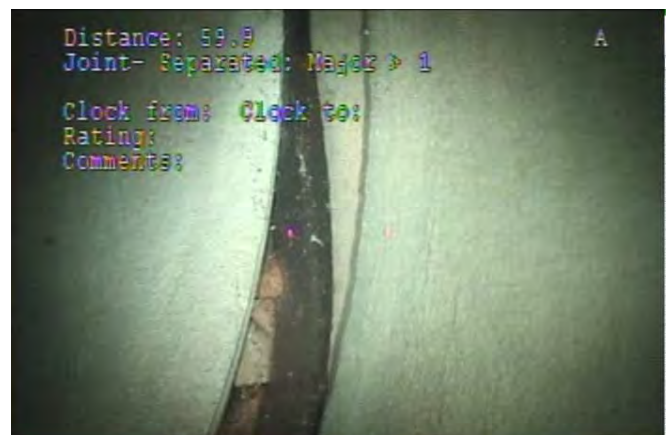
Joint - Separated at 53 ft (left) and 60 ft (right)

Based on the Video Pipe Inspection, Pipe D3 should be slip lined due to deficiencies. Capacity should be verified with slip lined pipe.

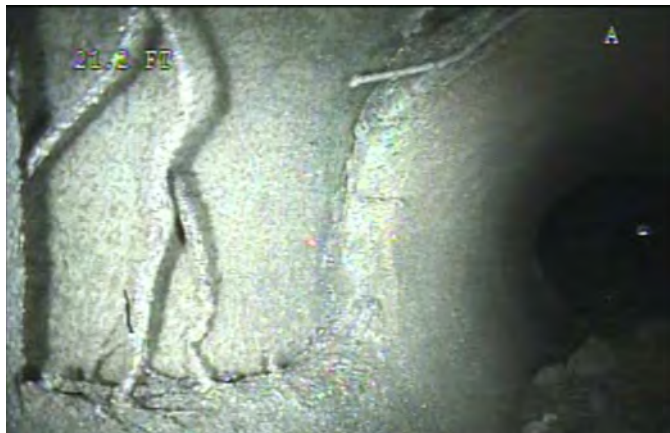
Hole at 22 ft

Based on the Video Pipe Inspection, Pipe D5 should be slip lined due to deficiencies. Capacity should be verified on slip lined pipe.

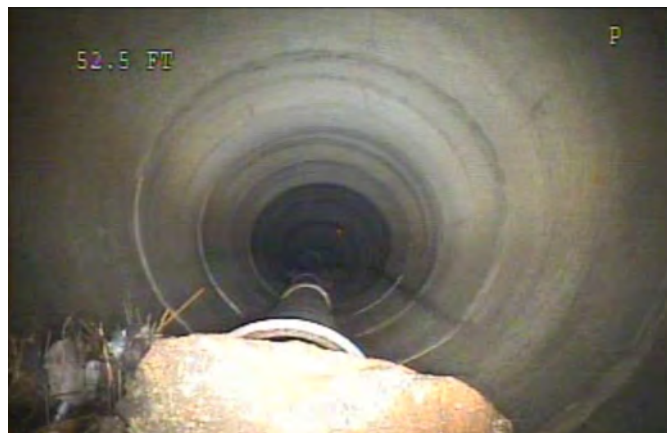
Ductile pipe at 55 ft

Based on Video Pipe Inspection and Hydraulic Information, Pipe D8 could be retained.

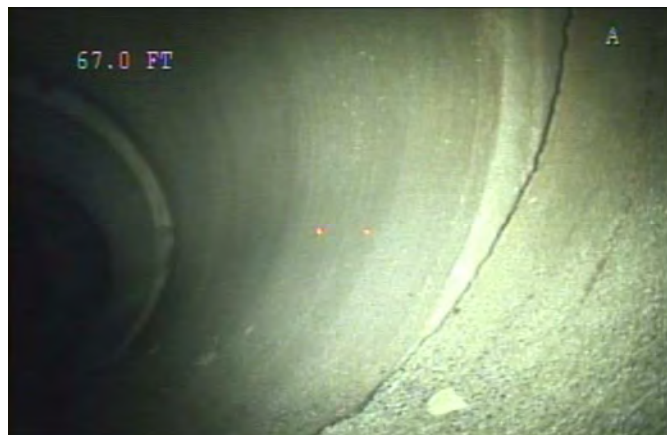
Joint Offset at 69 ft

Based on the Video Pipe Inspection and the Hydraulic Information, Pipe D9 could be retained.

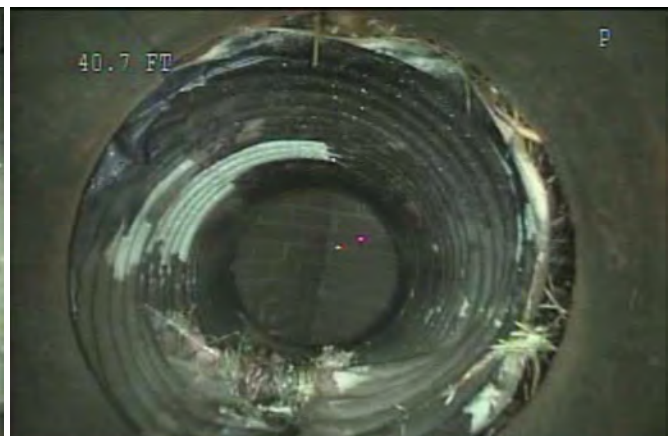
Joint failure at 43 ft

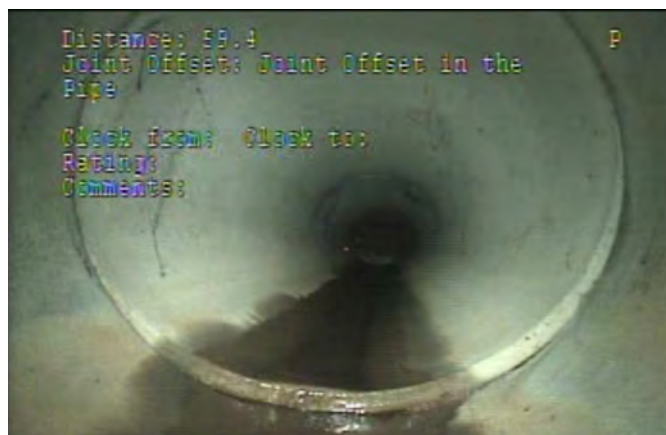
Joint Offset at 59 ft; other Joint Offset issues similar

Based on the Video Pipe Inspection, Pipe I2 could be retained. However, the Concept Plans remove the existing 18" R.C. Pipe.

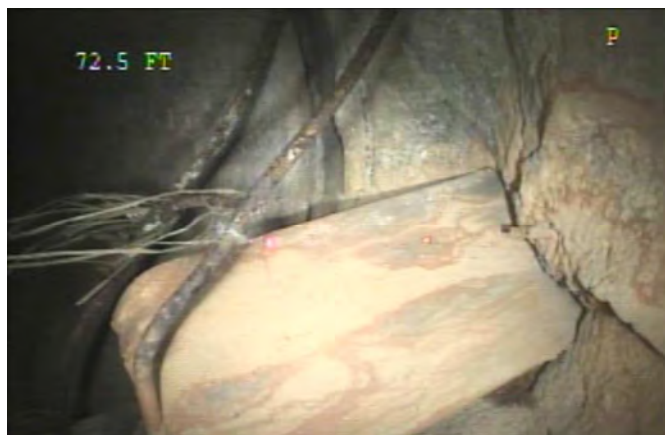
Guardrail post driven through pipe at 73 ft

Based on the Video Pipe Inspection, Pipe I3A would need to be repaired at approximately 73 ft from the median catch basin due to the guard rail post driven into the pipe. The rest of Pipe I3A could be retained. The Concept Plans plug & abandon existing 18" R.C. Pipe.

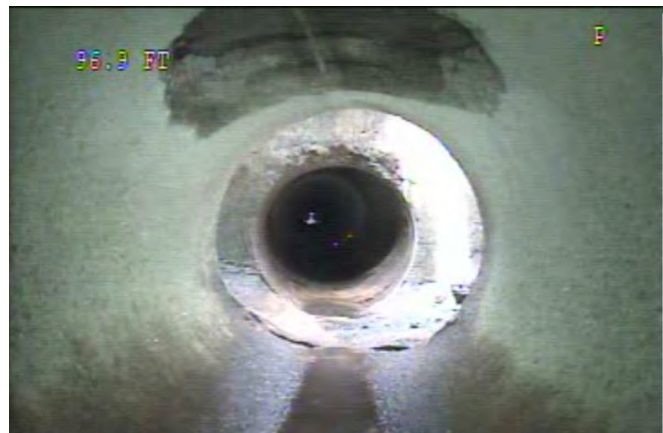
Broken (above) at 100 ft

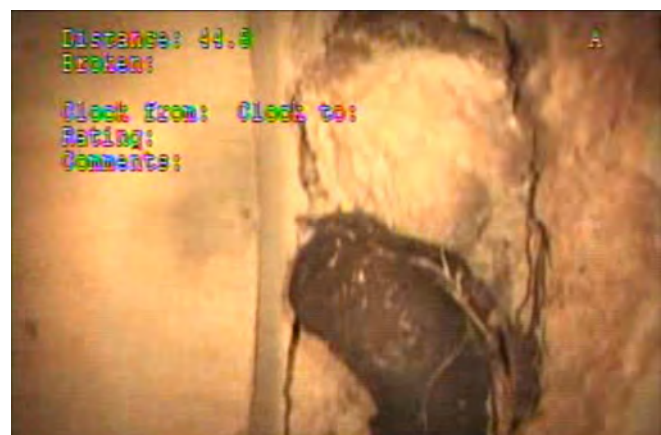
Broken at 37 ft (left) and 45 ft (right)

pavement and plug & abandon under the travelway.

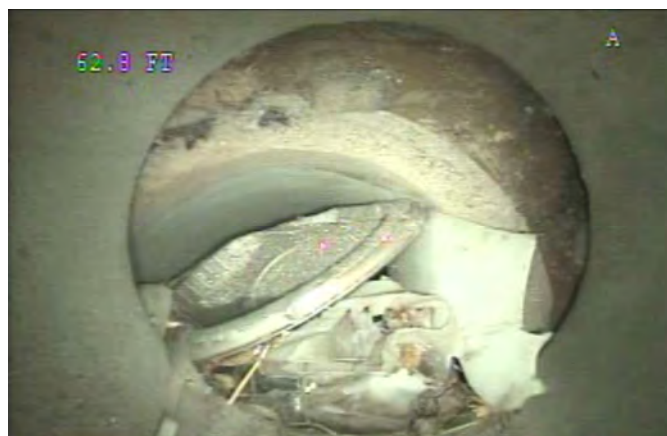
Broken at 65 ft

Based on the Video Pipe Inspection, Pipe I8 should not be used due to deficiencies under the travelway.

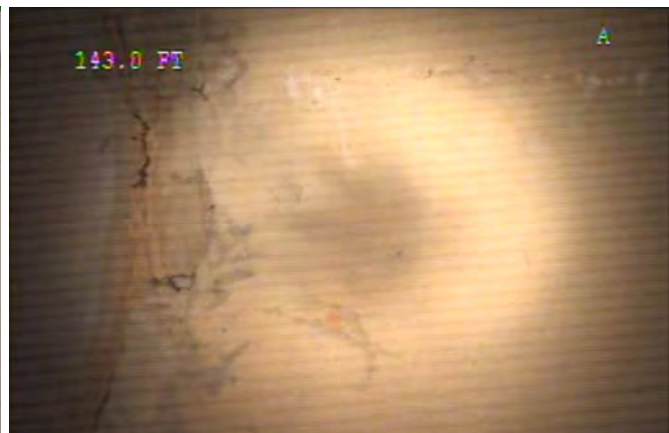
Joint - Separated and cracked at 42 ft (left) and 143 ft (right)

Based on the Video Pipe Inspection, Pipe I9 should be slip lined to be retained due to deficiencies. Capacity should be verified for slip lined pipe. Concept Plans remove the existing 36" R.C. Pipe.

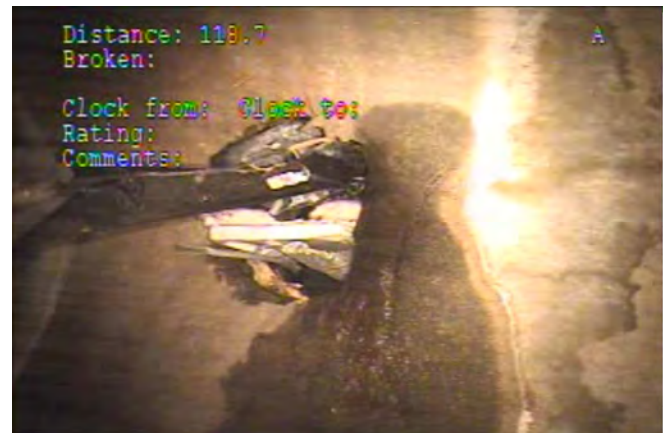
Broken at 119 ft

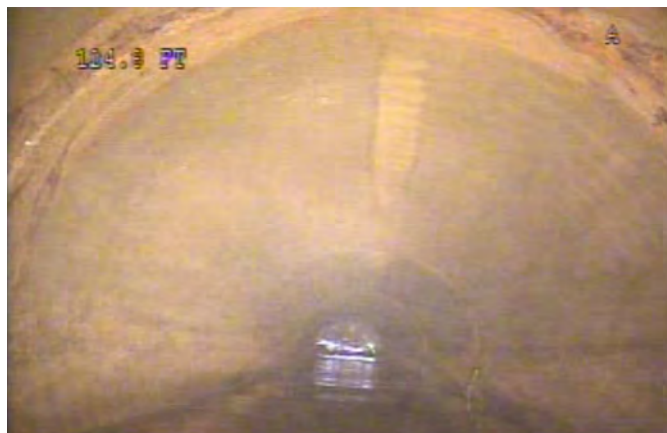
Deep water at 125 ft

Based on the Video Pipe Inspection and the Hydraulic Information, Pipe I13 could be retained. Deep water at 125' in the VPI is most likely from the stream at the existing outfall.

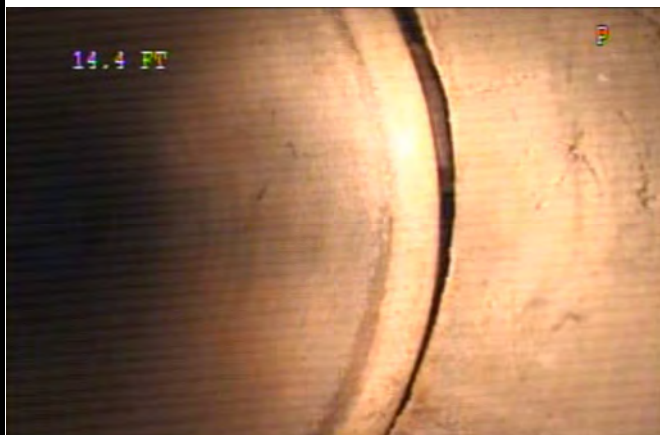
Joint - Separated and cracked at 14 ft

Capacity should be verified with slip lined pipe. Concept Plans remove existing  
15" R.C. Pipe.

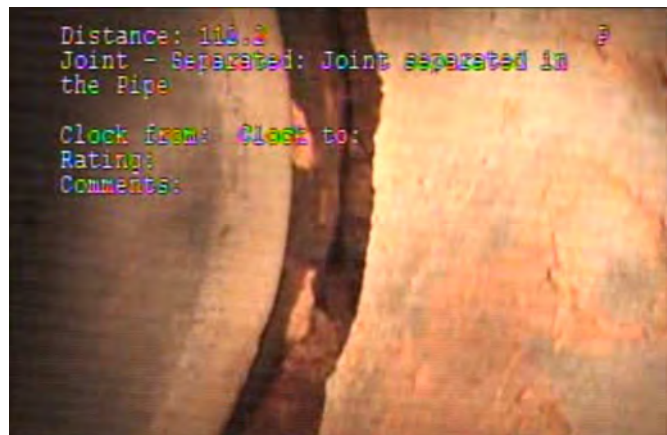
Joint - Separated at 112 ft

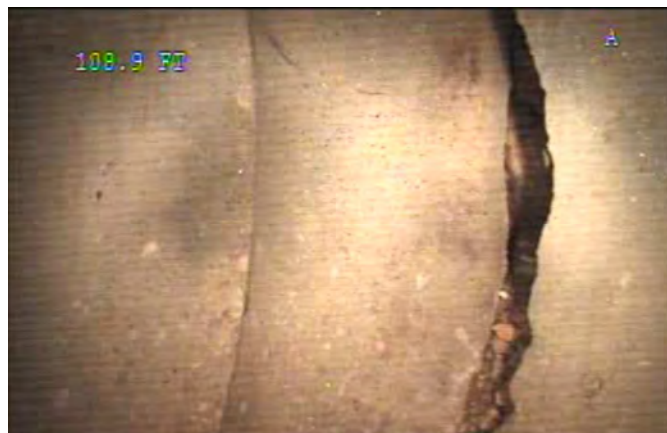
Joint - Separated at 109 ft

Based on the Video Pipe Inspection, Pipe I16 could be retained. Concept Plans remove existing 18" R.C. Pipe.

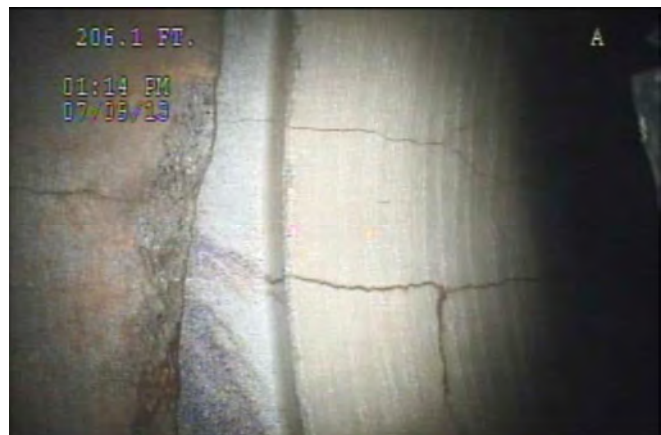
Crack at 206 ft

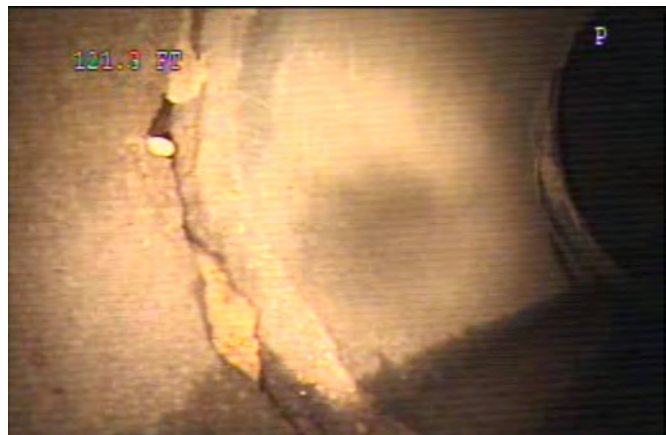
Joint - Separated at 122 ft

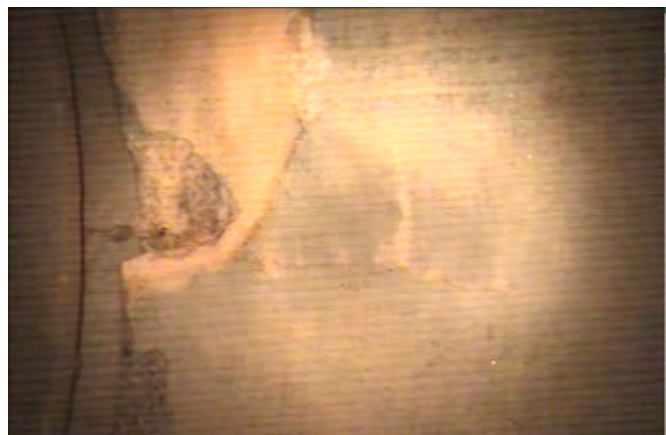
Joint Offset and crack at 404 ft

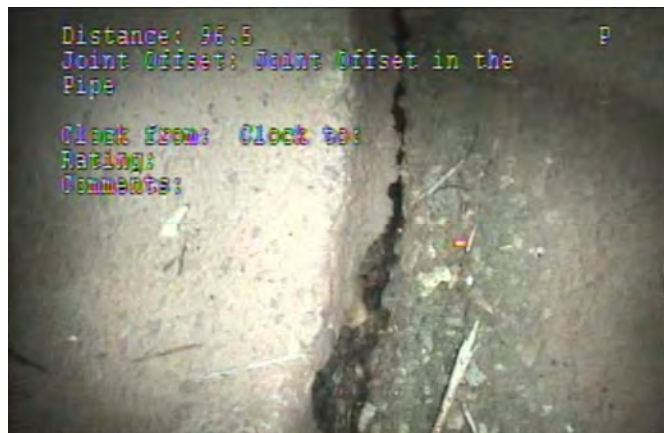
Joint Offset at 97 ft

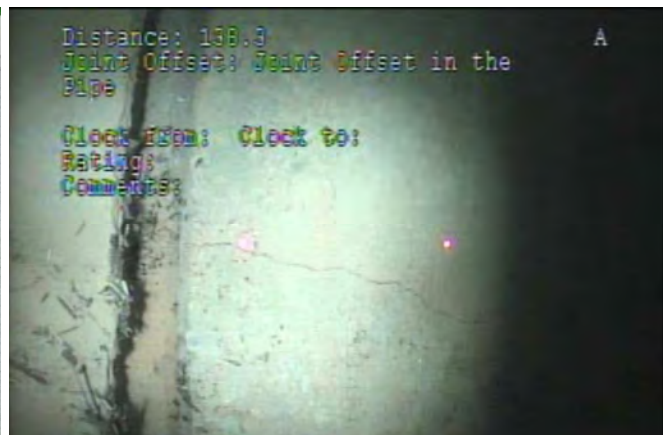
Joint Offset and crack at 138 ft

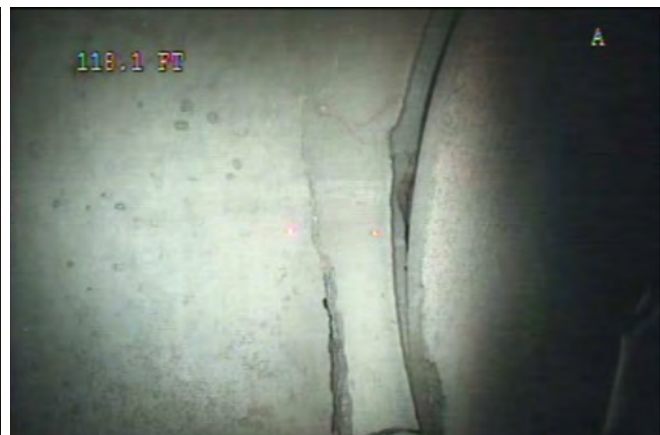
Joint Offset and chipped at 118 ft

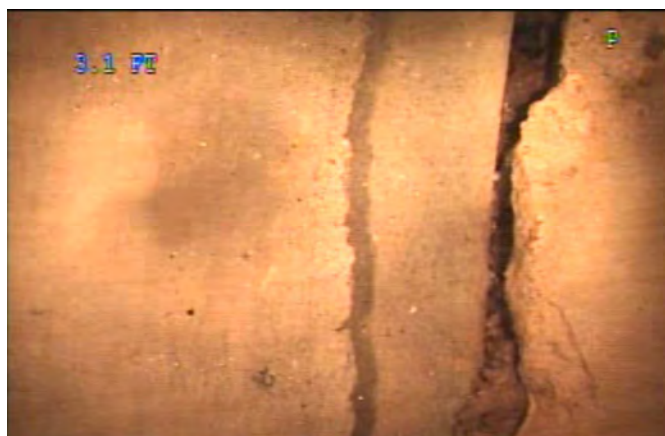
Joint - Separated at 3 ft

Based on the Video Pipe Inspection and the Hydraulic Information, fix the joint    
  seperation at 3 ft in the VPI and retain the rest of the pipe.

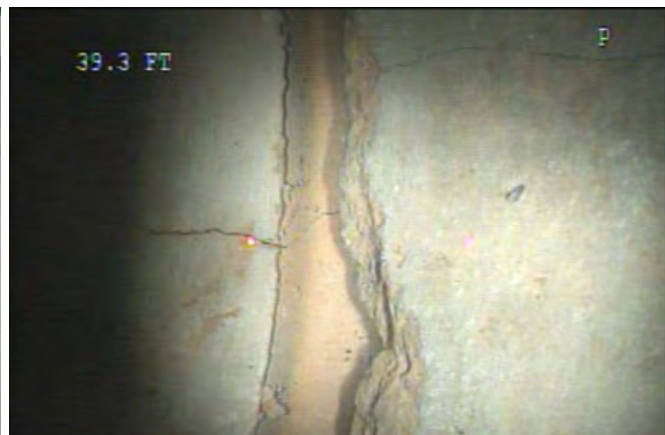
Joint - Separated and crack at 39 ft

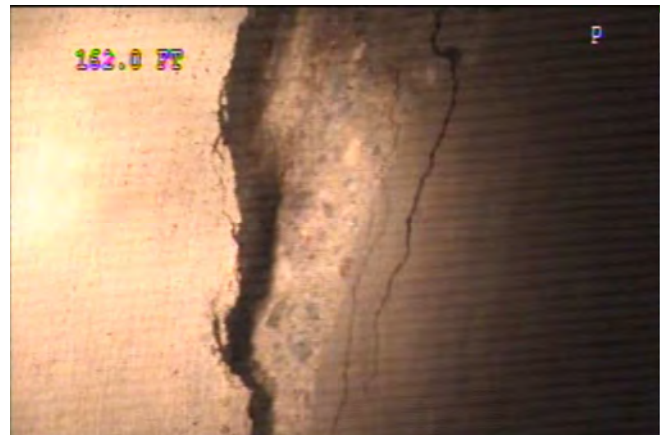
Joint - Separated and cracked at 162 ft

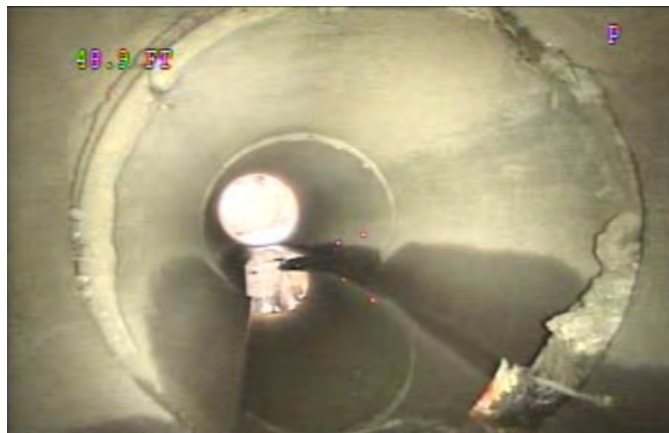
Joint - Alignment at 51 ft

Based on the Video Pipe Inspection and Hydraulic Information, retain 48' from the downstream junction box and replace from the bad joint to the end of I37.

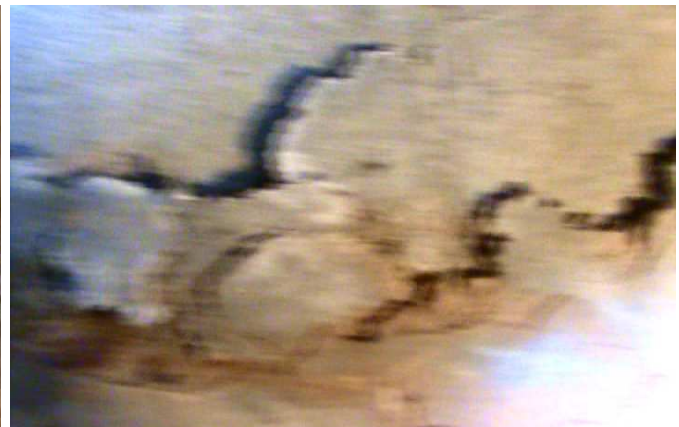
Typical cracking/chipping along side
