S-11-99 (Tribal Road) Bridge over I-85 (Exit 104) Cherokee County, South Carolina

Asbestos and Lead-Based Paint Survey Report

Structure # 117009900100 ARM Project #16-314-15

March 8, 2017

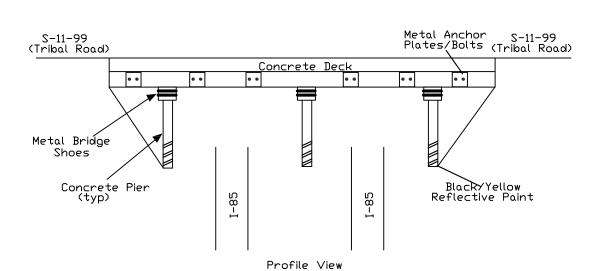
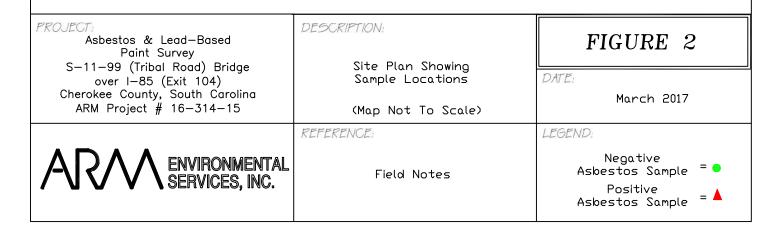
Plan View

Samples of the suspect materials were collected and submitted for laboratory analysis for Polarized Light Microscopy (PLM). One sample of each material was also collected for transmission electron microscopy (TEM) confirmation analysis in the event that the PLM analysis indicated less than 1 percent asbestos. The sample locations are shown in Appendix A, Figure 2. The results of the laboratory analysis are presented in Table 1 on the following page.

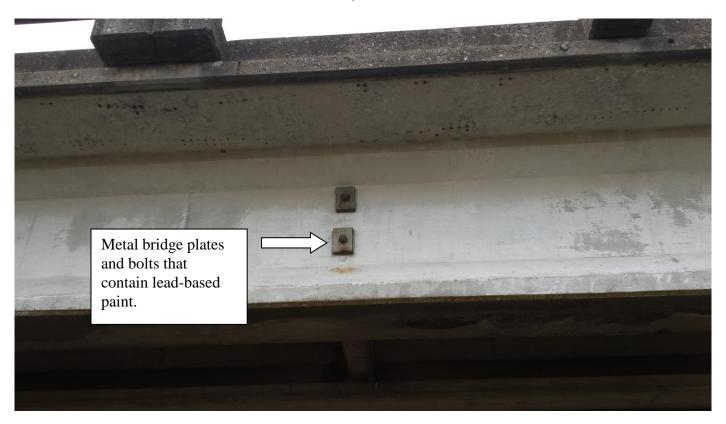
Sample Number	Material Description	Material Location	Color	Material Condition	LEAD Content mg/cm ²
Readings 75, 76, 77	Metal Bridge Shoes	Left Side of Bridge	Grey	Intact	26.60 to 40.30
Readings 78, 79, 80, 81	Metal Bridge Bolts and Plates	Left Side of Bridge	Grey	Intact	15.80 to 20.70
Readings 83, 84, 85	Concrete Bridge Piers	Left Side of Bridge	Yellow	Intact	2.50 to 3.40

Photograph 4 – View of the metal bridge plates and bolts that were positive for lead-based paint.

practices and personal protective equipment should be used to prevent exposure to lead dust/fumes or spreading lead contamination from the work site. The building components containing lead based paint should be disposed of in accordance with federal and state regulations. All waste debris coated with lead-based paint equal to or greater than 0.7mg/cm² must be disposed of in an approved Class II (C&D) or Class III (MSWLF) landfill or approved metal recycler. The OSHA lead standard for construction work (29CFR 1926.62) would apply to all demolition or renovation activities that disturb any of the materials containing lead.

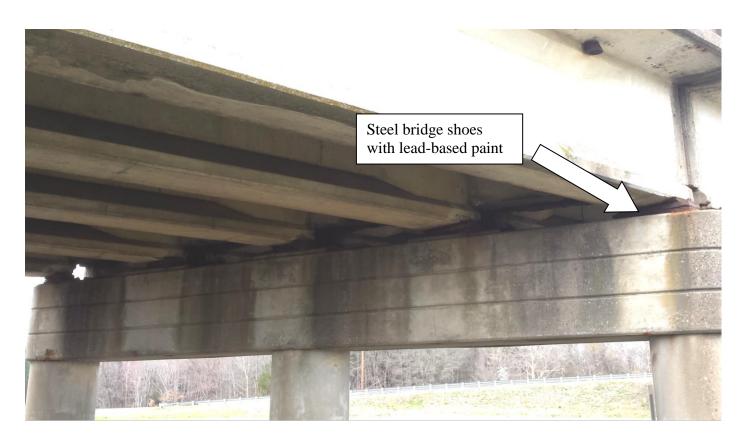
Photograph 5 – View underneath the bridge showing the steel bridge shoes between the concrete pier caps and the concrete deck that tested positive for lead-based paint.

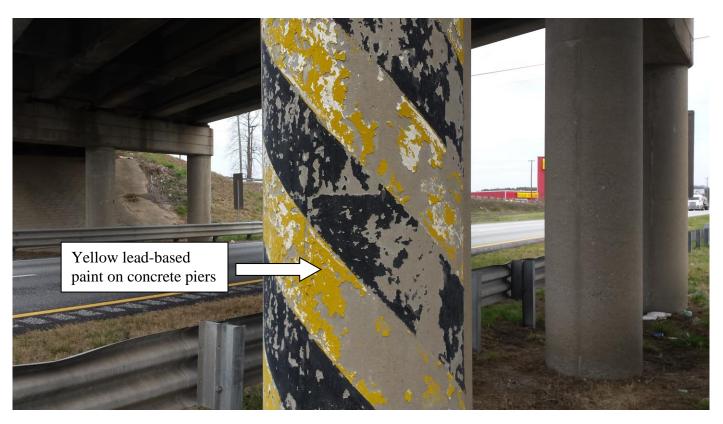
Photograph 6 – View of the yellow paint on the concrete piers that tested positive for lead-based paint.
