SC 5/198 (North Mountain Street) Bridge over I-85  
(Exit 102) Cherokee County, South Carolina

Asbestos and Lead-Based Paint  
Survey Report - Revised

Structure # 114019800200  
ARM Project #16-314-15

April 17, 2017

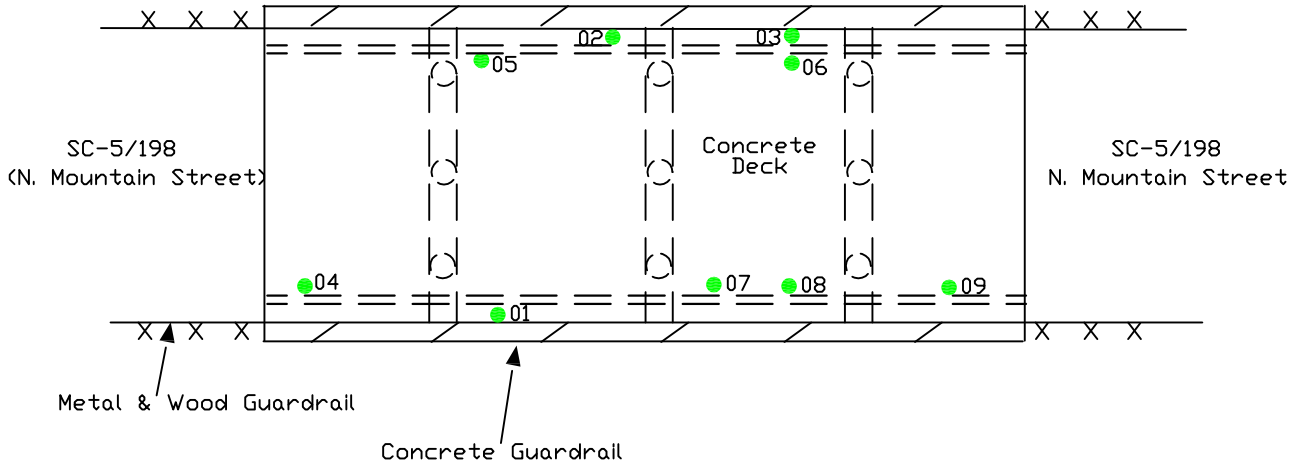
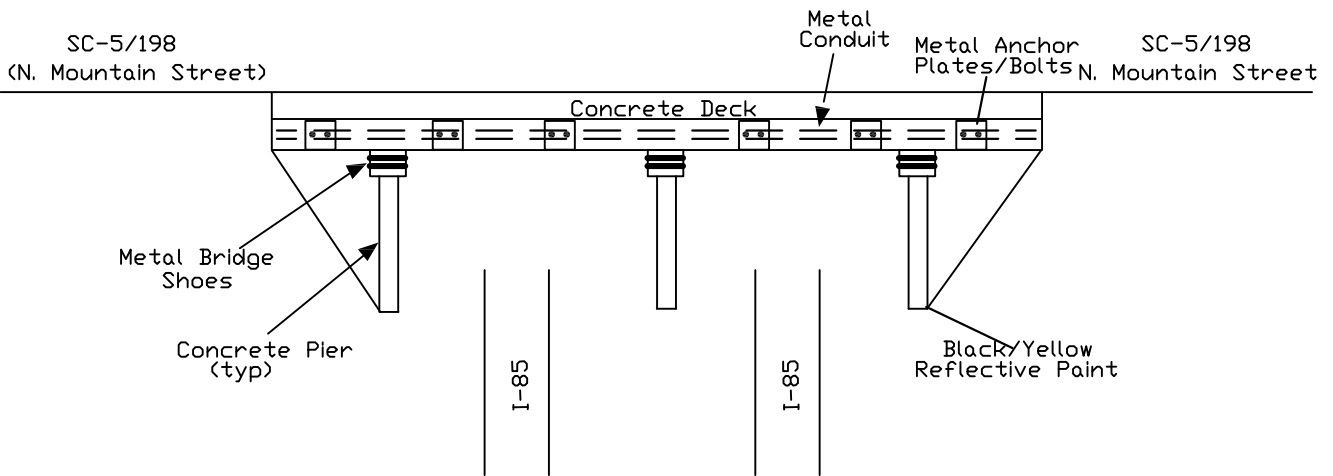
**FIGURE 2**

**DESCRIPTION:**  
 Site Plan Showing  
 Sample Locations  
 (Map Not To Scale)

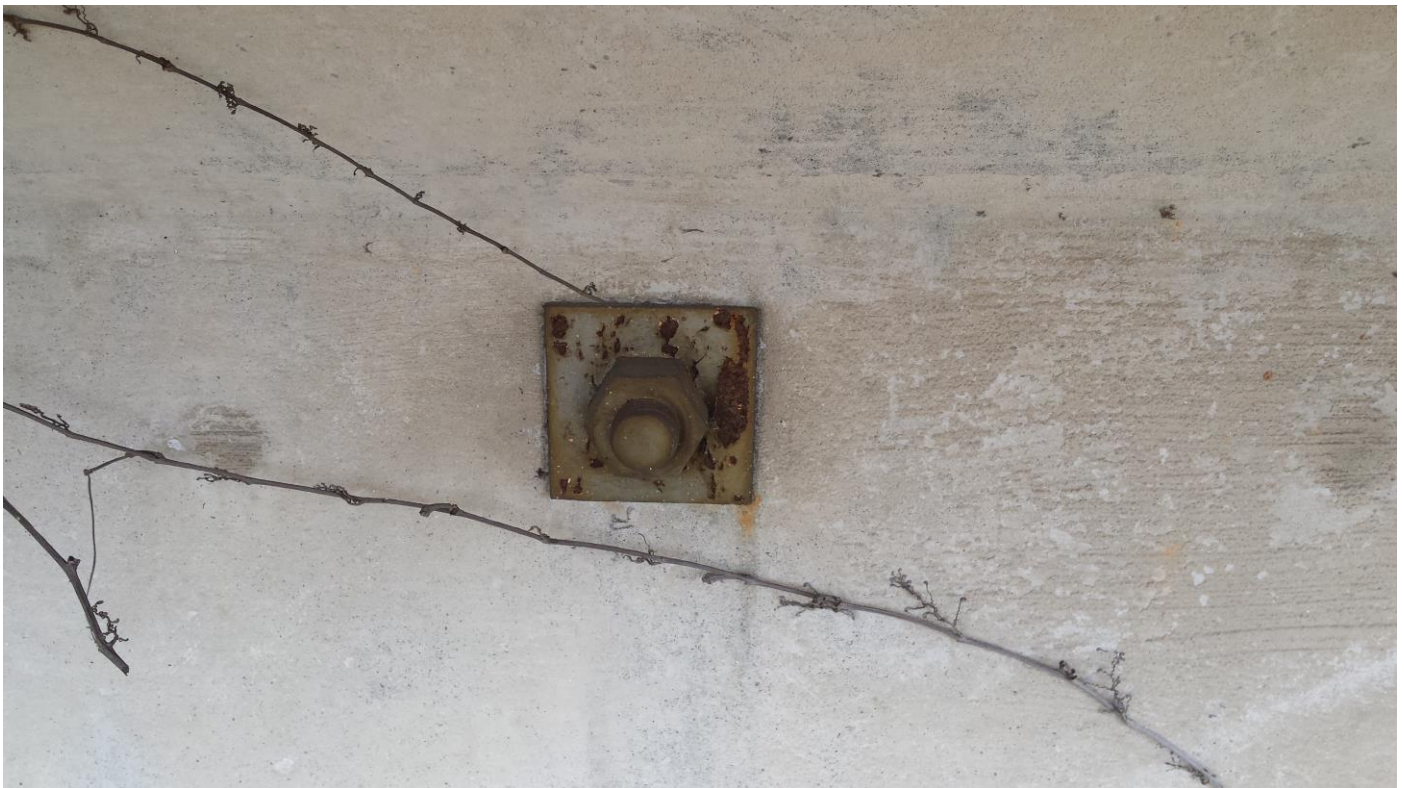
**Photograph 4** – View of the metal bridge plates and bolts that tested positive for lead-based paint.

A lead-based paint survey was performed for the SC 5/198 (North Mountain Street) Bridge over I-85 in Cherokee County, South Carolina. **The results of the XRF analyses indicate that the metal bridge shoes, metal bridge bolts and plates, and the concrete bridge piers were found to be coated with lead-based paint.** If these bridge components are disturbed during renovation or demolition, contractors and workers should be informed as to the presence of lead-based paint and appropriate work practices and personal protective equipment should be used to prevent exposure to lead dust/fumes or spreading lead contamination from the work site. The building components containing lead based paint should be disposed of in accordance with federal and state regulations. All waste debris coated with lead-based paint equal to or greater than  $0.7\text{mg}/\text{cm}^2$  must be disposed of in an approved Class II (C&D) or Class III (MSWLF) landfill or approved metal recycler. The OSHA lead standard for construction work (29CFR 1926.62) would apply to all demolition or renovation activities that disturb any of the materials containing lead.

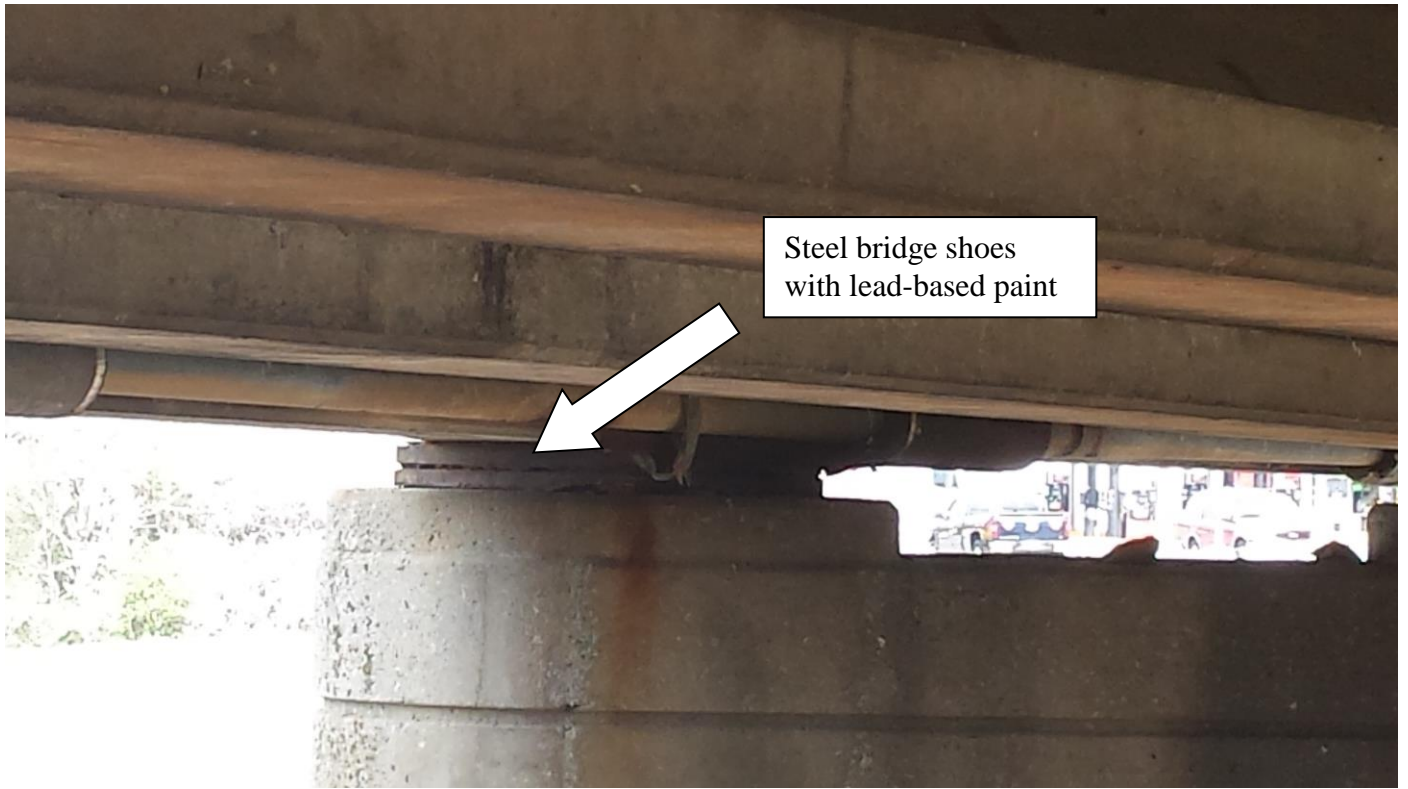
**Photograph 5** – View underneath the bridge showing the steel bridge shoes between the concrete pier caps and the concrete deck that tested positive for lead-based paint.

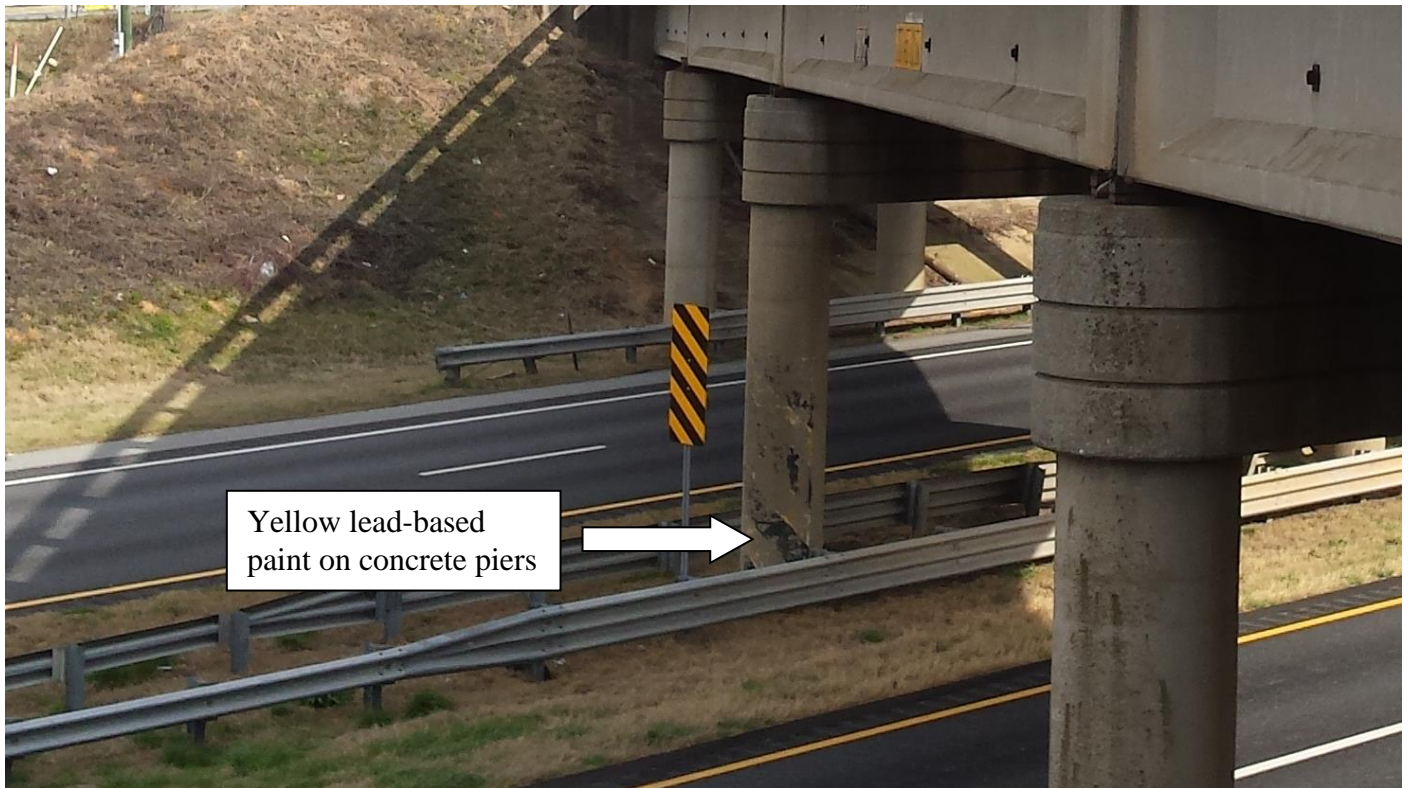
**Photograph 6** – View of the side of the bridge showing the yellow paint on the concrete piers that tested positive for lead-based paint.
