January 24, 2017

SCDOT Bridge Joint Inspections for I-85 over Buffalo Creek and I-85 over Broad River

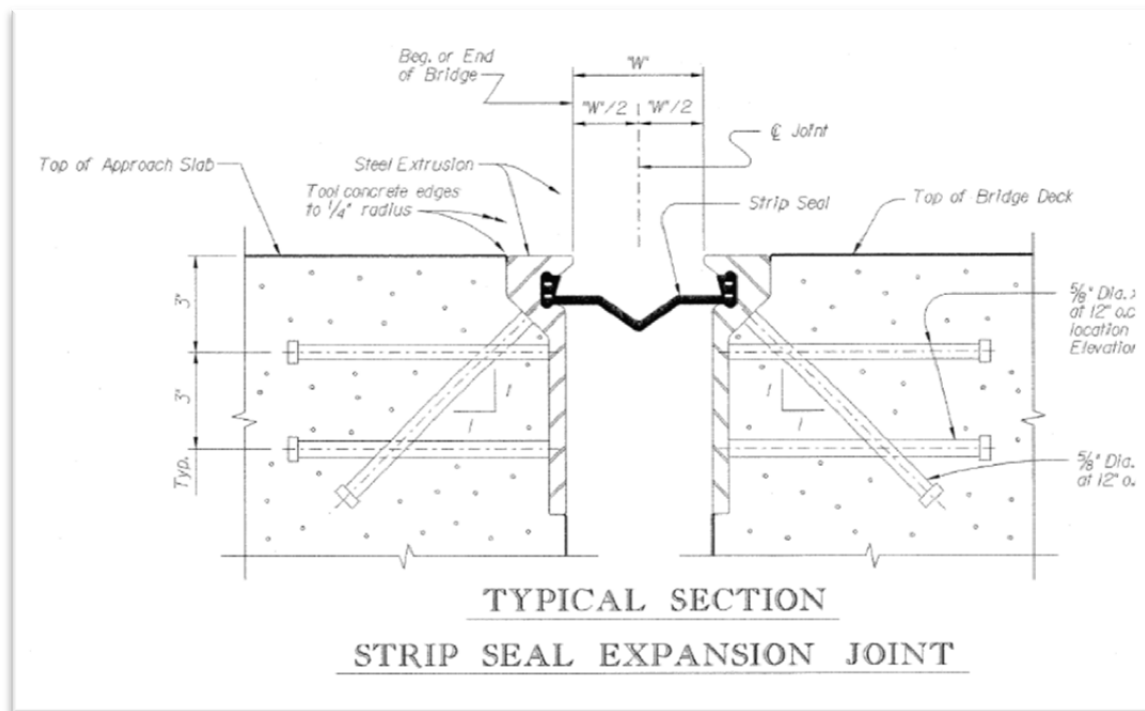
Figure 1: Typical Strip Seal Joint

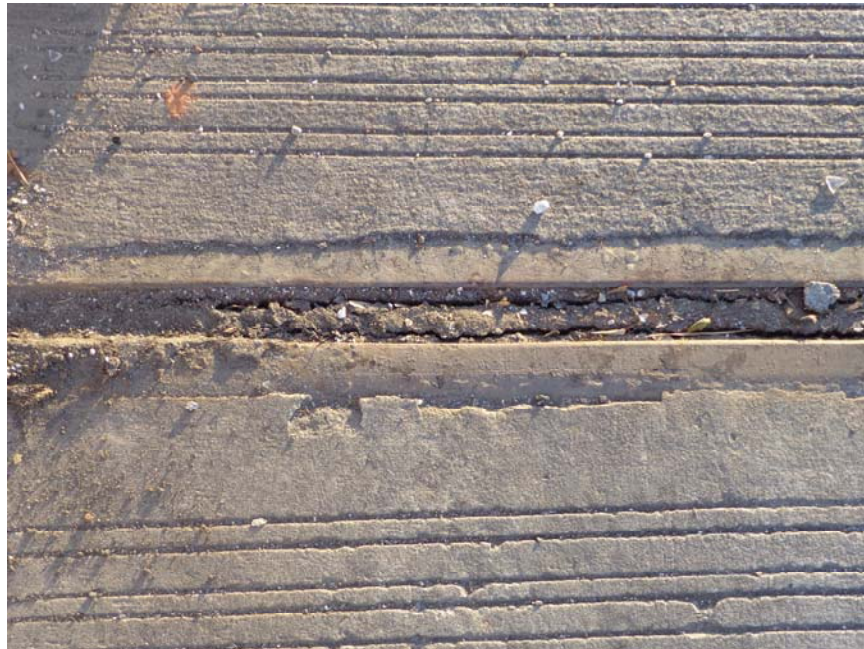
The expansion joint was in good condition at both abutments. There were no noticeable tears in the existing strip seals and no evidence of leaking was overserved on the end bent backwalls or beam seats. The armor joints were in good condition and were in alignment. The joints appeared to be functioning as intended. Some debris had collected in the joint on top of the strip seal. It is recommended that the joints be cleaned to prevent any future damage. The latest inspection report from SCDOT done in January 2016 backs up our field inspection that the joints are in good condition.

Figure 2: Debris in Joint (End Bent 1)

In summary the joint was in good condition and joint replacement is not recommended at this time.

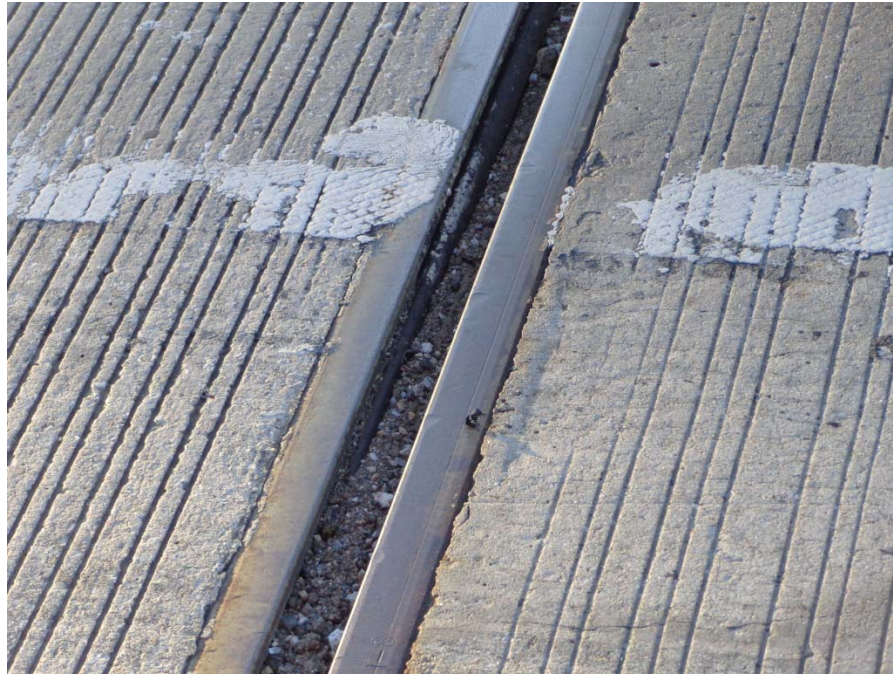
Figure 3: Joint View from Deck (End Bent 1)

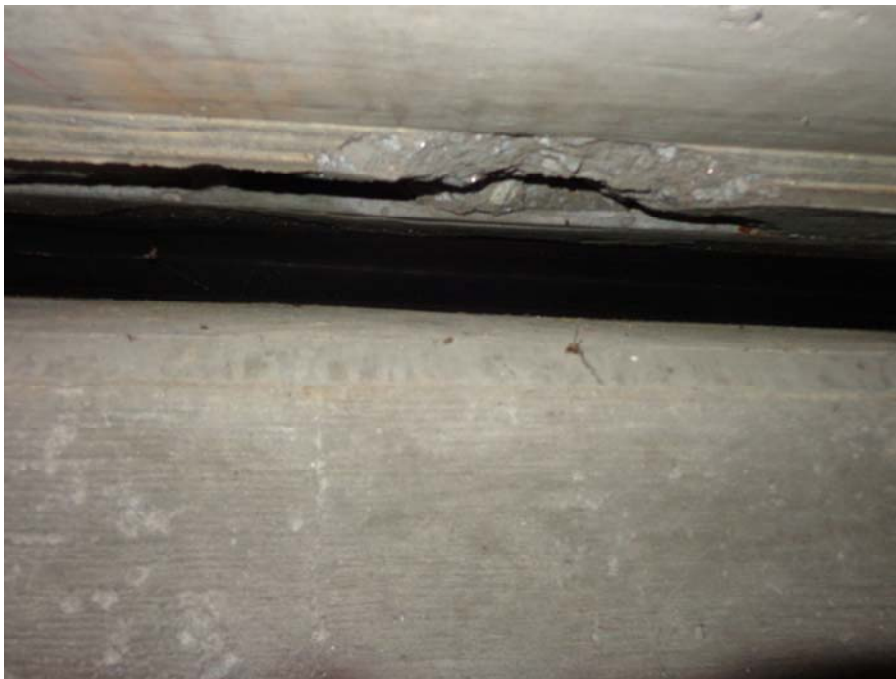
Figure 4: Typical Underside of Joint (End Bent 6)

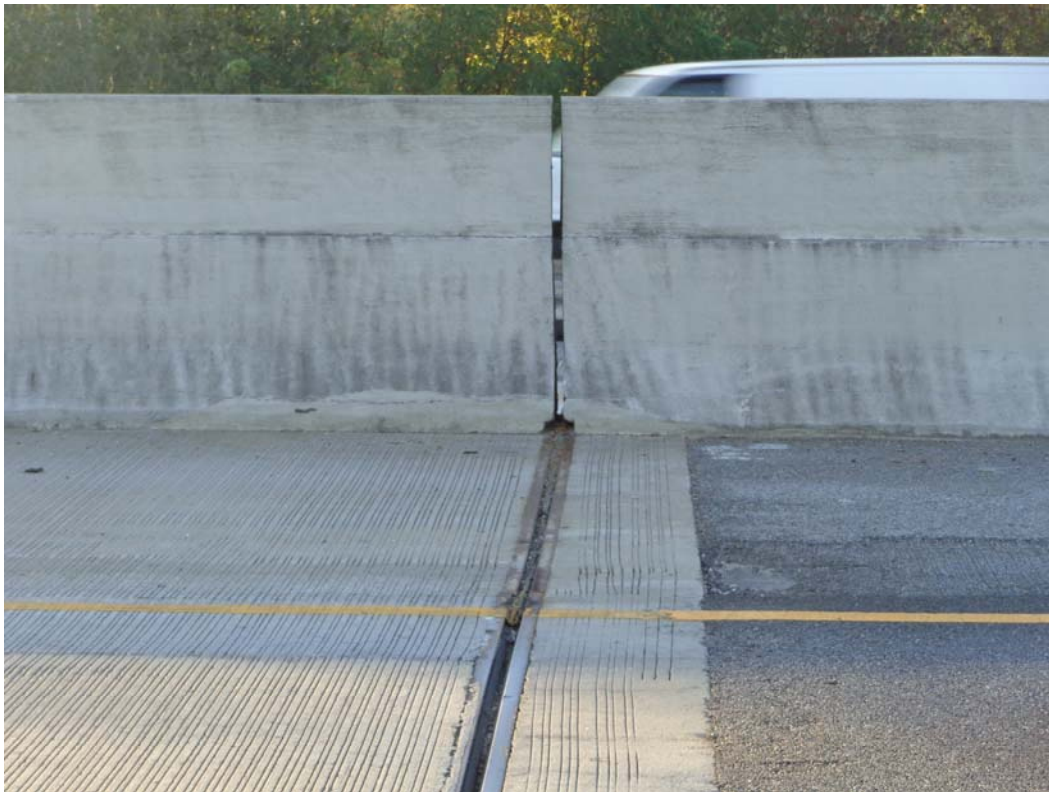
The expansion joint was in good condition at both abutments. There were no noticeable tears in the existing strip seals and no evidence of leaking was overserved on the end bent backwalls or beam seats. The armor joints were in good condition and were in alignment. The joints appeared to be functioning as intended. Some debris had collected in the joint on top of the strip seal. It is recommended that the joints be cleaned to prevent any future damage. The latest inspection report from SCDOT done in January 2016 backs up our field inspection that the joints are in good condition.

Figure 4: Joint View from Deck (End Bent 4)

In summary the joint was in good condition and joint replacement is not recommended at this time.

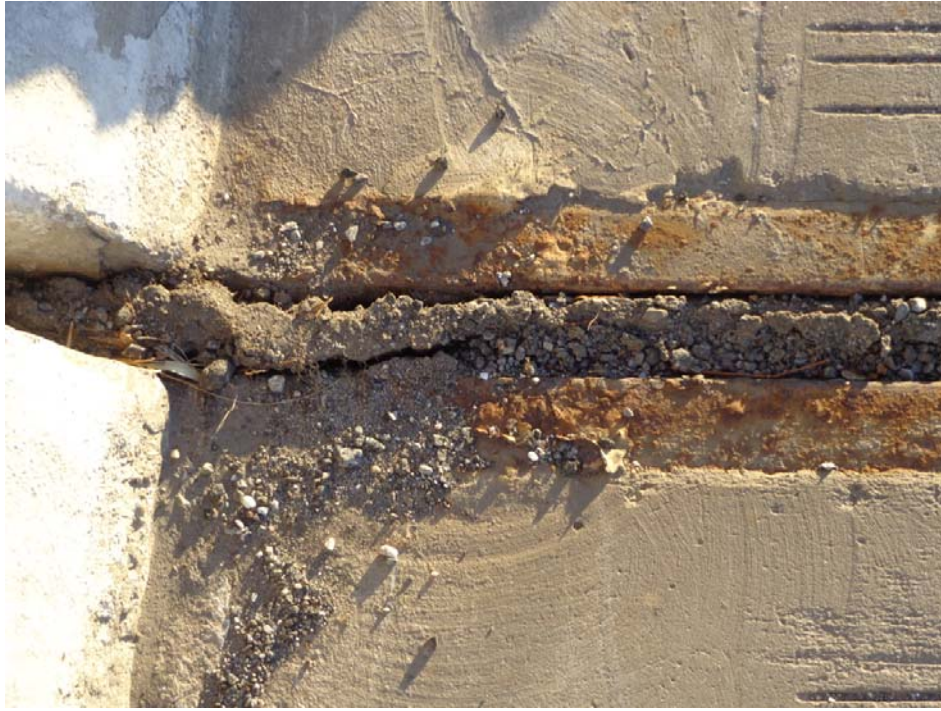
Figure 2: Debris in Joint along Barrier (End Bent 1)
