Reference: Lead-based Paint Assessment Report
Exit 217 North Meeting Street On and Off-ramps
Structure# 101002600891 and 102005200191
North Charleston, South Carolina
S&ME Project No. 1413-15-075

LEAD-BASED PAINT ASSESSMENT REPORT
EXIT 217 NORTH MEETING STREET ON AND OFF-RAMPS
STRUCTURE# 101002600891 AND 102005200191
NORTH CHARLESTON, SOUTH CAROLINA
S&ME Project No. 1413-15-075

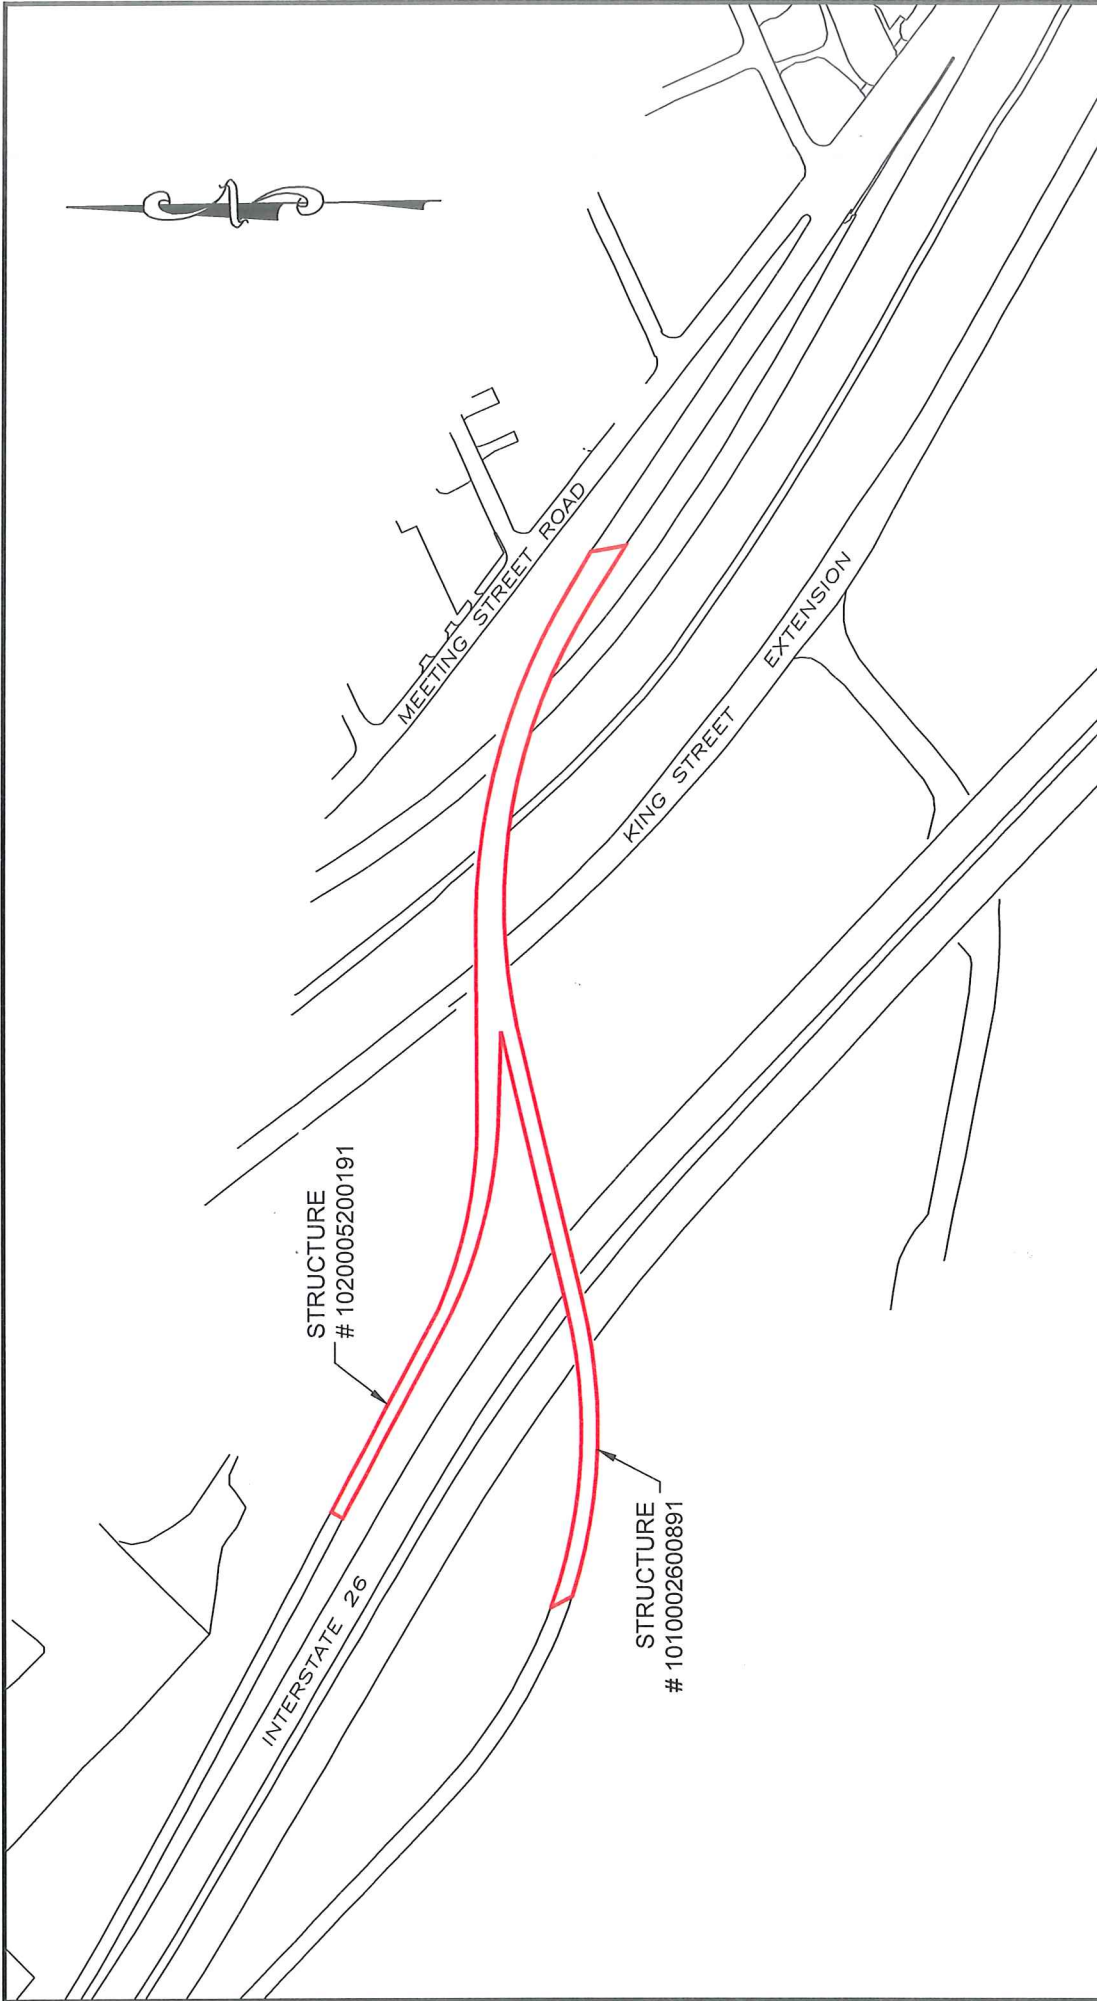
FIGURE NO.

NOTE: NO LEAD-BASED PAINT APPLICABLE TO THE SCDHEC AND EPA DISPOSAL REQUIREMENTS WAS IDENTIFIED.

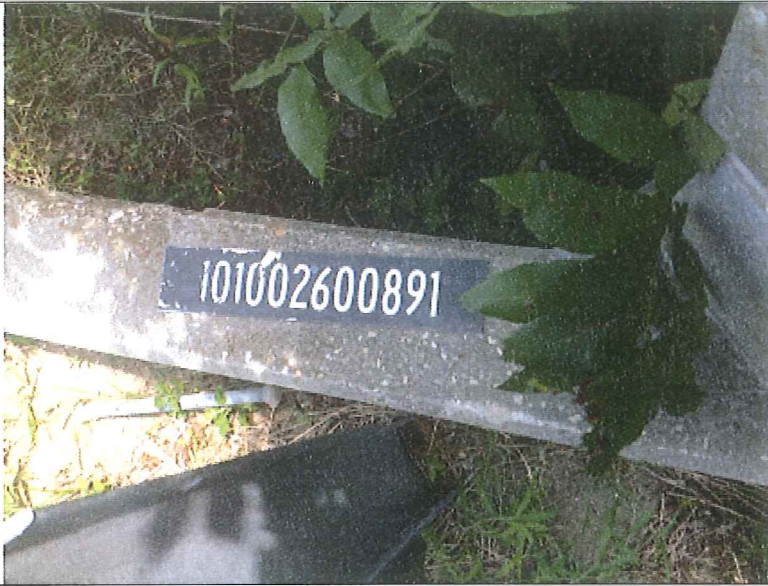
Photo 1

<p>Date: 07-09-15</p> <p>Photographer: Seaborn</p>
Location/Orientation	ID label on I-26 exit ramp
Remarks

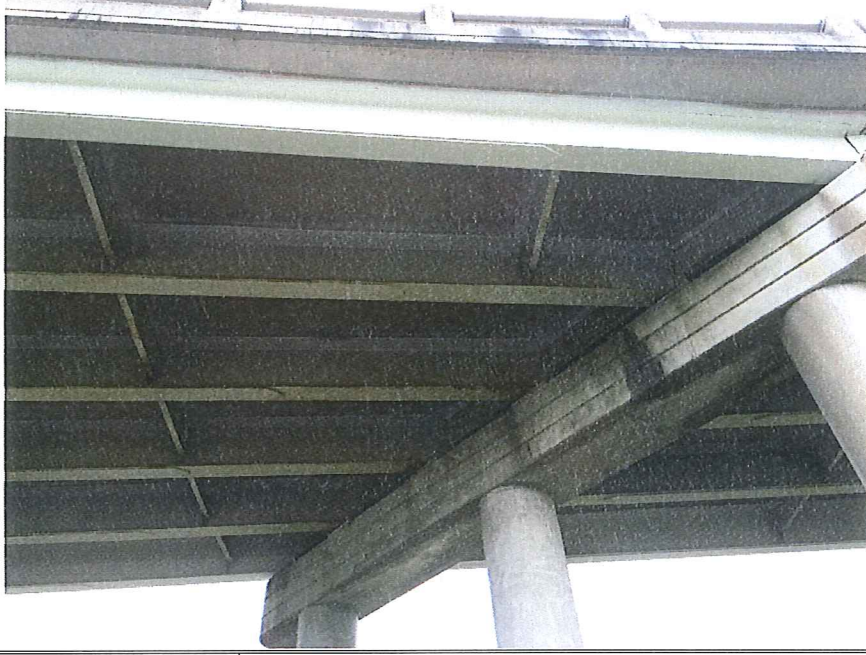
Photo 2

<p>Date: 07-24-15</p> <p>Photographer: Richburg</p>
Location/Orientation	Structure# 101002600891 / 102005200191
Remarks	Representative painted I-beams under bridge deck
