Reference: Lead-based Paint Assessment Report
Exit 218 Spruill Avenue On and Off-ramp
Structure# 101002600992
North Charleston, South Carolina
S&ME Project No. 1413-15-075

LEAD-BASED PAINT ASSESSMENT REPORT
EXIT 218 SPRUILL AVENUE ON AND OFF-RAMP
STRUCTURE# 101002600992
NORTH CHARLESTON, SOUTH CAROLINA
S&ME Project No. 1413-15-075

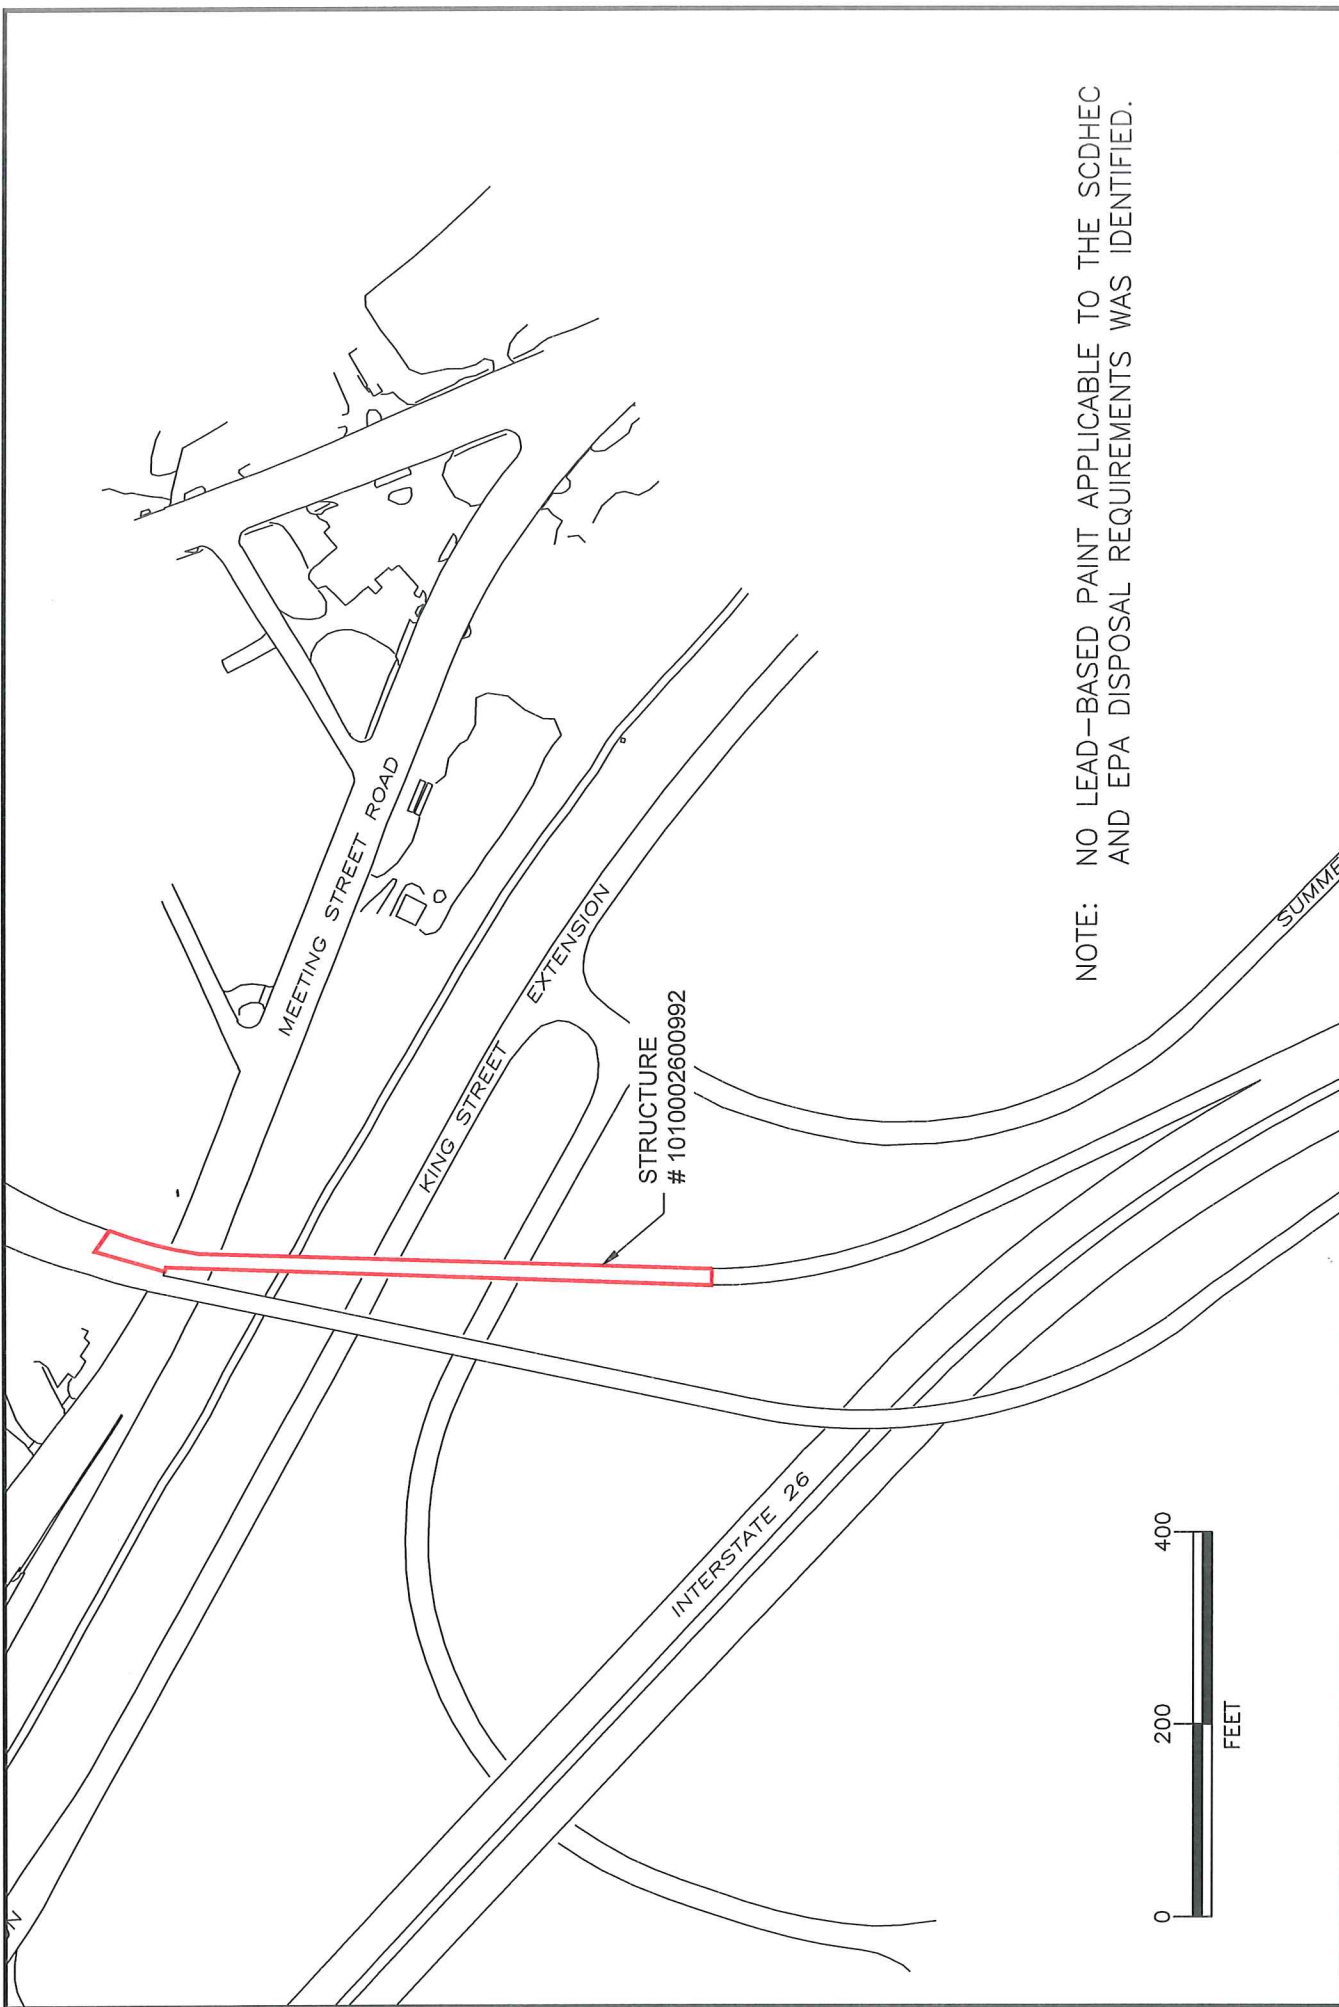
FIGURE NO.
 1

NOTE: NO LEAD-BASED PAINT APPLICABLE TO THE SCDHEC AND EPA DISPOSAL REQUIREMENTS WAS IDENTIFIED.

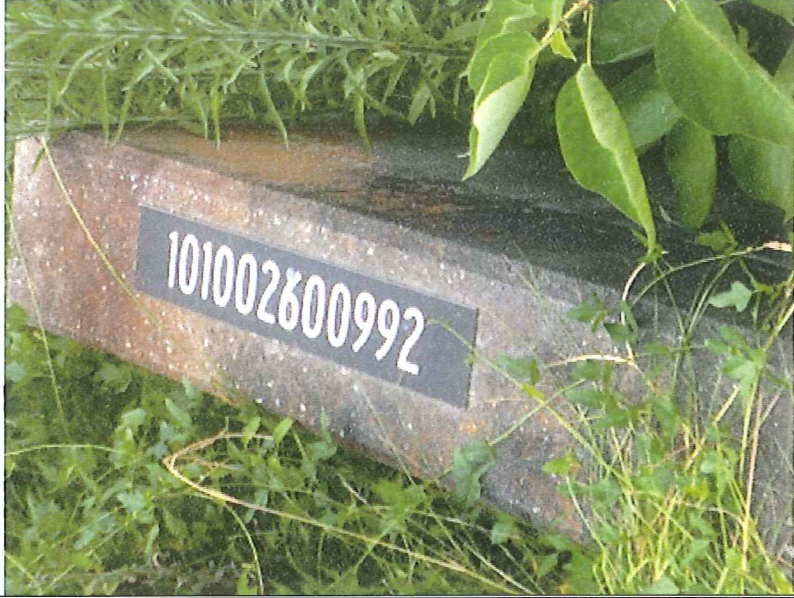
Photo 1

Date: 07-09-15	
Photographer: Seaborn	
Location/Orientation	ID label on exit ramp
Remarks
