SCDOT BRIDGE INSPECTION FORM

(008) BRIDGE ID: 0840004100100
 (005) ROUTE: BERKELEY SC 41
 (006) CROSSING: WANDO RIVER

(009) LOCATION: 13MI NE CHAS
 (026) FUNCTIONAL CLASS: 14

Bridge Element Group Textual Data

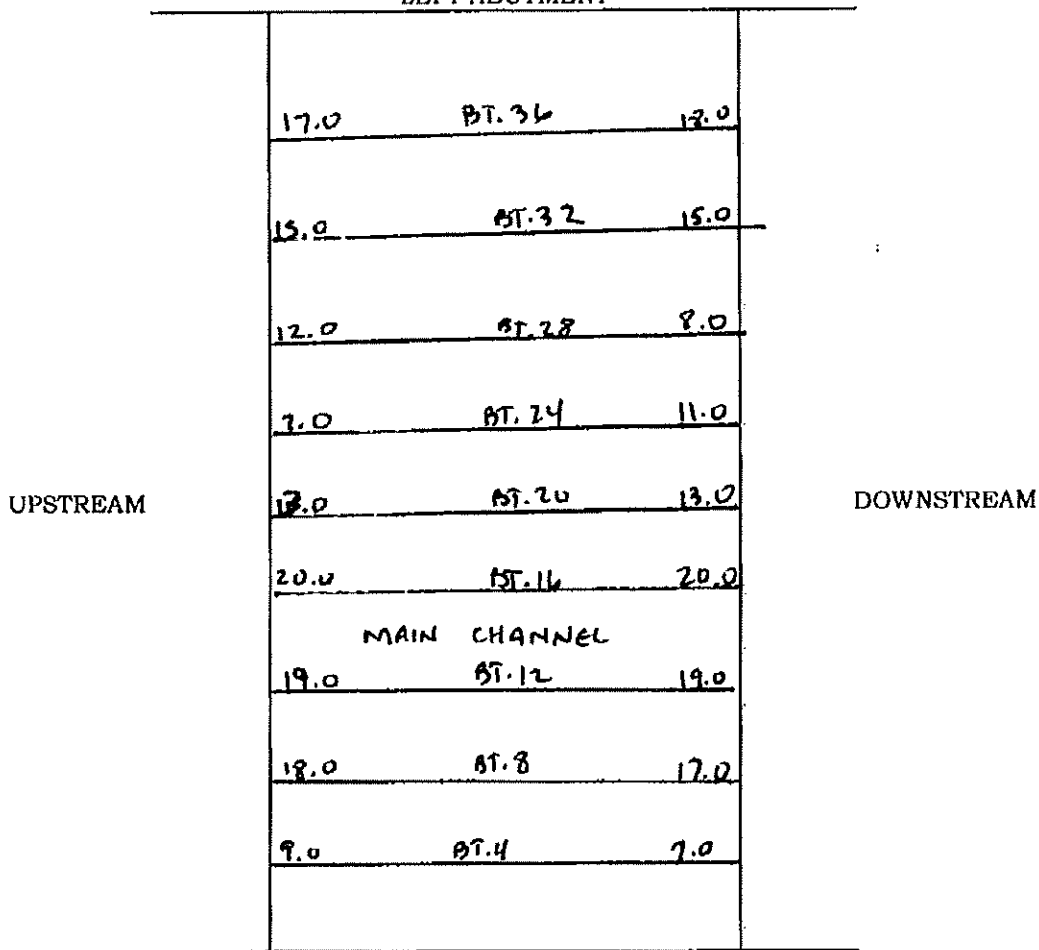
**BRIDGE INSPECTION
STREAM/GROUND
PROFILE**

COMMENTS: To TOP of Water(Upstream)=

Taken Midstream @ Bent=

WATER PROFILE TAKEN WITH
BOAT
