Asbestos & Lead Paint Survey Report

S-13-130 Bridge over Clay Creek
Chesterfield County, South Carolina
Bridge Asset No. 03620

June 28, 2023

Terracon Project No. 7323P100_6

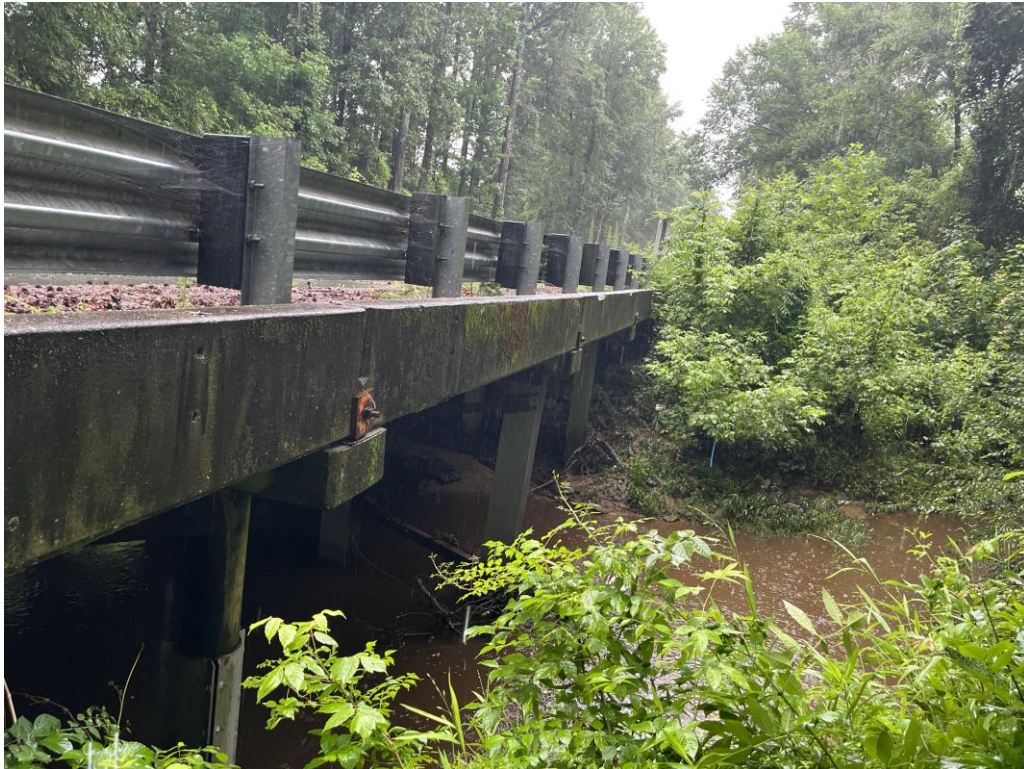
- Orange Metal Bracket – 4.87 mg/cm²

It should be noted that on this bridge all metal brackets have rusted and decayed over time leaving behind little to no lead paint. The silver paint located on the metal piers tested negative for lead on the XRF.

Photo 3 View of the side of the bridge facing east with the orange metal bracket in view.

XRF analysis detected lead concentrations greater than 0.7 mg/cm². SCDHEC regulations require that lead painted demolition debris be disposed in a permitted Class II landfill. Landfills should be contacted to determine their specific disposal requirements. Metal components painted with lead-based paint may be recycled however the recycler should be contacted to determine their specific requirements. Additionally, the provisions in the OSHA Standard for Lead (29 CFR 1926.62) should be followed by contractor personnel conducting work activity during the demolition. A summary of the lead paint laboratory results is presented in Table 2 in Appendix A.

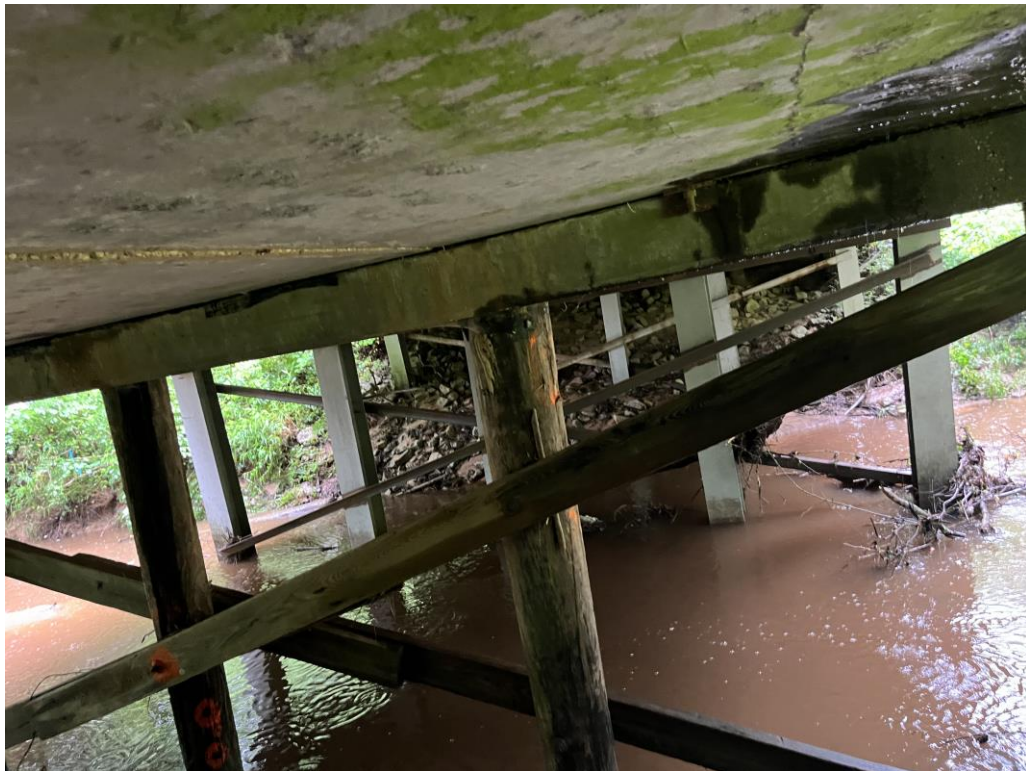
Based on the results of laboratory analyses, **asbestos was not detected** in the friction barrier samples collected from the bridge. These results were confirmed by TEM analysis. Asbestos laboratory analytical reports are included in Appendix B.

Photo 4 View of thin friction barrier between pier and pier cap.

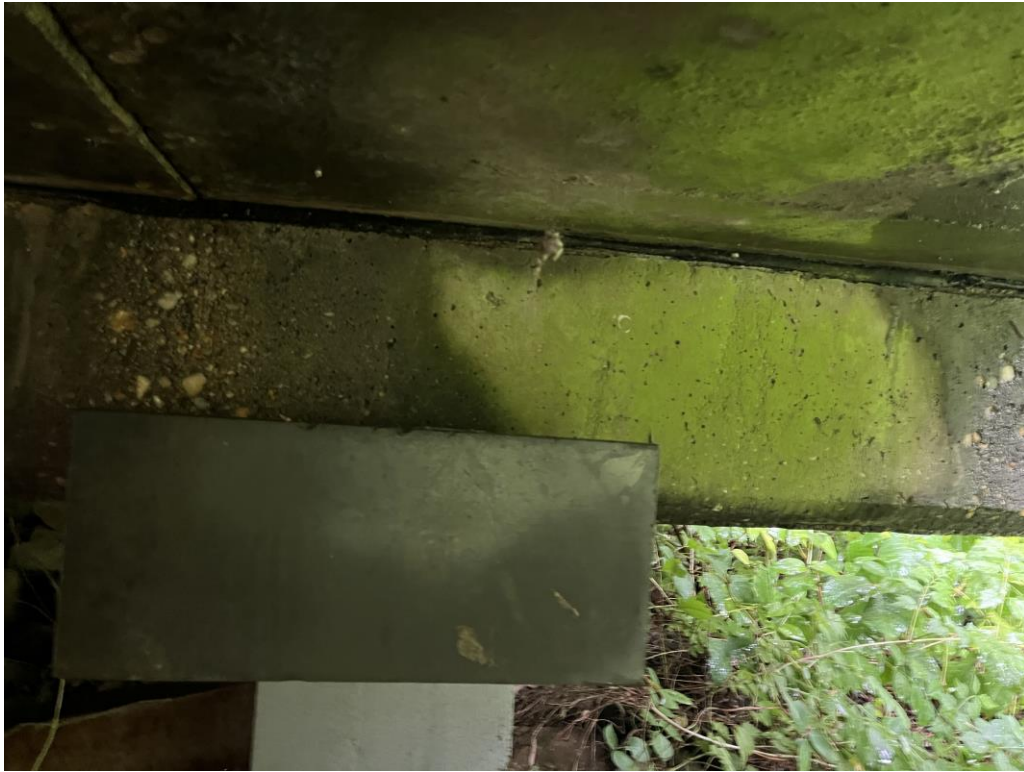
Photo 5 View of the thick friction barrier in between pier cap and decking.
