Asbestos & Lead Paint Survey Report

S-13-531 Bridge over Mangum Branch
Chesterfield County, South Carolina
Bridge Asset No. 04978

June 28, 2023

Terracon Project No. 7323P100_9

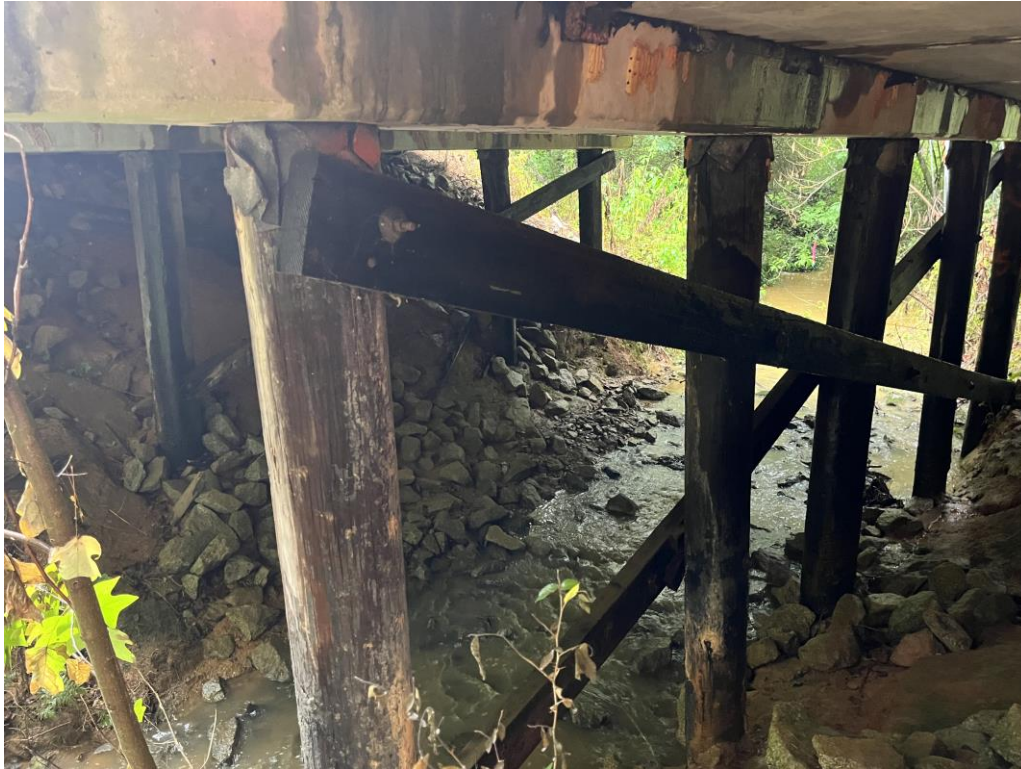
HA	Approx. Quantity (ft ²)	Samples Collected	Description	Sample Location	Lab Result	Category	Condition
1	20	3	Thin Friction Barrier	Between piers and pier caps	NAD	Misc	NF, Good
2	100	3	Thick Friction Barrier	Between pier caps and decking	NAD	Misc	NF, Good

Photo 3 View of thin friction barrier between pier and pier cap.

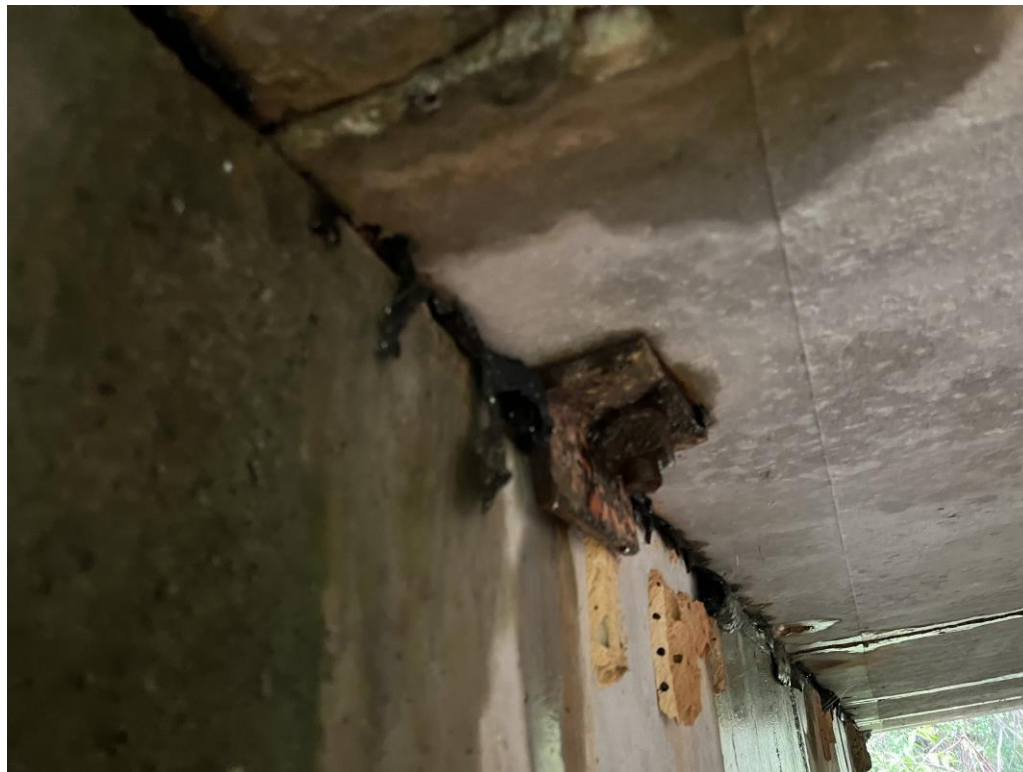
- Orange Metal Bracket – 2.88 mg/cm²

It should be noted that on this bridge all metal brackets have rusted and decayed over time leaving behind little to no lead paint.

Sample Number	Description	Location	Lab Result
LP-1	Orange Metal Bracket	Between decking joints	2.88 mg/cm ²

Photo 4 View of thick friction barrier between pier cap and decking and orange metal bracket.

XRF analysis detected lead concentrations greater than 0.7 mg/cm². SCDHEC regulations require that lead painted demolition debris be disposed in a permitted Class II landfill. Landfills should be contacted to determine their specific disposal requirements. Metal components painted with lead-based paint may be recycled however the recycler should be contacted to determine their specific requirements. Additionally, the provisions in the OSHA Standard for Lead (29 CFR 1926.62) should be followed by contractor personnel conducting work activity during the demolition. A summary of the lead paint laboratory results is presented in Table 2 in Appendix A.
