ASBESTOS CONTAINING MATERIAL INVESTIGATION REPORT

S-294 (E. BROAD ST.) RBO WILSON CREEK
ANDERSON COUNTY, SOUTH CAROLINA

September 22, 2022

F&ME Project No.: G6656.001

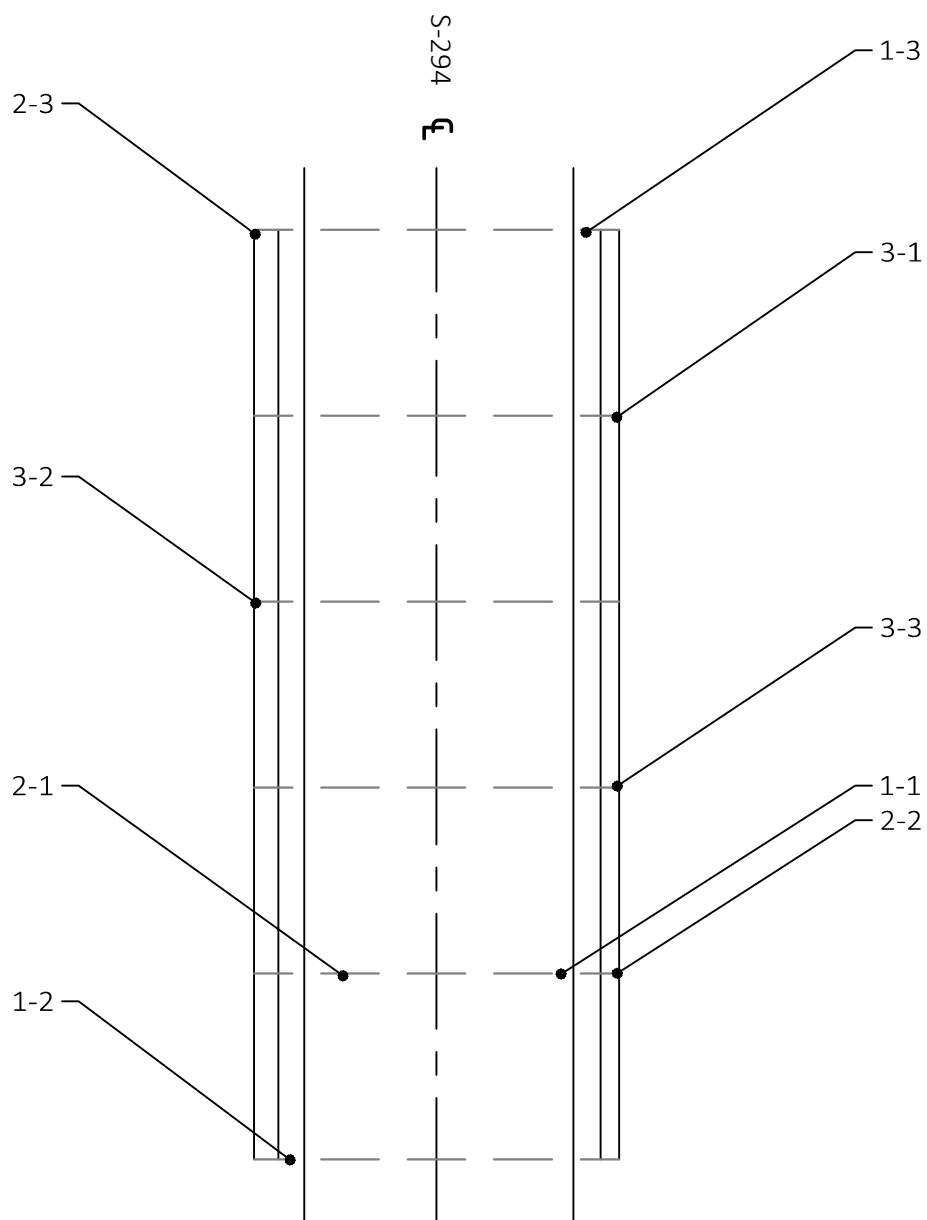
2

materials was observed/visible on the Bridge. The only suspect materials noted on the Bridge were the black bond break pad material, timber pile cap felt, and the black road patch seam filler. Samples of these materials were taken from random locations on the bridge. See Appendix B – Sample Location Plan, for detailed sample locations. Also, see Appendix G – Site Photographs, for more details.

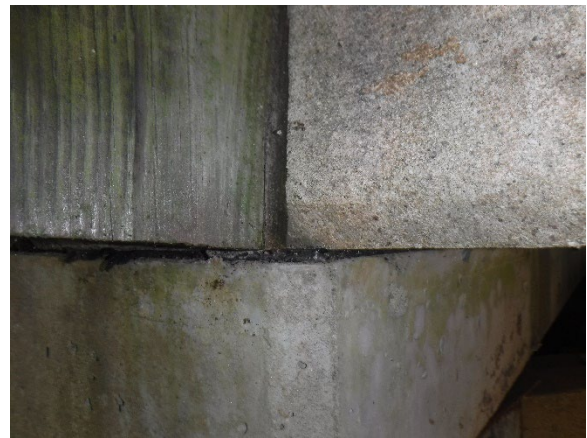
Sample ID	Description	Appearance	% Matrix Material	% Non-Asbestos Fibers	Asbestos Types
1-3 022206809-0007	Timber Pile Cap Felt	Brown/Black Non-Fibrous Homogeneous	100.0 Other	None	No Asbestos Detected
2-3 022206809-0008	Black Bond Break Material	Black Non-Fibrous Homogeneous	100.0 Other	None	No Asbestos Detected
3-3 022206809-0009	Black Road Patch/Sealer	Black Non-Fibrous Homogeneous	100.0 Other	None	No Asbestos Detected

Photo 4. Bond Break Pad Material.

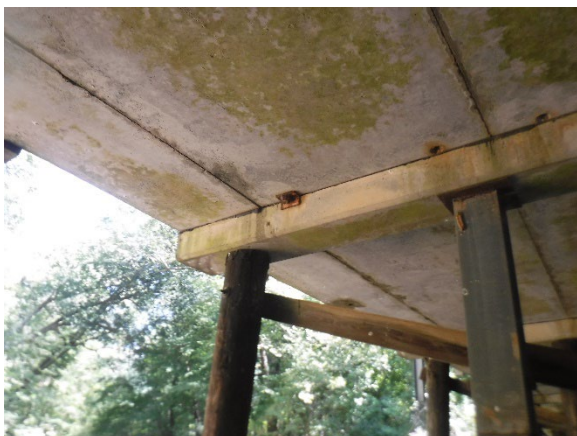
Photo 5. Timber Pile Cap Felt.

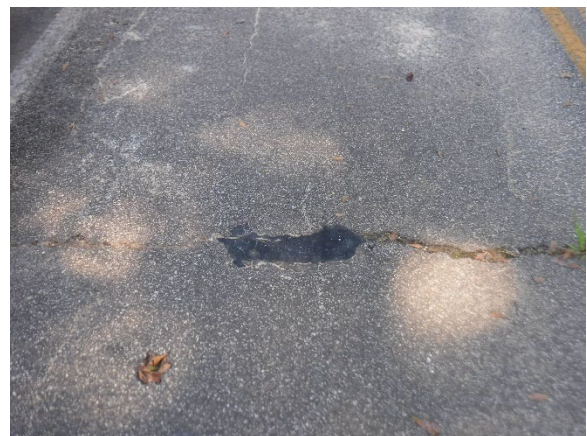
Photo 6. Black Road Patch/Sealer.
