ASBESTOS CONTAINING MATERIAL INVESTIGATION REPORT

S-765 (HANGING ROCK CHURCH RD.) RBO
HANGING ROCK CREEK
LANCASTER COUNTY, SOUTH CAROLINA
PREPARED FOR:

September 22, 2022

F&ME Project No.: G6656.004

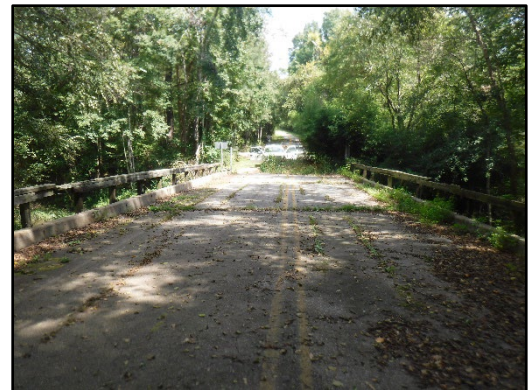
Photo 1: S-765 (Hanging Creek Church Rd.) over Hanging Creek in Lancaster County, South Carolina.

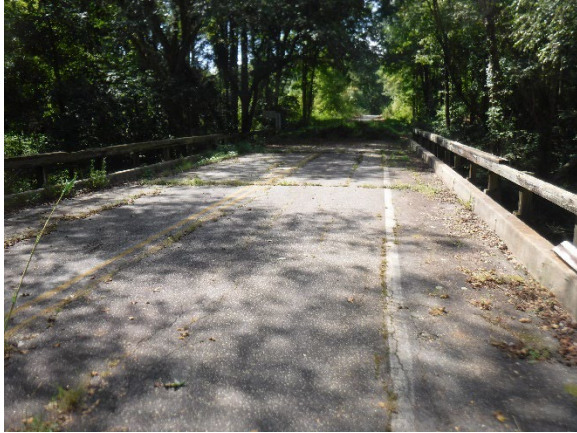
Photo 1. Top View of Bridge Deck.

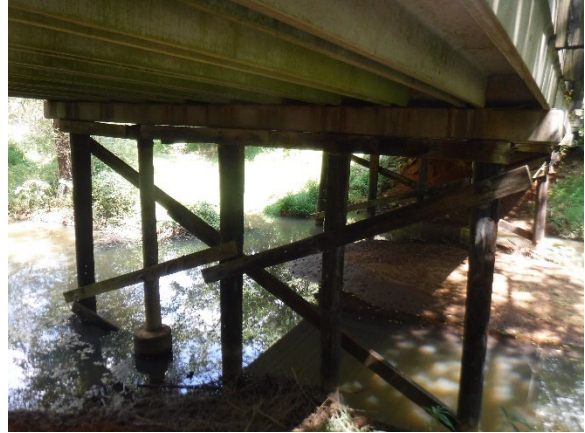
Photo 2. Underside View of Bridge.

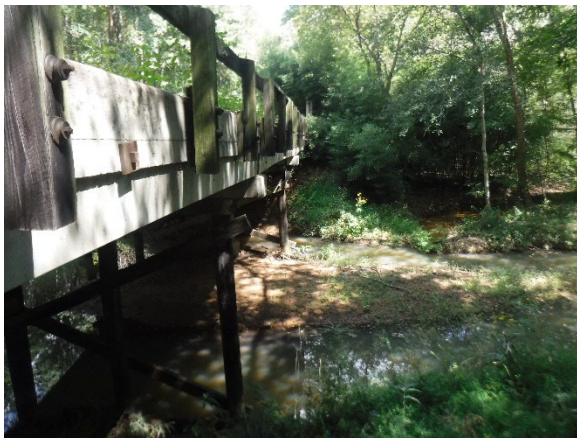
Photo 3. South Side View of Bridge.

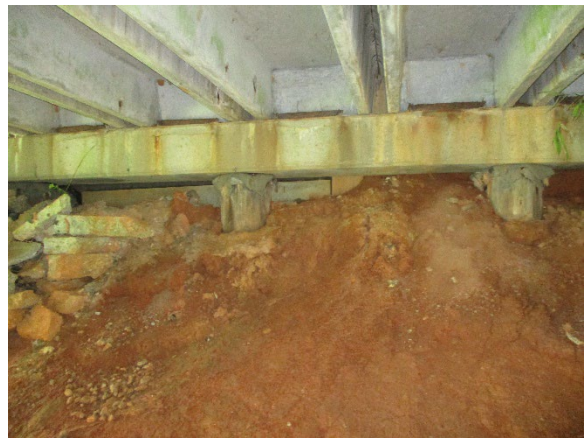
It is our understanding that the subject structure is to be demolished in anticipation of an on-alignment replacement of the existing Bridge. **The results of the analysis indicated that the bond break pad material and timber pile cap felt sampled during this investigation contained no asbestos.** Therefore, there are no foreseen special handling or disposal requirements, regarding asbestos, that will be required for the demolition of this bridge.

Photo 4. Timber Pile Cap Felt.

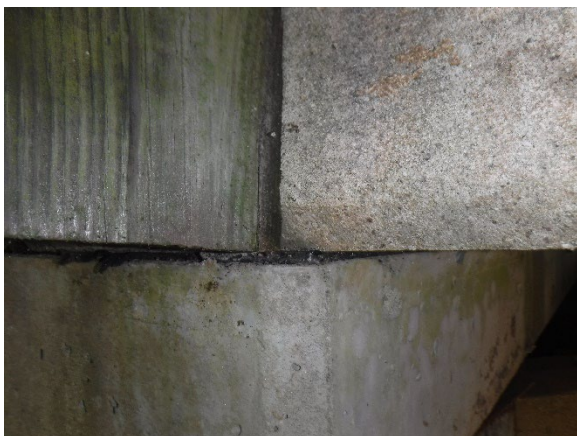
Photo 5. Bearing Pad Material.

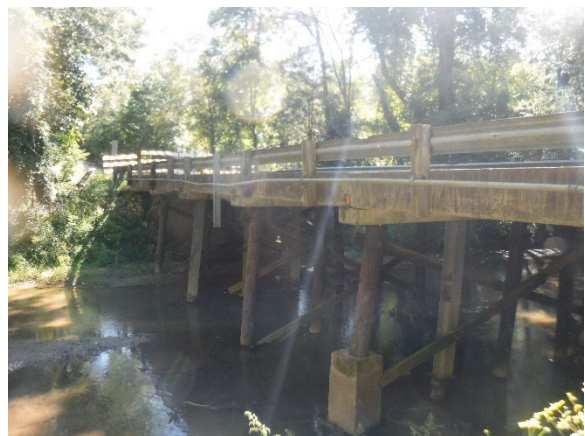
Photo 6. North Side View of Bridge.
