ASBESTOS CONTAINING MATERIAL INVESTIGATION REPORT

US HIGHWAY 123 (CALHOUN MEMORIAL HWY.)
SOUTHBOUND BRIDGE OVER GEORGES CREEK
SCDOT BRIDGE #392012330600
PICKENS COUNTY, SOUTH CAROLINA

November 23, 2022

F&ME Project No.: G6657.002

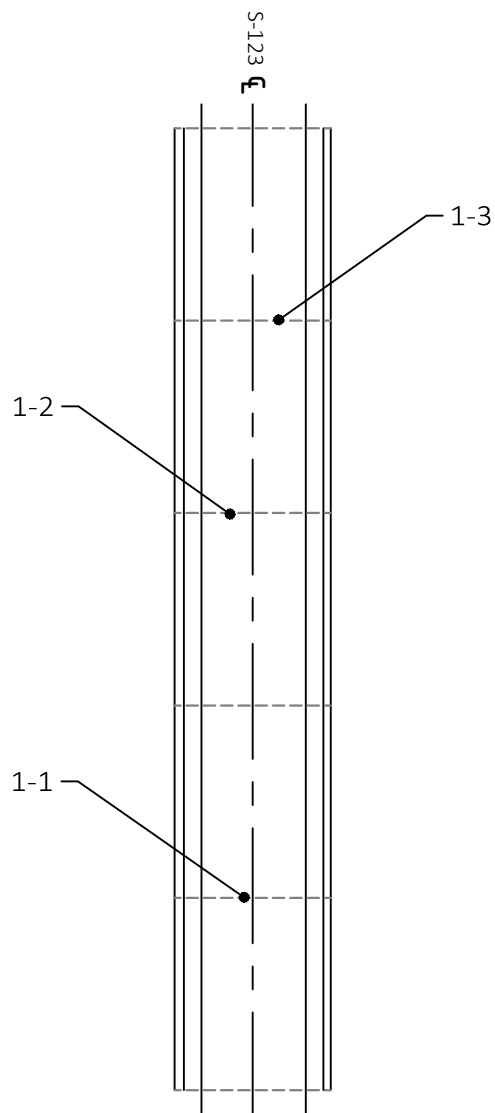
Sample Location Plan

During the investigation, bent cap bearing pads were the only suspect material identified associated with the Bridge. A total of three (3) samples were taken of this suspect material for laboratory analysis, and physical characteristics were recorded. The remaining structural materials (i.e., wood, steel, etc.) were not considered suspect and were not sampled.

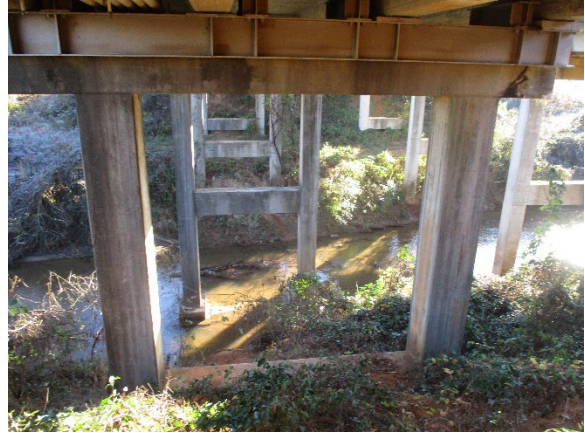
Photo 2. Underside View of Bridge.

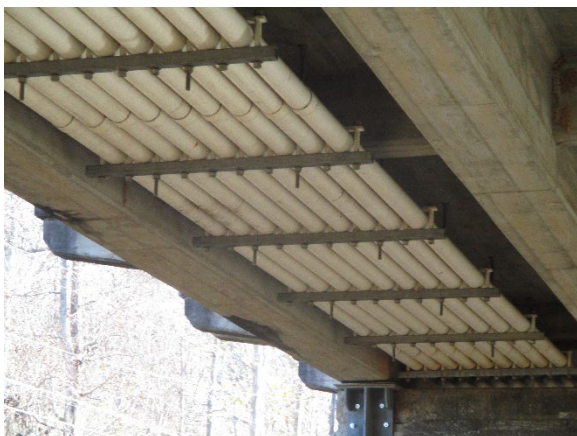
During the field investigation, FME personnel noted nine (9) communication conduits attached to the underside of the concrete bridge deck under the north side of the Bridge. All nine (9) communication conduits ran the entire length of the Bridge. See Appendix A – Site Vicinity Map,

Photo 5. Nine (9) Communication Conduits attached to the North Underside of Bridge.

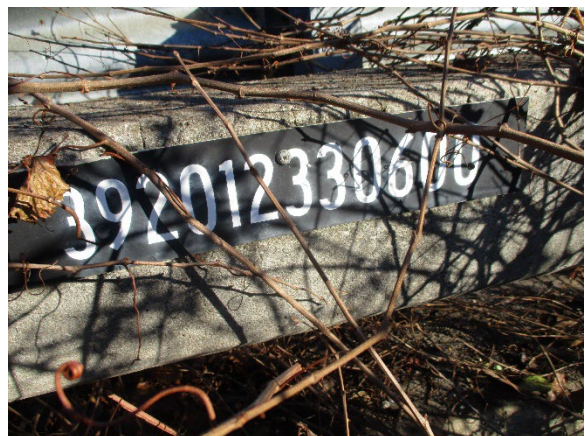
Photo 6. SCDOT Bridge Number Placard Attached to the Concrete Guardrail.
