LEAD-BASED PAINT INVESTIGATION REPORT

US 123 (CALHOUN MEMORIAL HWY.)
NORTHBOUND BRIDGE OVER GEORGES CREEK
SCDOT BRIDGE #392012310600
SCDOT PROJECT ID: P041233
PICKENS COUNTY, SOUTH CAROLINA

February 9, 2023

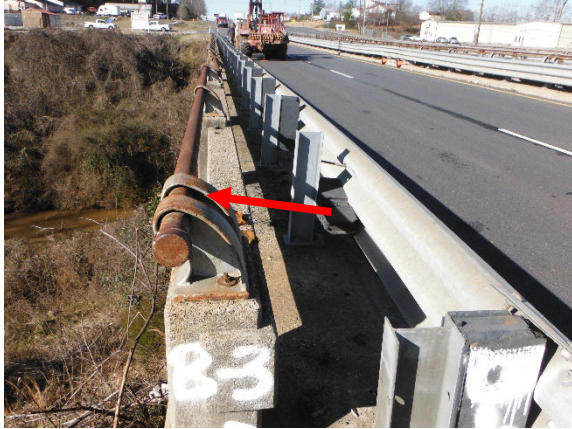
Photo 1. LBP on silver painted original metal guardrails.

Therefore, OSHA regulations and procedures should be followed when impacting these components. If possible, they should be removed in whole and disposed of properly. Also, SCDHEC disposal requirements for lead containing materials should also be followed.

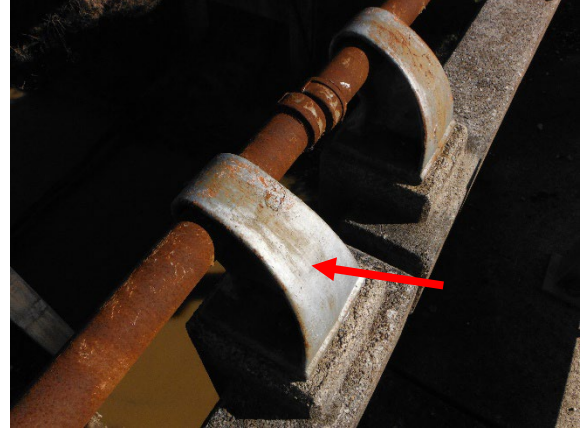
Photo 2. Close-up view of LBP silver painted original metal guardrails.

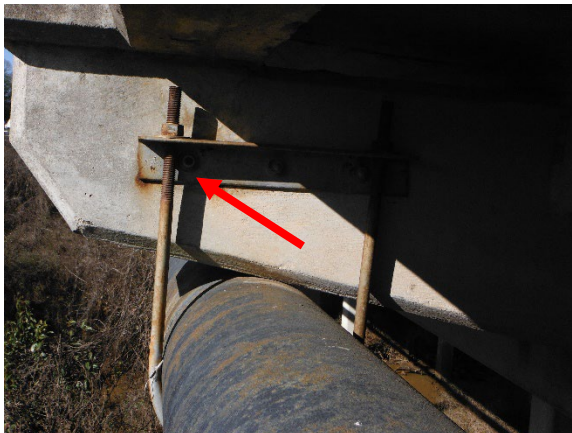
Photo 3. LBP on utility pipe support bracket.

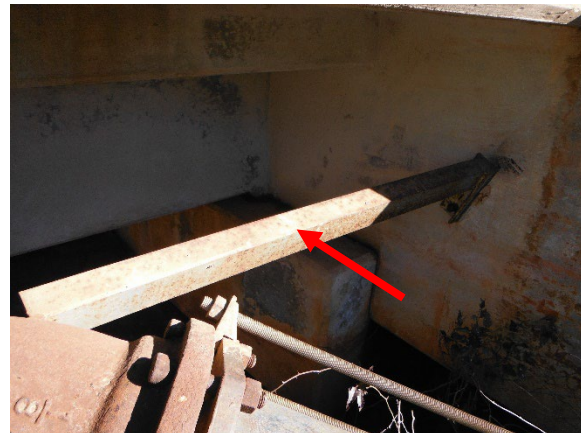
Photo 4. LBP on utility pipe support bracket.
