## LEAD-BASED PAINT INVESTIGATION REPORT

US 123 HIGHWAY (CALHOUN MEMORIAL HWY.)  
SOUTHBOUND BRIDGE OVER GEORGES CREEK  
SCDOT BRIDGE #392012310600  
PICKENS COUNTY, SOUTH CAROLINA

November 23, 2022

FME Project No.: G6657.002

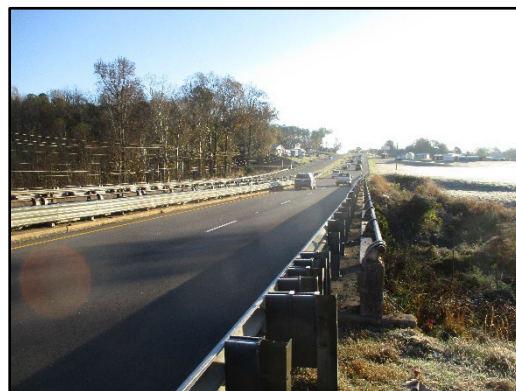
*Photo 1: US 123 (Calhoun Memorial Hwy.) Southbound Bridge over Georges Creek in Pickens County, South Carolina.*

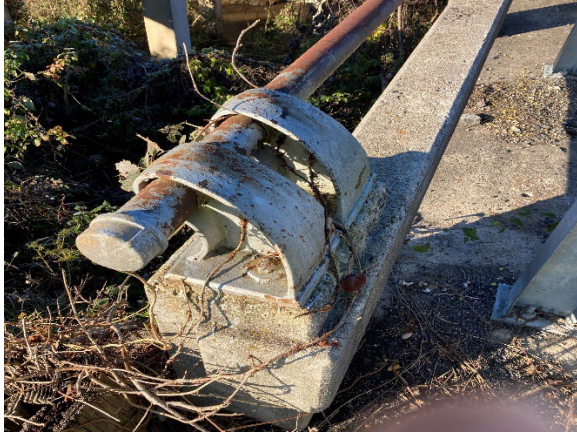
- **Original Silver Painted Metal Guardrails**

**Photo 1.** LBP containing silver painted original metal guardrail.

Therefore, OSHA regulations and procedures should be followed when impacting these components. If possible, they should be removed in whole and disposed of properly. Also, SCDHEC disposal requirements for lead containing materials should also be followed.

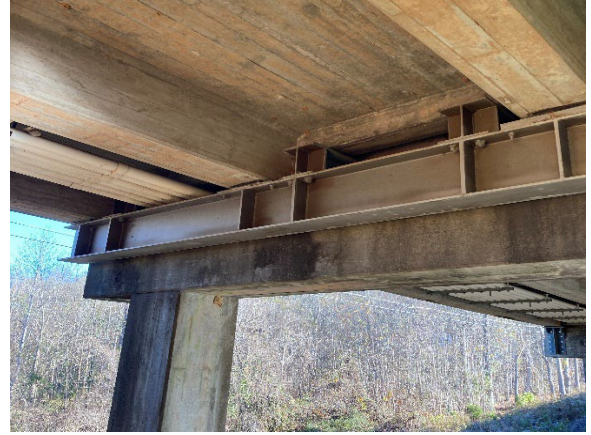
**Photo 2.** View of Bent Cap Repair

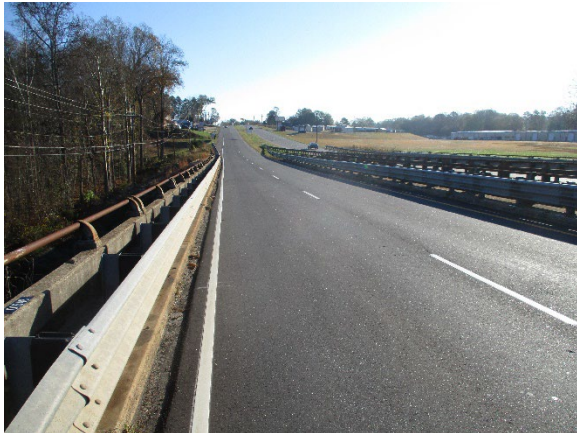
**Photo 3.** Top View of Bridge.

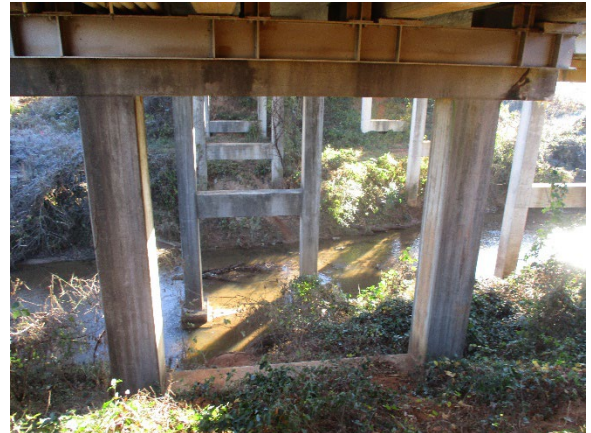
**Photo 4.** Underside View of Bridge.

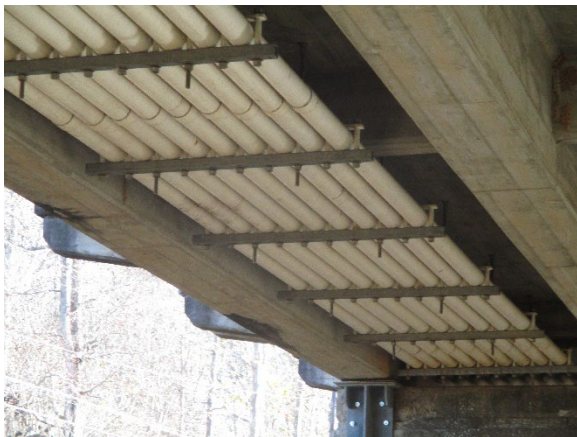
During the field investigation, FME personnel noted nine (9) communication conduits attached to the underside of the concrete decking on the north side of the Bridge. All nine (9) communication conduits run the entire length of the Bridge. See Appendix A – Site Vicinity Map, for the location of the Bridge. See Appendix B – General Bridge Plan, for a layout of the Bridge.

**Photo 5.** Nine (9) Communication Conduits attached to the North Underside of Bridge.

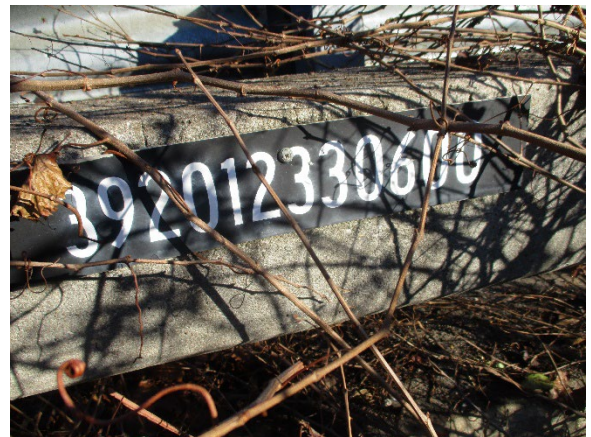
**Photo 6.** SCDOT Bridge Number Placard Attached to the Concrete Guardrail.
