## LEAD-BASED PAINT INVESTIGATION REPORT

SC 124 (OLD EASLEY HWY.) BRIDGE OVER GEORGES CREEK  
SCDOT BRIDGE #394012400100  
PICKENS COUNTY, SOUTH CAROLINA

November 23, 2022

FME Project No.: G6657.003

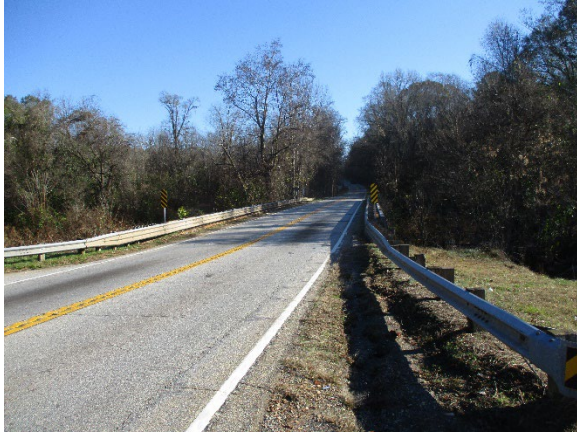
**Photo 1.** Top View of Bridge Deck.

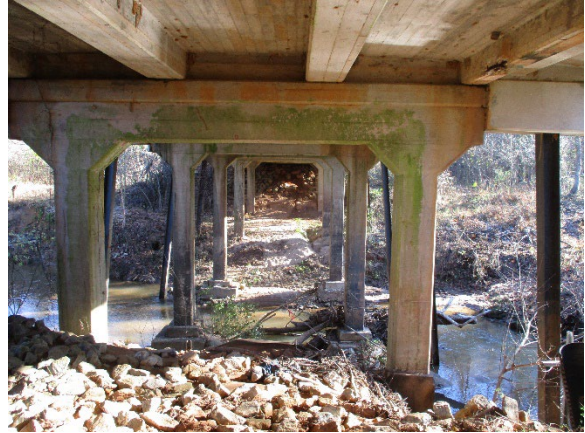
**Photo 2.** Underside View of Bridge.

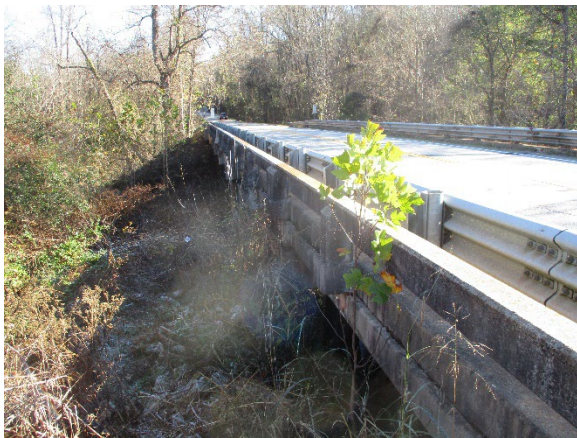
**Photo 3.** North Side View of Bridge.

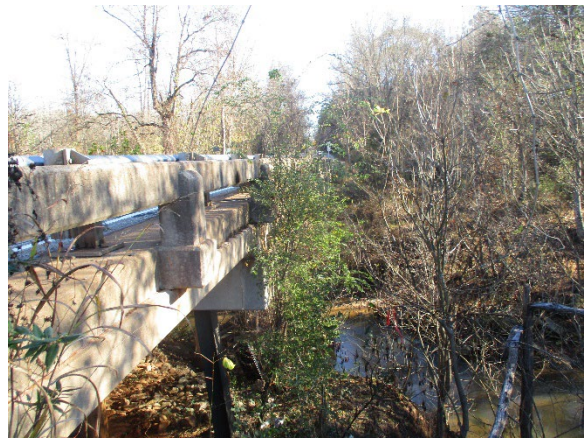
**Photo 4.** South Side View of Bridge.

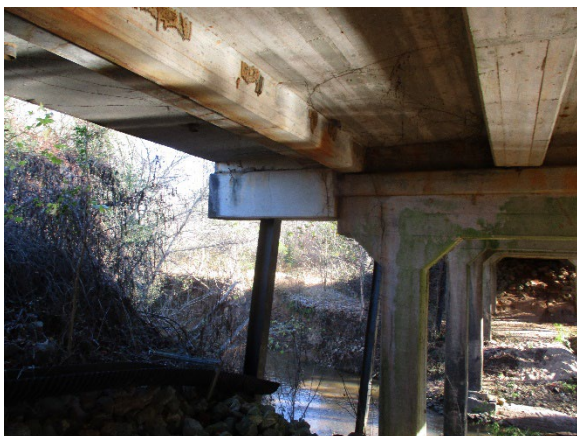
**Photo 5.** New Bridge Addition Underside View.

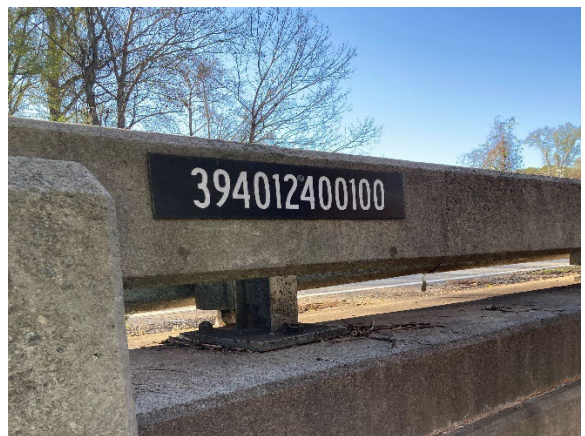
**Photo 6.** SCDOT Bridge Number Placard Attached to the Concrete Guardrail.
