LEAD-BASED PAINT INVESTIGATION REPORT

SC 183 (WALHALLA HWY.) BRIDGE OVER 12 MILE CREEK
SCDOT BRIDGE #394018300400
PICKENS COUNTY, SOUTH CAROLINA

November 14, 2022

FME Project No.: G6657.001

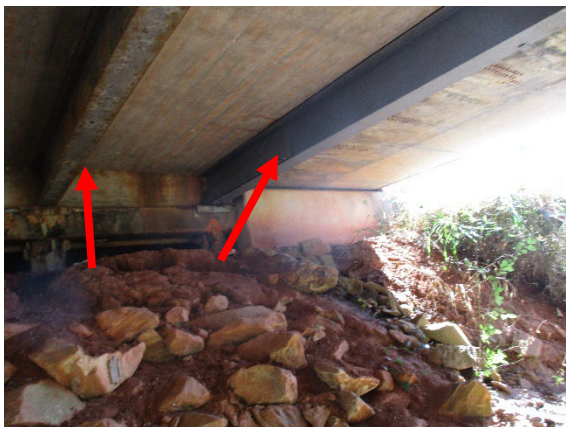
Scan No.	Pbc (mg/cm ²)	Component	Substrate	Side	Condition	Color
1	0.88	Calibrate				
2	0.89	Calibrate				
3	0.87	Calibrate				
4	4.36	Horizontal Steel Girder	Metal	Center	Poor	Gray
5	3.83	Horizontal Steel Girder	Metal	Center	Poor	Gray
6	0.10	Girder Plate	Metal	Center	Intact	Gray
7	0.16	Girder Plate	Metal	Center	Intact	Gray
8	<LOD	Girder Plate	Metal	Center	Intact	Gray
9	2.87	Steel Bearing Plate	Metal	Center	Poor	Gray
10	2.30	Steel Bearing Plate	Metal	Center	Poor	Gray
11	0.10	X-Bracing	Metal	D	Intact	Gray
12	0.16	X-Bracing	Metal	D	Intact	Gray
13	<LOD	X-Bracing	Metal	D	Intact	Gray
14	0.13	H-Pile	Metal	D	Intact	Gray
15	0.25	H-Pile	Metal	B	Intact	Gray
16	0.16	H-Pile	Metal	B	Intact	Gray
17	0.95	Calibrate				
18	0.89	Calibrate				
19	0.93	Calibrate

Photo 5. LBP on Gray Horizontal Steel Girders.

Therefore, OSHA regulations and procedures should be followed when impacting these components. If possible, they should be removed in whole and disposed of properly. Also, SCDHEC disposal requirements for lead containing materials should also be followed.

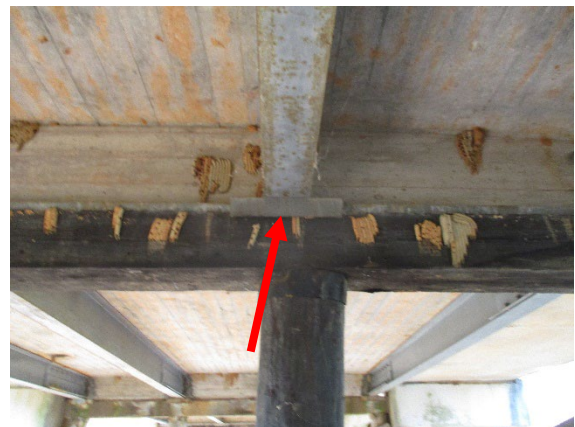
Photo 6 LBP on Gray Girder Bearing Plates.
