## LEAD-BASED PAINT INVESTIGATION REPORT

SC 183 (WALHALLA HWY.) BRIDGE OVER GREGORY CREEK  
SCDOT BRIDGE #394018300300  
PICKENS COUNTY, SOUTH CAROLINA

**November 14, 2022**

FME Project No.: G6657.001

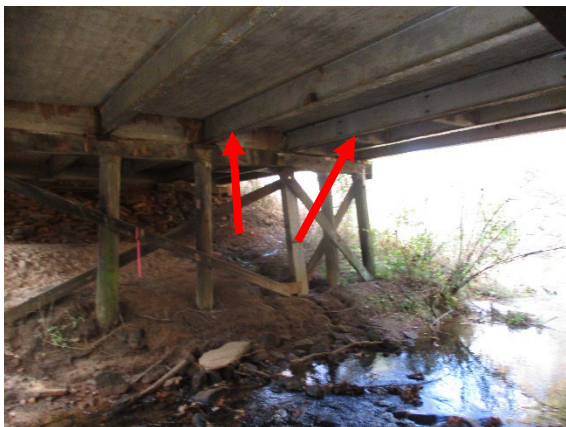
| Scan No. | Pbc (mg/cm <sup>2</sup> ) | Component | Substrate | Side | Condition | Color |
|---|---|---|---|---|---|---|
| 4 | 4.28 | Horizontal Steel Girder | Metal | Center | Poor | Gray |
| 5 | 4.12 | Horizontal Steel Girder | Metal | Center | Poor | Gray |
| 8 | 36.0 | New Add. Girder | Metal | A | Intact | Gray |

**Photo 5.** LBP on Gray Horizontal Steel Girders on Original and New Addition.

Therefore, OSHA regulations and procedures should be followed when impacting these components. If possible, they should be removed in whole and disposed of properly. Also, SCDHEC disposal requirements for lead containing materials should also be followed.

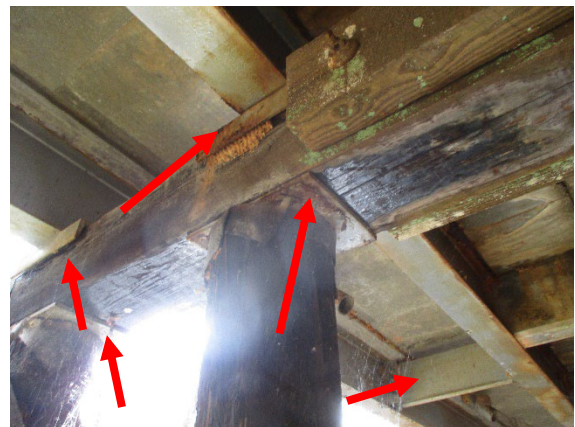
| Scan No. | Pbc (mg/cm <sup>2</sup> ) | Component | Substrate | Side | Condition | Color |
|---|---|---|---|---|---|---|
| 6 | 4.26 | Girder Bearing Plate | Metal | Center | Poor | Gray |
| 7 | 4.04 | Girder Bearing Plate | Metal | Center | Poor | Gray |
| 9 | 35.0 | New Add. Diaphragm | Metal | A | Intact | Gray |
| 10 | 35.0 | New Add. Girder Bearing Plate | Metal | Center | Intact | Gray |
| 11 | 36.0 | Timber Pile Plate | Metal | A | Intact | Gray |

**Photo 6** LBP on Gray Girder Bearing Plates, Gray Timber Pile Plates and Diaphragms.
