## ASBESTOS CONTAINING MATERIAL INVESTIGATION REPORT

S-32-273 – BUSH RIVER RD. BRIDGE OVER I-20 (EAST & WEST BOUND LANES) SCDOT BRIDGE #3327027300200 LEXINGTON COUNTY, SOUTH CAROLINA

F&ME Project No.: G5662.010

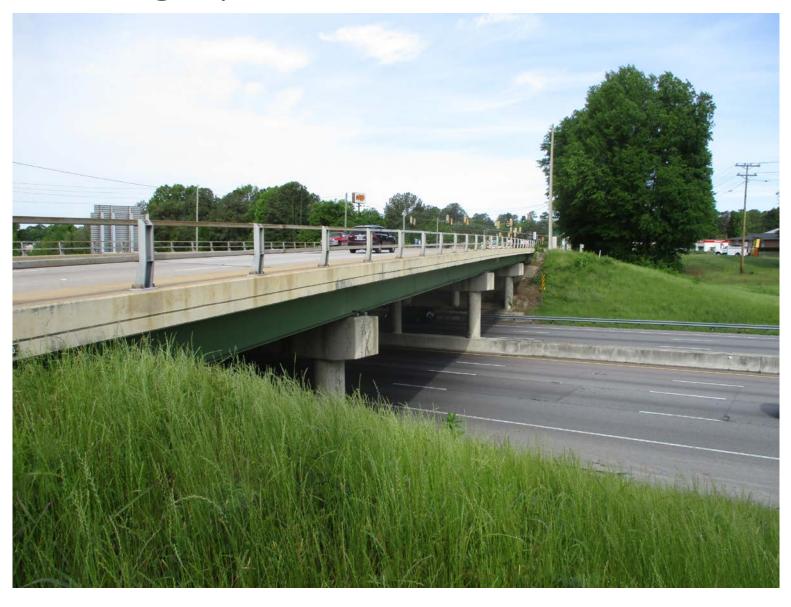
East Side View of Bridge

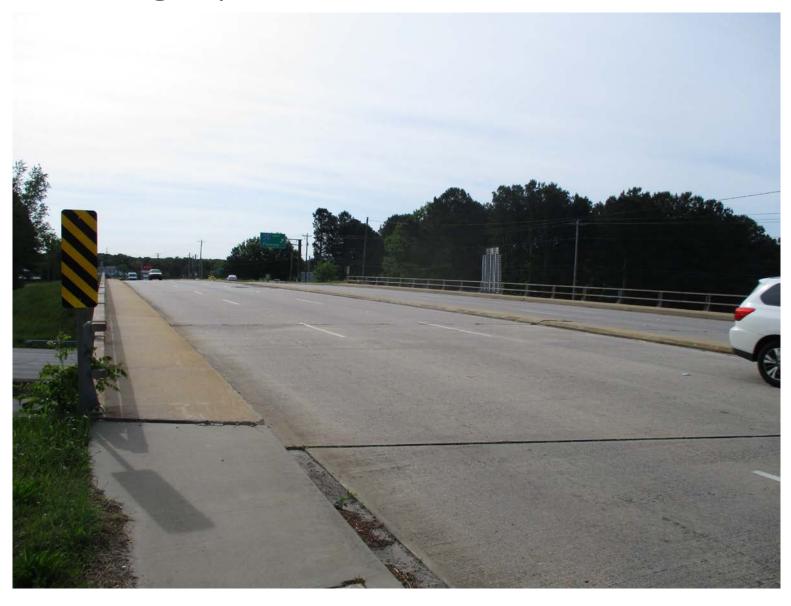
Top of Bridge DeckView

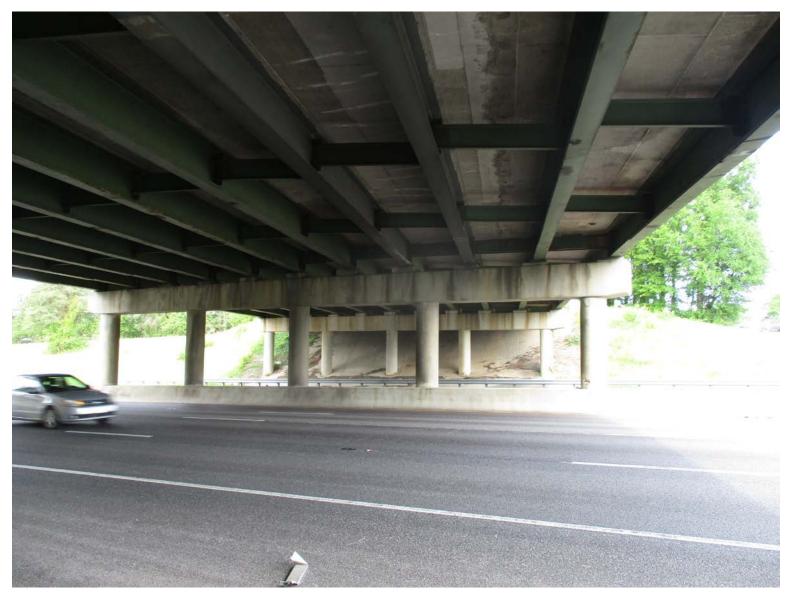
- Underside of Bridge View.

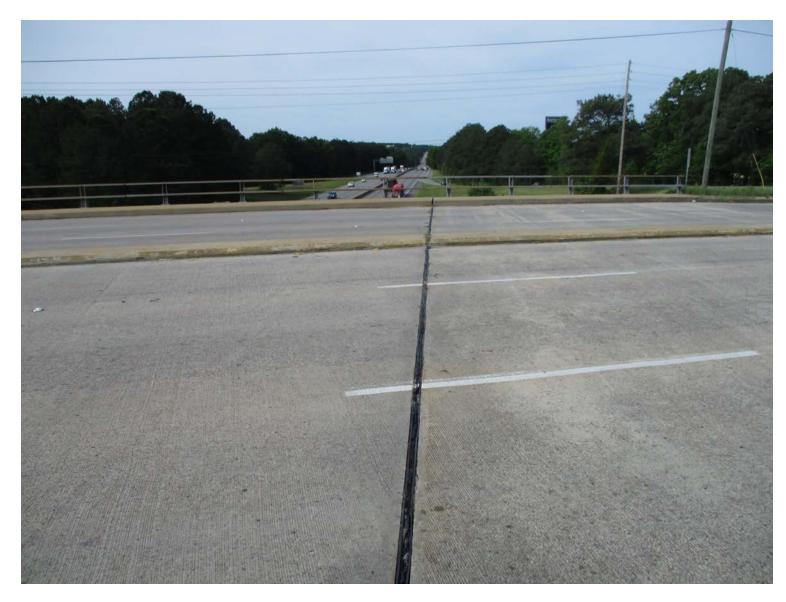
During the investigation, the deck expansion joint material and column expansion joint material were the only suspect materials observed on the subject bridge. Three (3) random samples of each suspect material were collected for laboratory analysis, and their physical characteristics were recorded. The remaining structural materials (i.e. concrete, steel, etc.) were not considered suspect and were not sampled.

Expansion Joint Material on Top of Bridge Deck.

It is our understanding that the subject structure is to be demolished as part of this project. All accessible suspect materials have been sampled and analyzed by an accredited laboratory and found to contain no ACM. Therefore, there are no foreseen special handling or disposal requirements, regarding asbestos, that will be required for the demolition of this bridge.

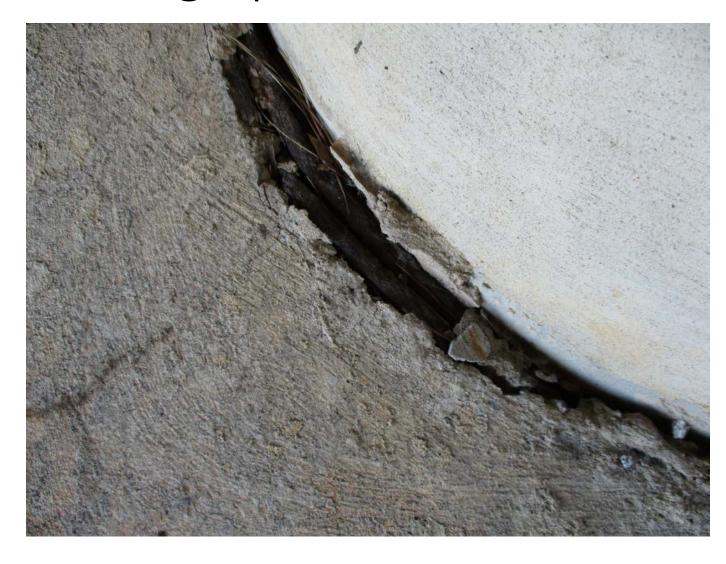
Column Expansion
 Joint Material
 Located at the
 Interface of Concrete
 at Grade and
 Concrete Column
