# LEAD-BASED PAINT INVESTIGATION REPORT

S-32-273 – BUSH RIVER ROAD BRIDGE OVER I-20 (EAST & WEST BOUND LANES) SCDOT BRIDGE #3327027300200 LEXINGTON COUNTY, SOUTH CAROLINA

### May 4, 2018

F&ME Project No.: G5662.010

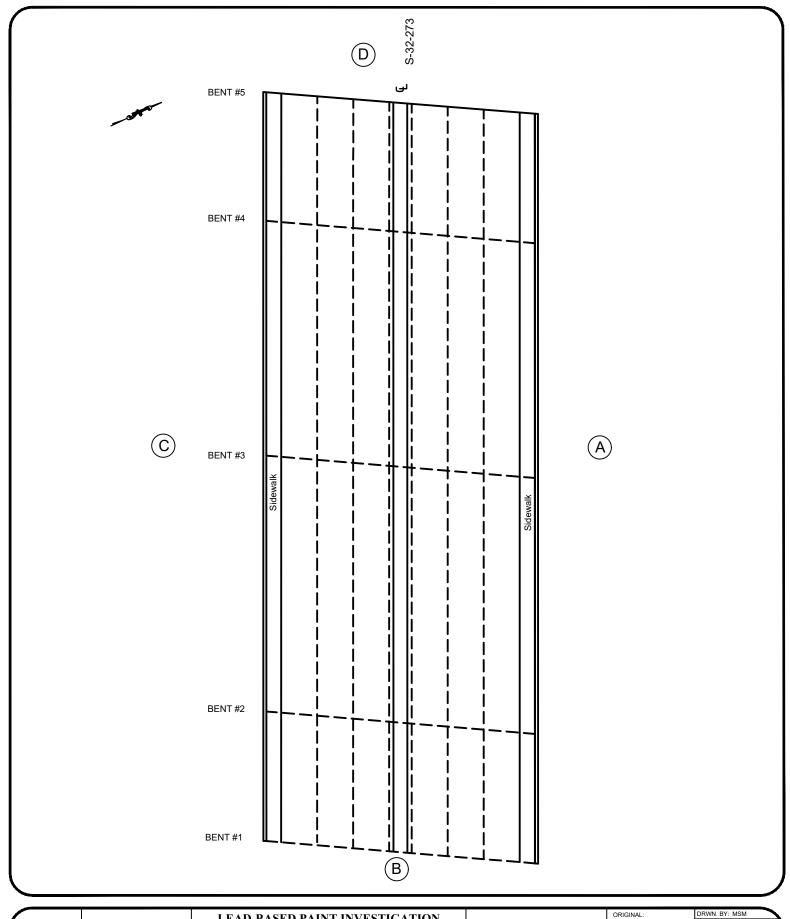
### **General Site Plan**

F&ME Consultants has completed a Lead-Based Paint (LBP) Investigation on the S-32-273 (Bush River Rd.) Bridge Over I-20 in Lexington County, South Carolina, for HDR, Inc (David Kinard, P.E. - Project Manager), on April 26, 2018. Appendix A – Site Vicinity Map is provided to show the location of the bridge. Appendix B – Bridge Plan, is provided to show the bridge lay-out and locations of XRF scans taken on the bridge.

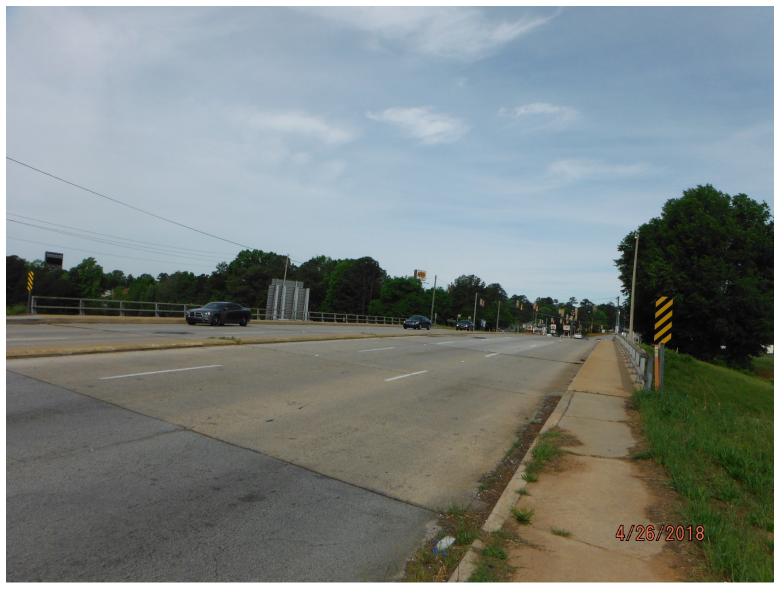
Top view of the subject bridge looking up station with a view of the top deck of the bridge.

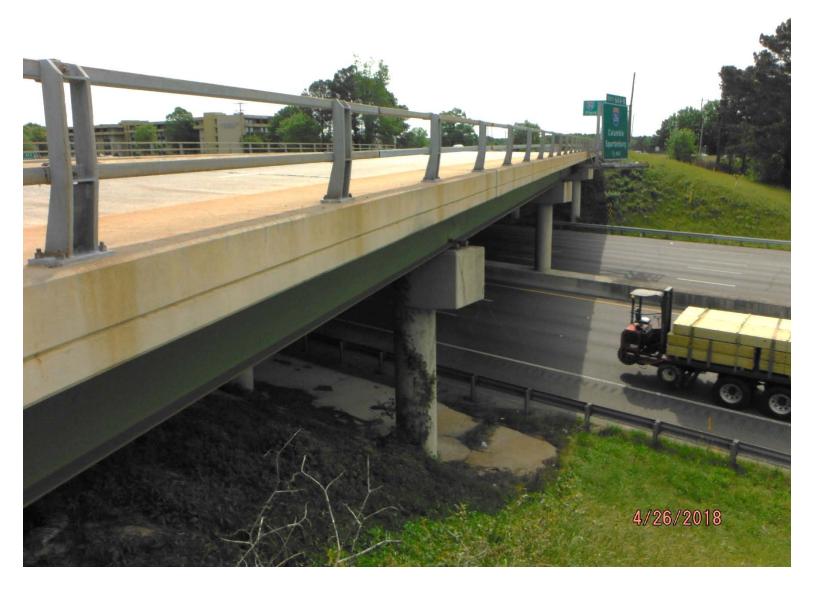
Side view of the bridge.

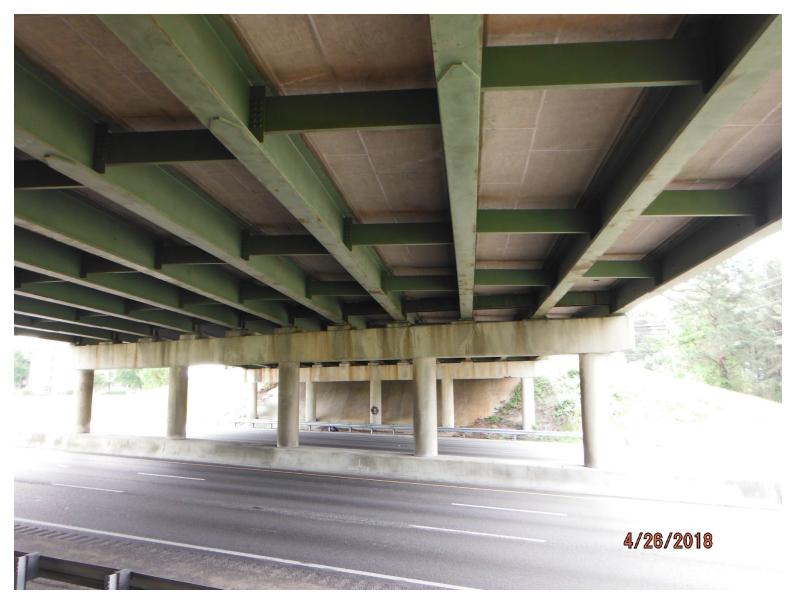
The results from the XRF quantitative testing indicate that lead is present in paint and/or coatings at levels that equal to or exceed the SCDHEC threshold for lead (0.7 mg/cm2) in the following bridge component associated within the areas of this LBP investigation: bridge beams, diaphragms, and beam plates. For more information regarding the specific descriptions and locations of the items that were scanned, refer to the Appendix C – XRF Data. Also, Appendix D – Site Photographs, shows top and underside views of the bridge along with photos of the bridge components that tested positive for lead. Appendix E - Personnel Certification, is included to show F&ME qualifications with regards to LBP Investigations.

View from underside of bridge with view of the beams and diaphragms that tested positive for LBP.

Components found to contain lead should be handled appropriately. It is recommended that work tasks which require grinding, sanding, cutting torch, or other disturbance of the LBP surfaces identified herein be performed in accordance with federal regulations pertaining to worker protection from exposure to LBP. When lead containing items are disturbed or begin to decay they become a concern regarding human health and the environmental. The typical routes of exposure to lead are through the inhalation or ingestion of lead-contaminated materials. Minimal risk of exposure exists where the lead-containing paint and coating are intact (e.g., has not been aerosolized, free of chipping or flaking, etc.).

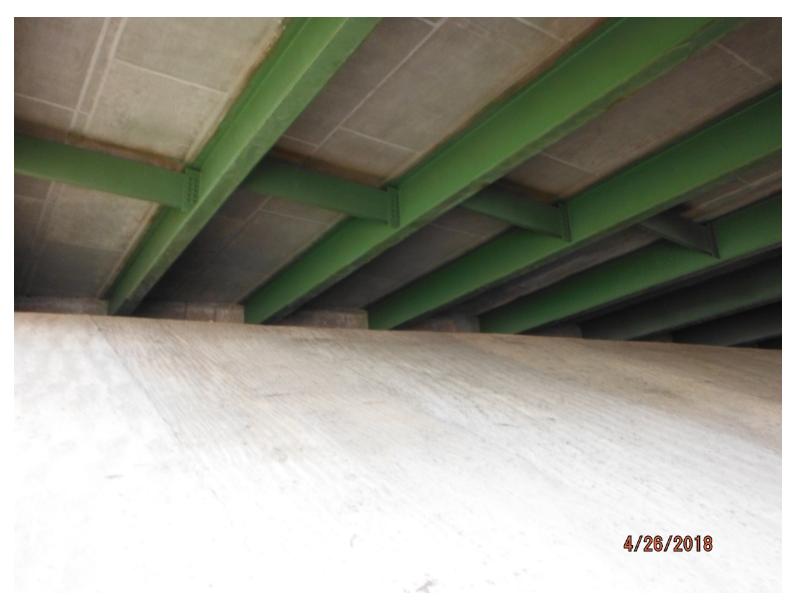
Another underside view of the beams and diaphragms that tested positive for LBP.

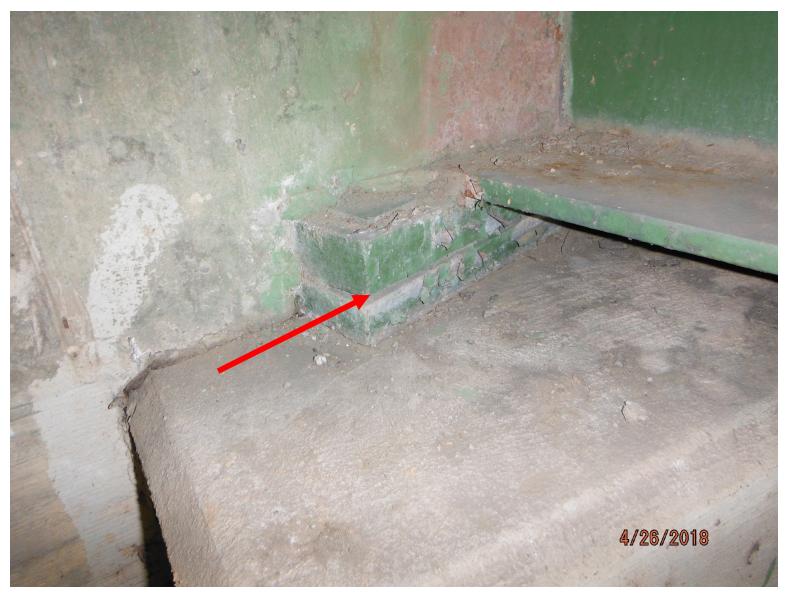
Underside view of the beam plates that tested positive for LBP and are peeling.
