Bridge Rehabilitation Requirements

1. GENERAL BRIDGE REHABILITATION REQUIREMENTS

SCDOT has performed deck evaluations on Asset ID 7937 (S-40-31 (Bush River Road) over I-26), Asset ID 7272 (S-40-273 (Bush River Road) over I-20), and Asset ID 7586 (S-40-36 (St. Andrews Road) over I-26). Quantities associated with the anticipated repairs, if these bridges are not replaced as part of the Contractor's Work, on these bridges are included in Tables 4, 5, and 6. Evaluation reports are included in Appendices A, B, and C.

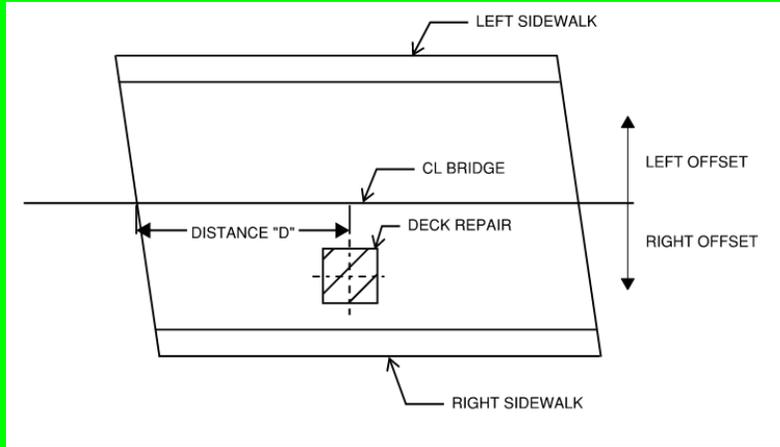
Table 4: Top of Deck Repairs (Asset ID 7937: S-40-31 (Bush River Road) over I-26)

* Quantity includes repairs in adjacent span (continuous deck).
Total square yardage of partial depth repair = 2,607 SY

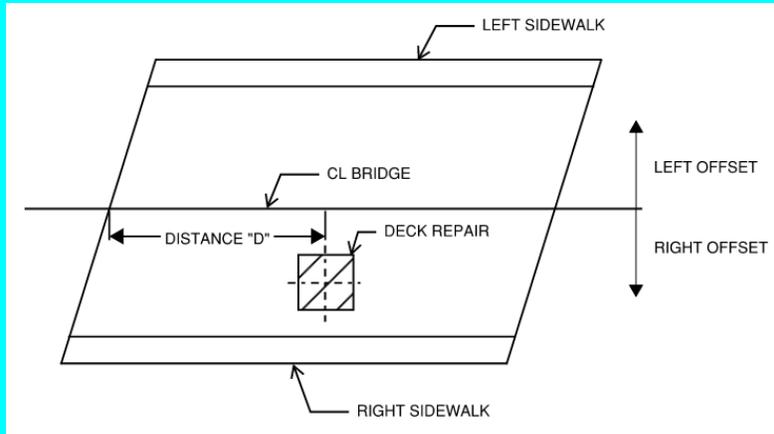
Table 5: Top of Deck Repairs (Asset ID 7272: S-40-273 (Bush River Road) over I-20)

Total square yardage of partial depth repair = 1,433 SY

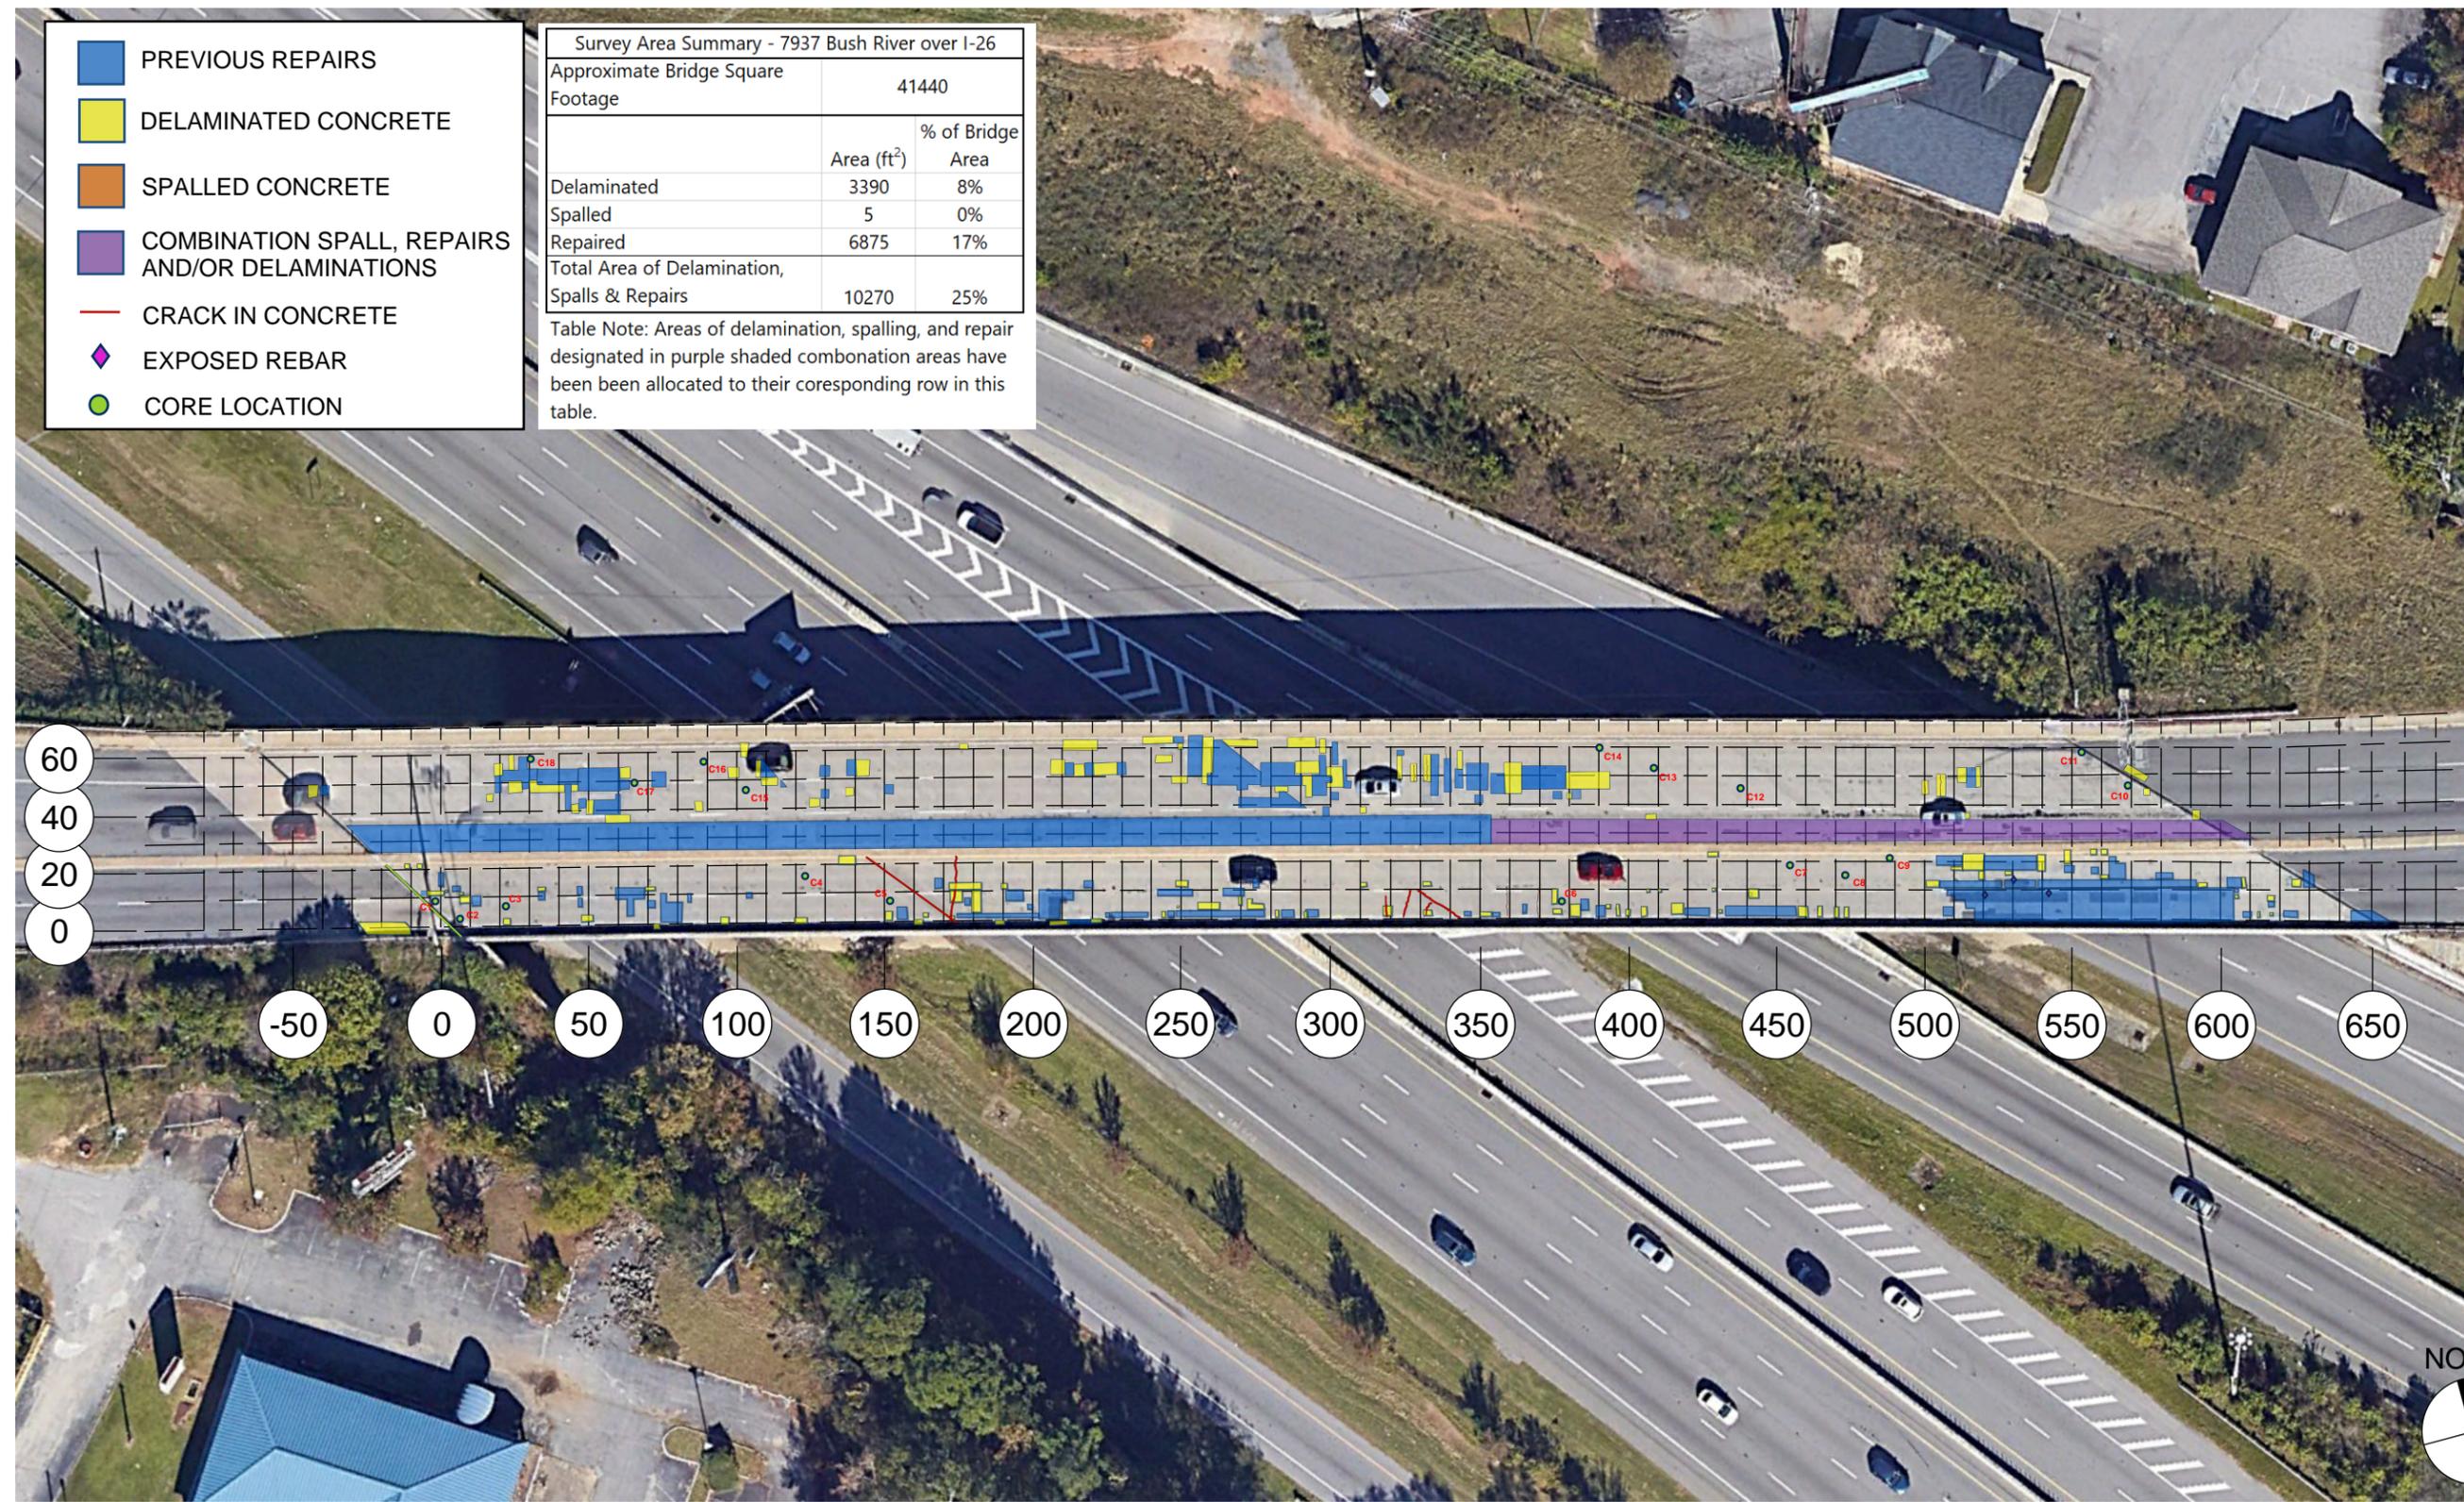
Survey Area Summary - 7937 Bush River over I-26		
Approximate Bridge Square Footage	41440	
	Area (ft ²)	% of Bridge Area
Delaminated	3390	8%
Spalled	5	0%
Repaired	6875	17%
Total Area of Delamination, Spalls & Repairs	10270	25%

Table Note: Areas of delamination, spalling, and repair designated in purple shaded combination areas have been allocated to their corresponding row in this table.

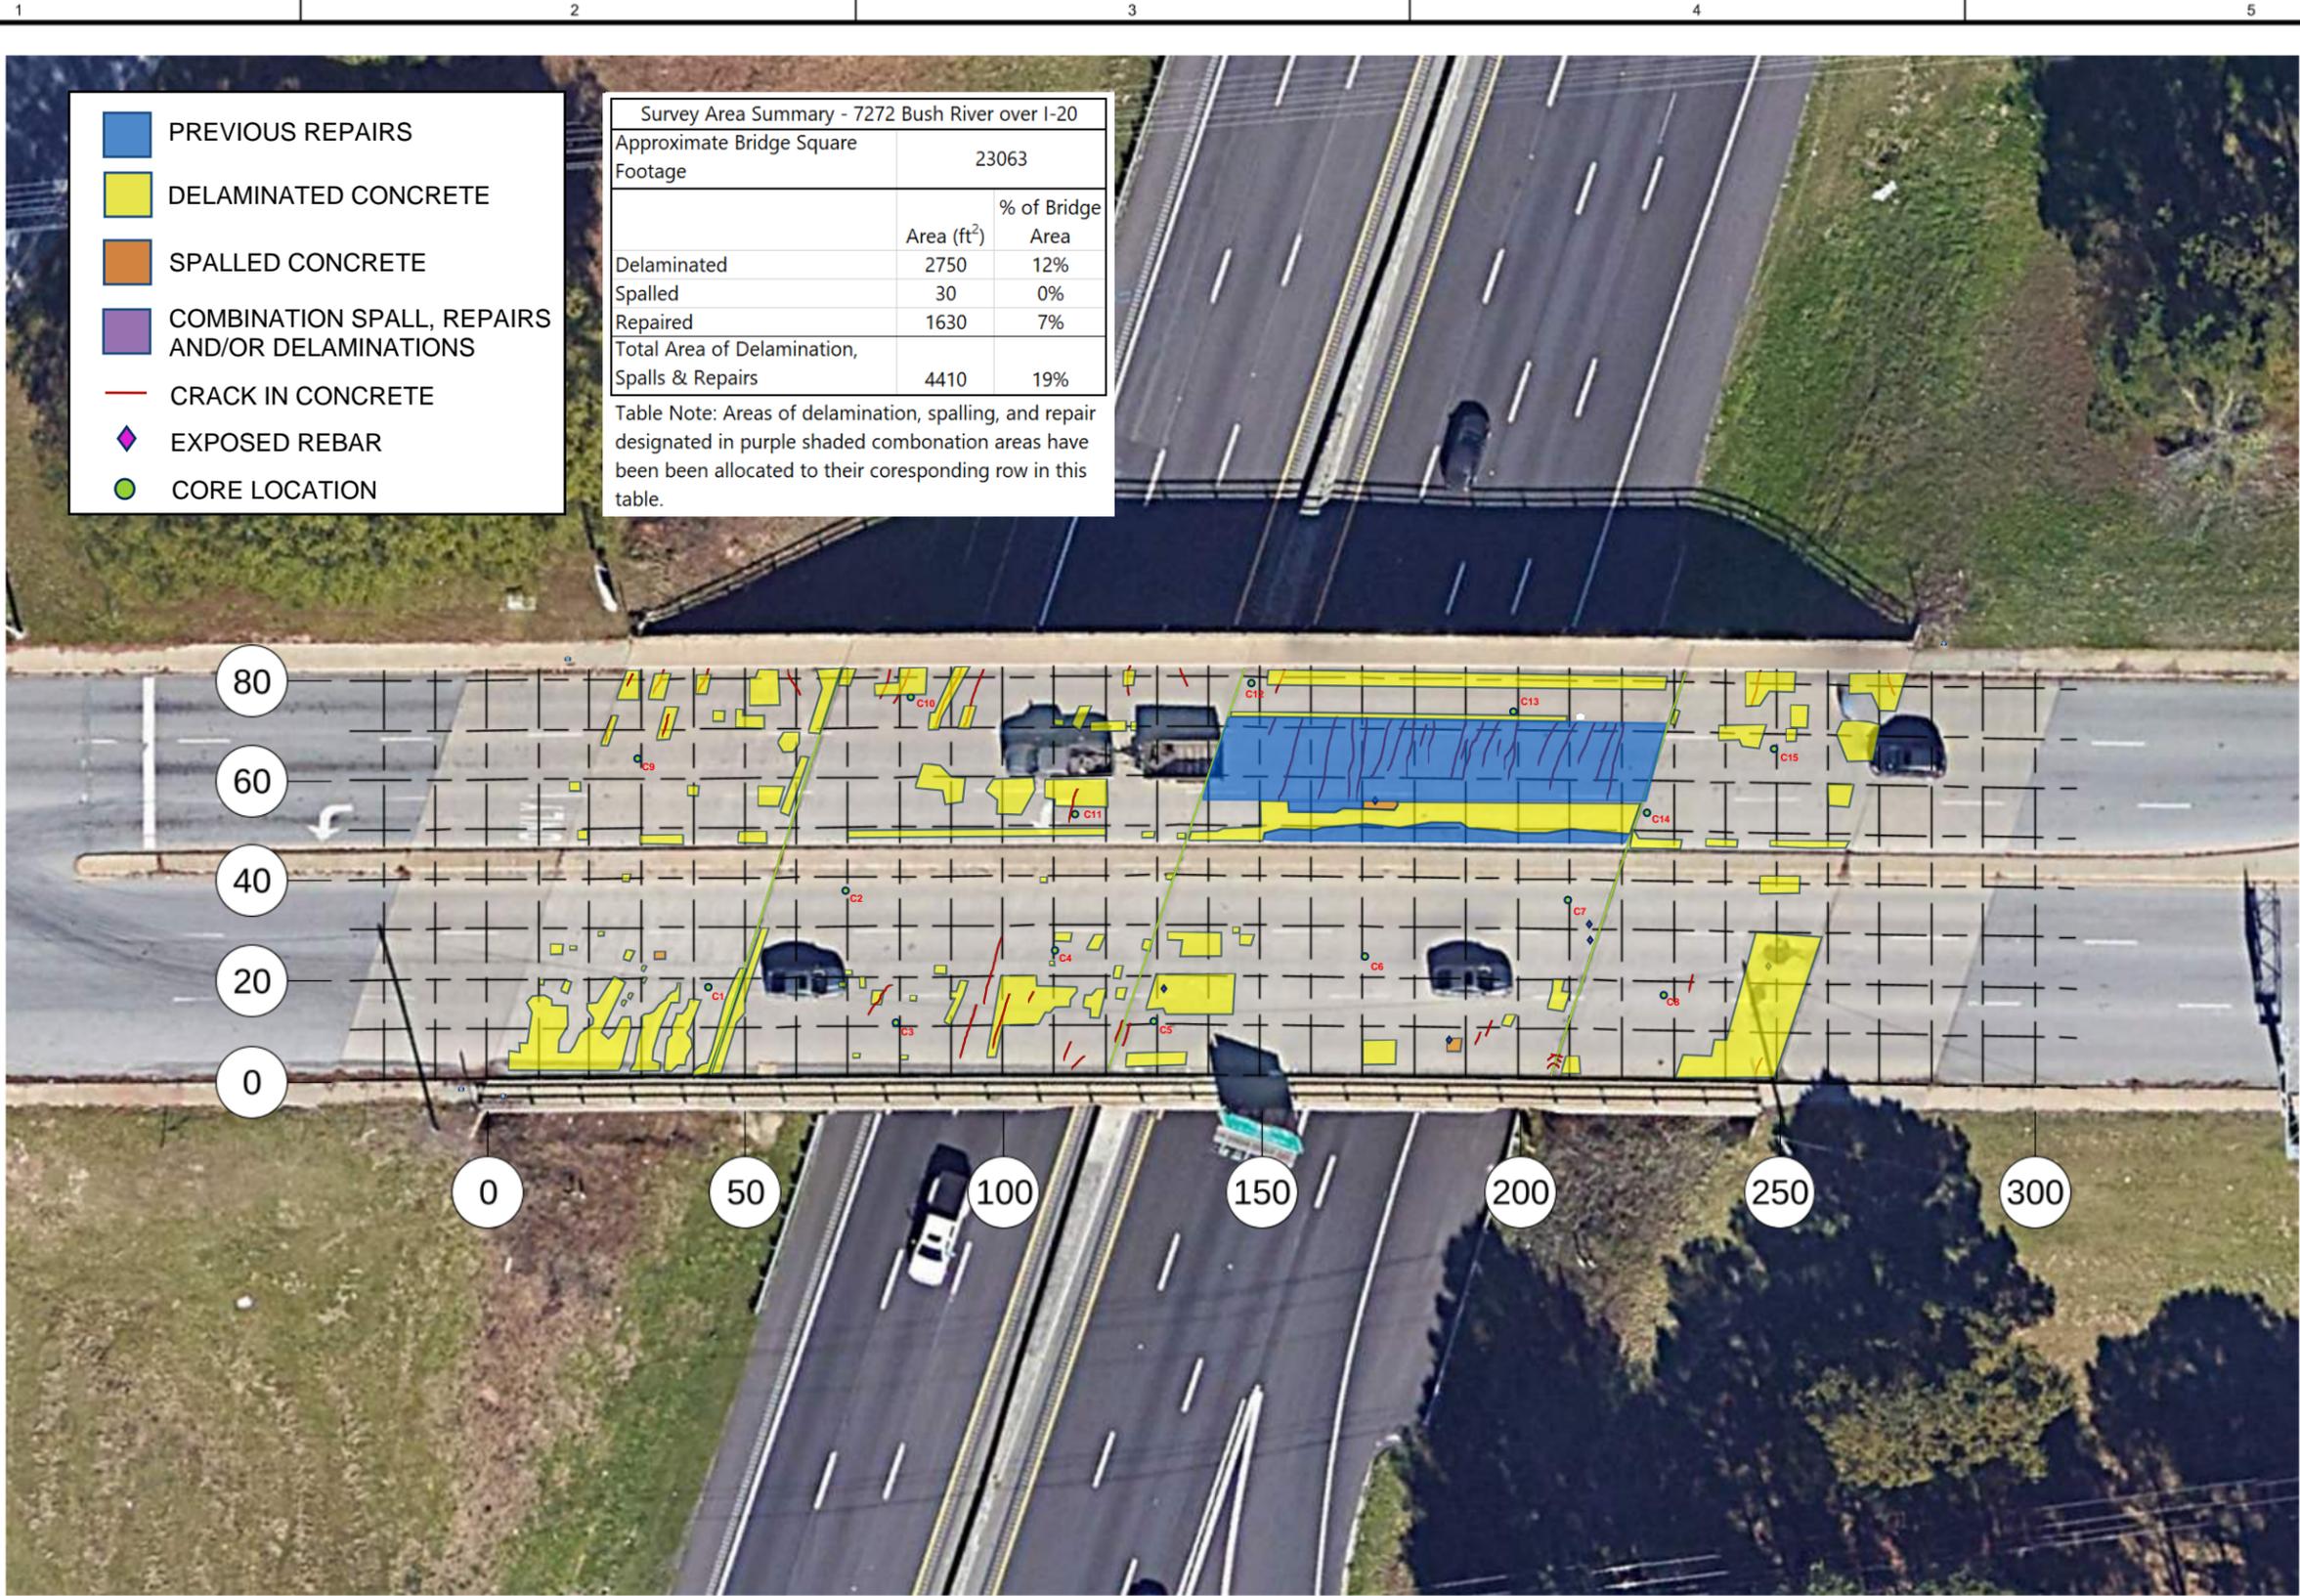
Survey Area Summary - 7272 Bush River over I-20		
Approximate Bridge Square Footage	23063	
	Area (ft ²)	% of Bridge Area
Delaminated	2750	12%
Spalled	30	0%
Repaired	1630	7%
Total Area of Delamination, Spalls & Repairs	4410	19%

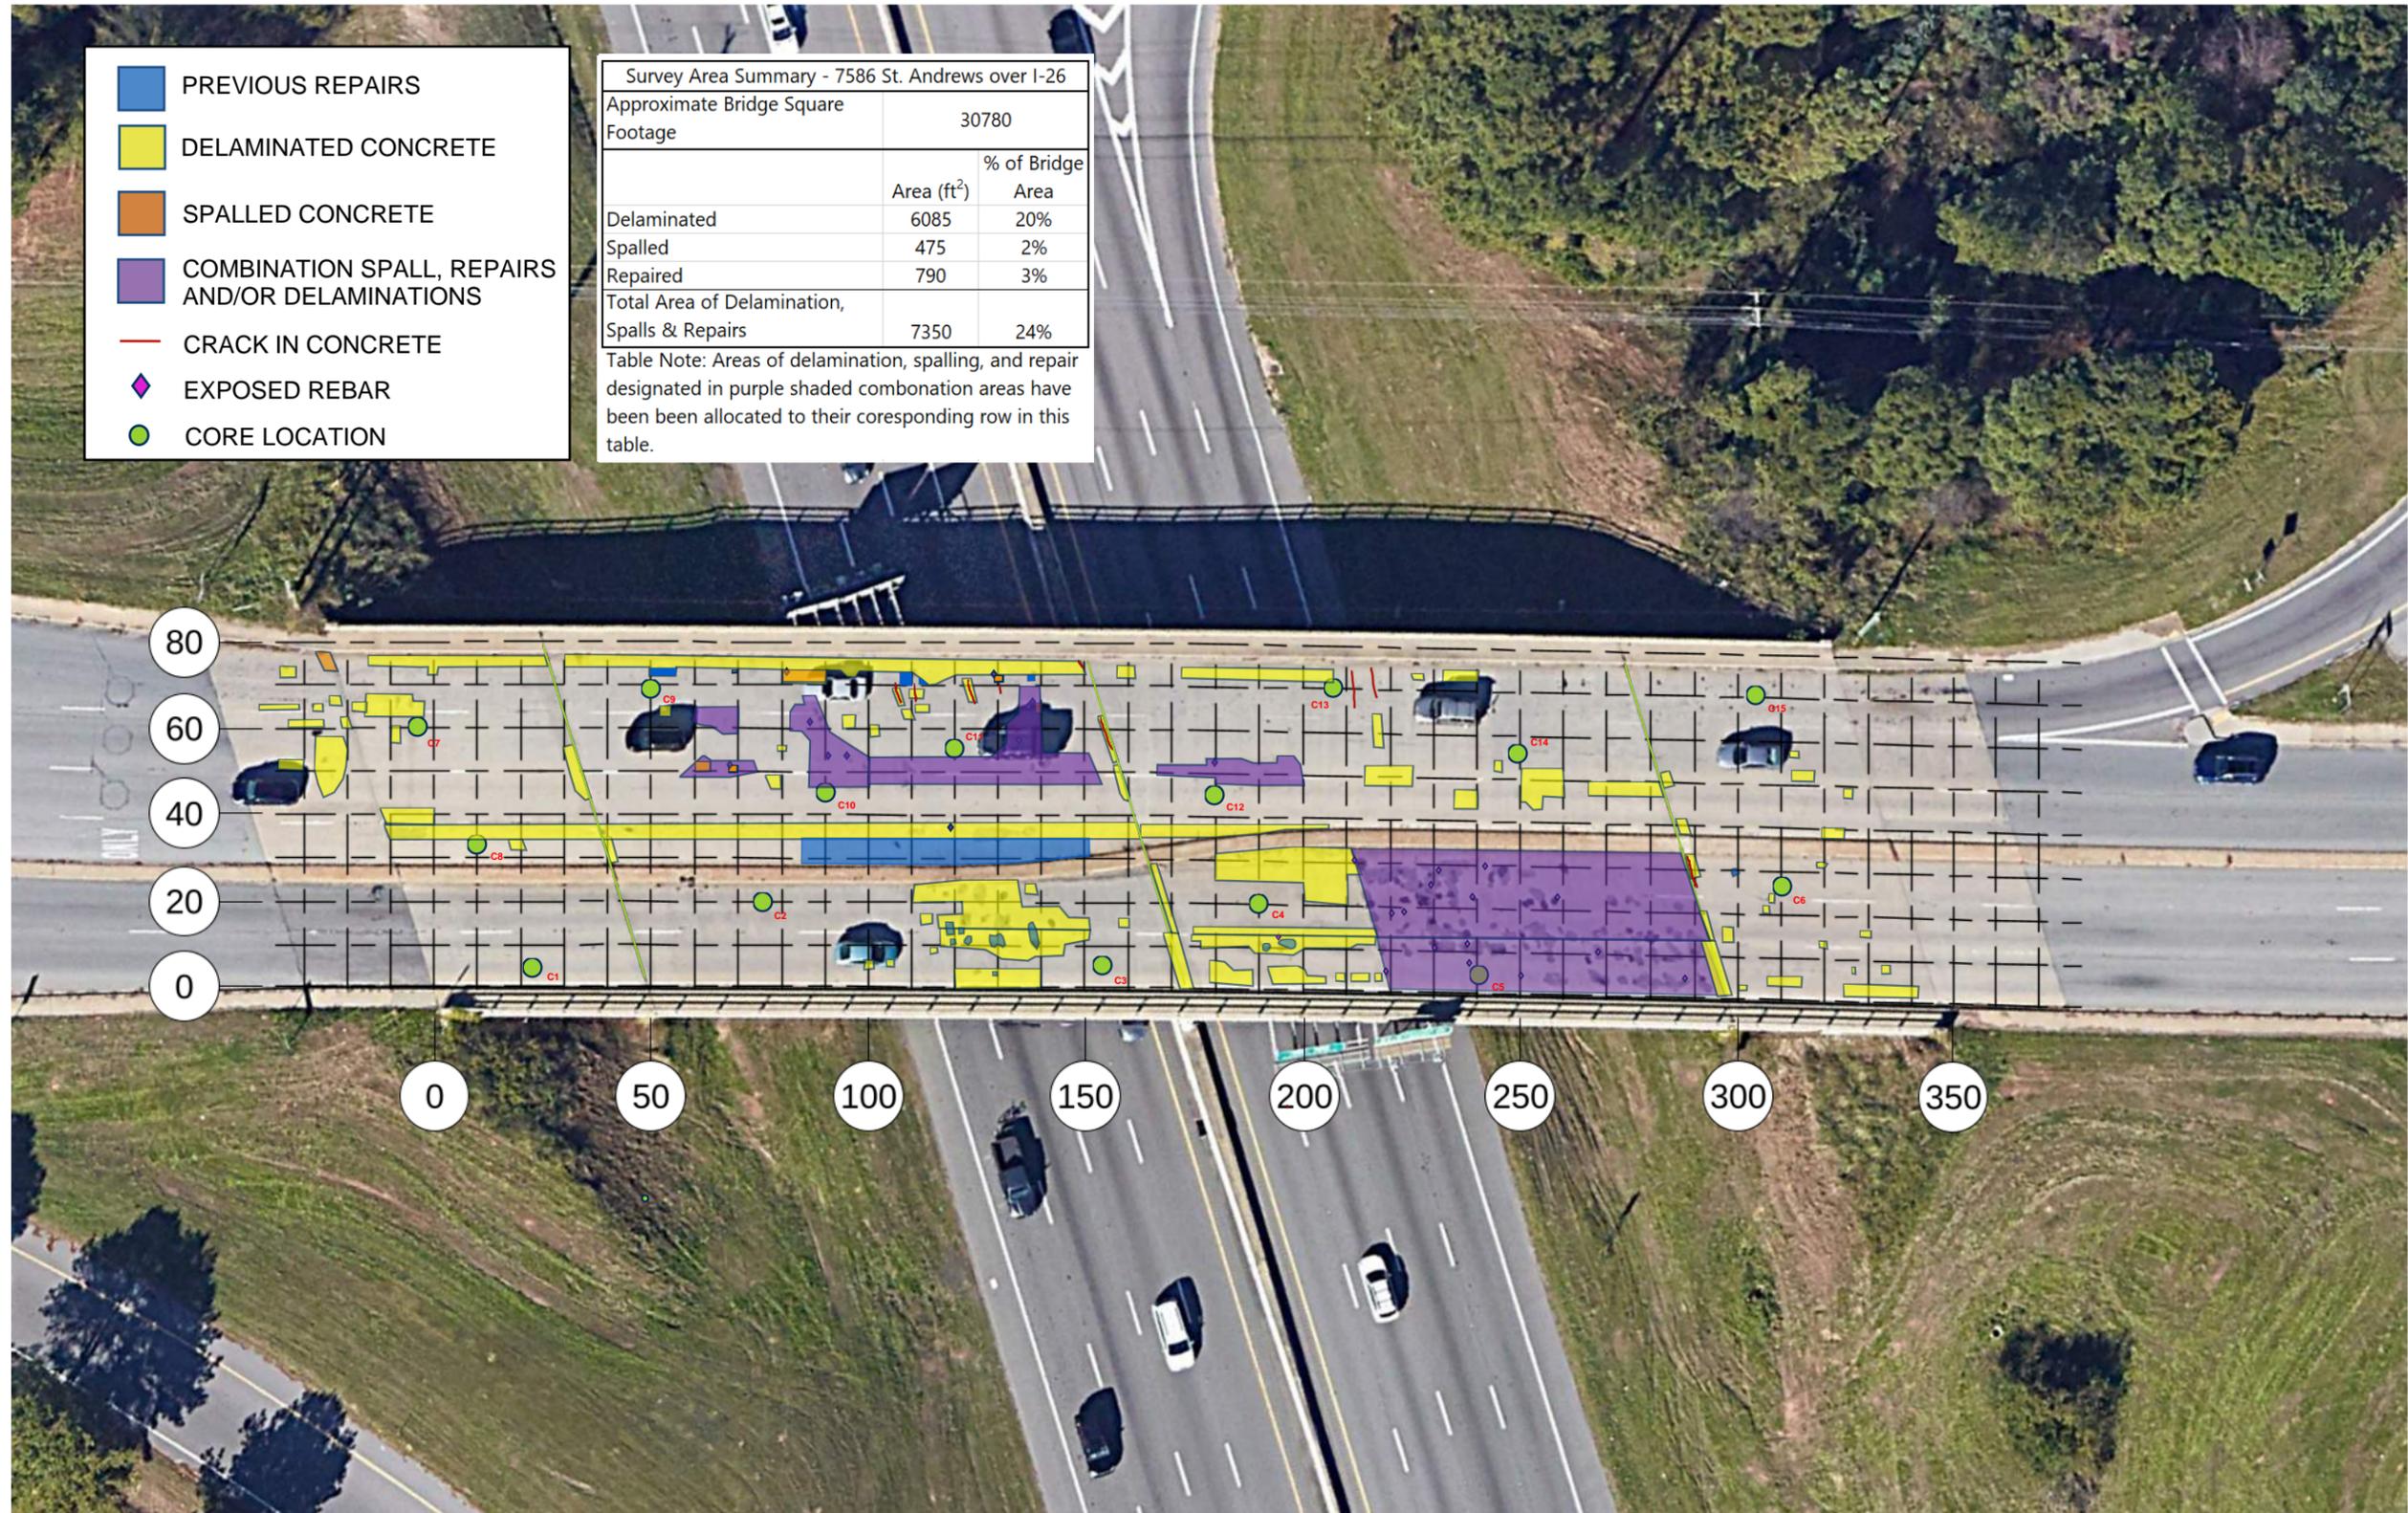
Survey Area Summary - 7586 St. Andrews over I-26		
Approximate Bridge Square Footage	30780	
	Area (ft ²)	% of Bridge Area
Delaminated	6085	20%
Spalled	475	2%
Repaired	790	3%
Total Area of Delamination, Spalls & Repairs	7350	24%

Table Note: Areas of delamination, spalling, and repair designated in purple shaded combination areas have been allocated to their corresponding row in this table.
