I-95 Northbound Bridge Over I-26  
Orangeburg County, South Carolina

Asbestos and Lead-Based Paint  
Survey Report

Structure # 381009510100  
ARM Project #16-318-22

October 14, 2022

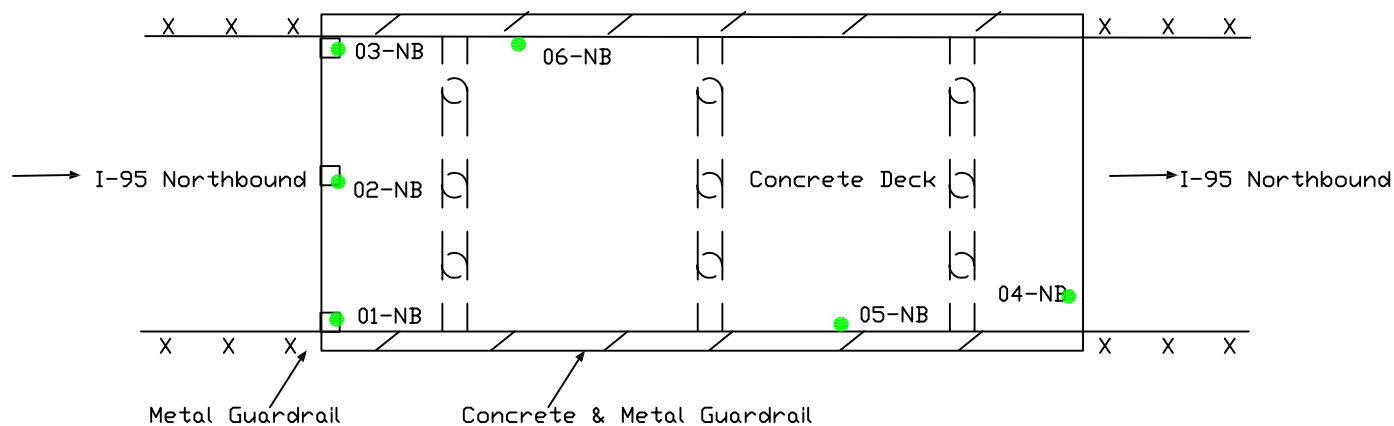
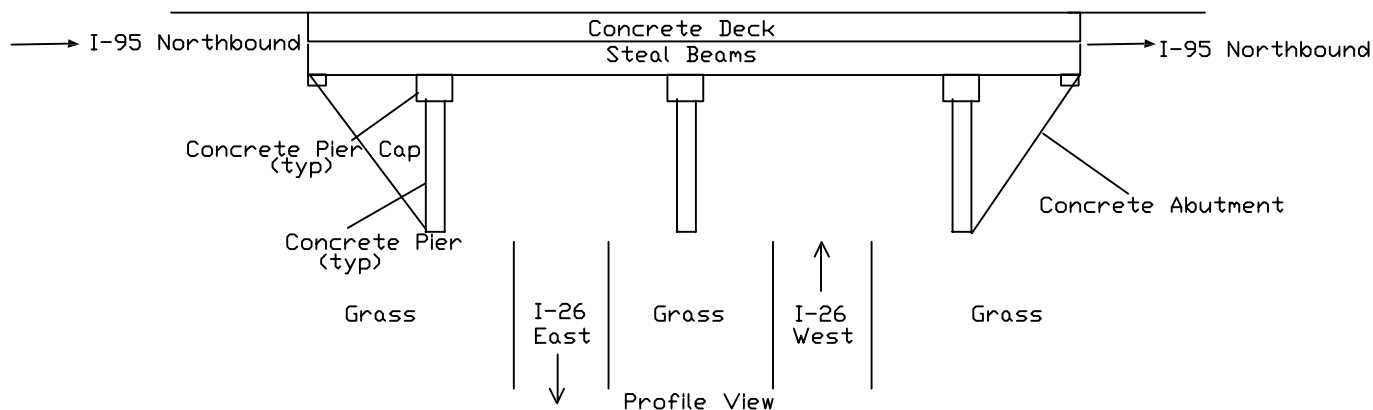
**FIGURE 2**

Site Plan Showing  
Sample Locations

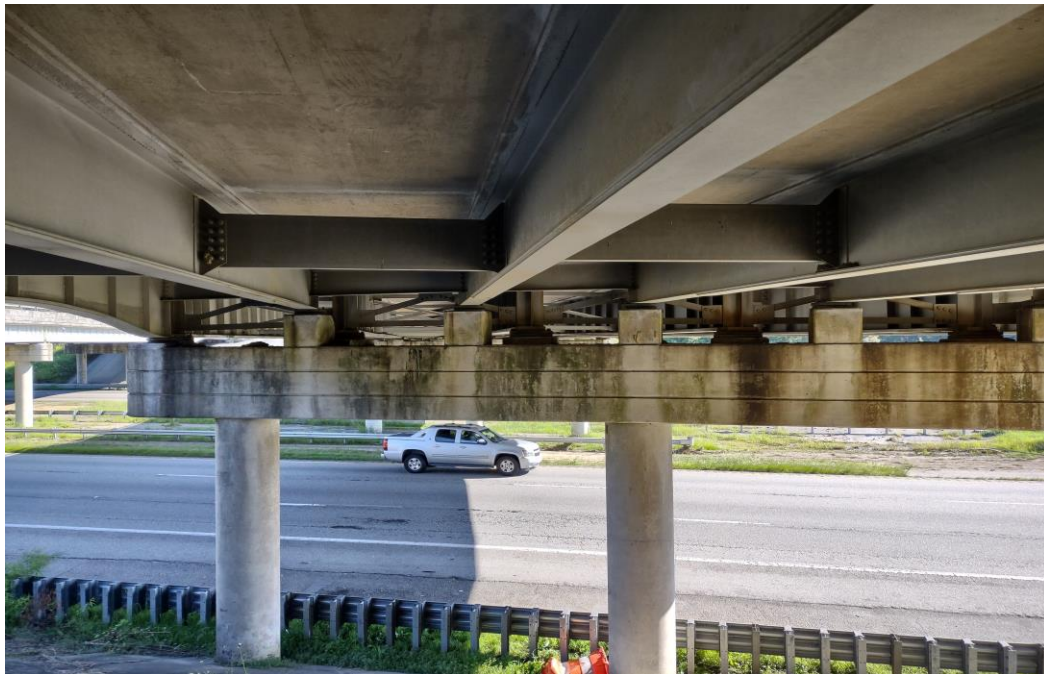
**Photograph 2**

A view of the underside of the I-95 northbound bridge over I-26 in Orangeburg County.

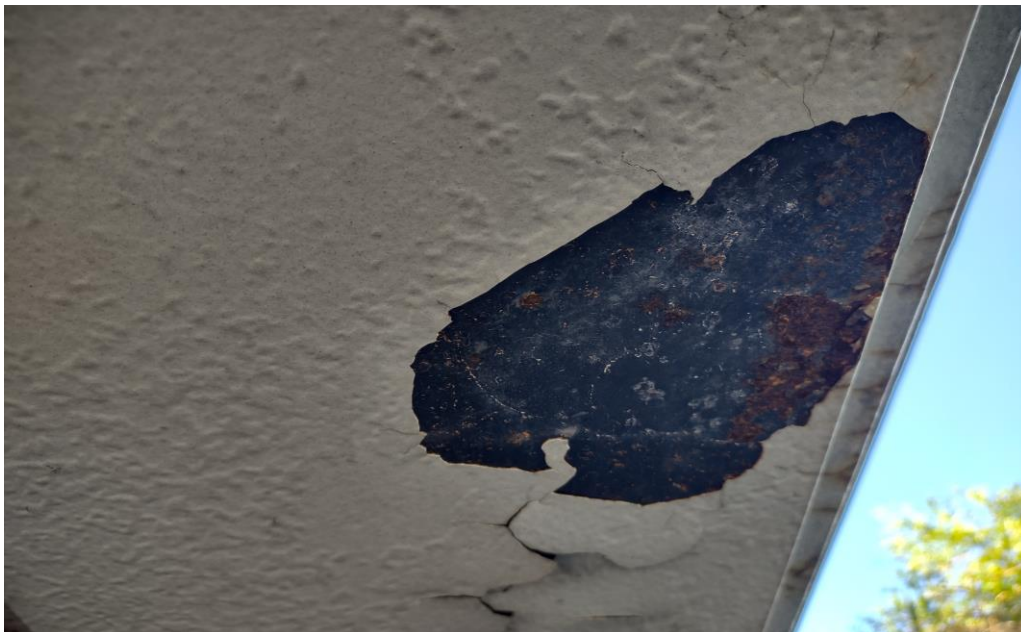
**Photograph 4**

The bridge structure is primarily composed of steel and concrete components, with the steel painted gray or white. It appears that this bridge may have been reconditioned at some point and repainted. **While the majority of XRF readings were negative for lead-based paint, there were two readings taken from a steel beam flange on the west underside where lead-paint was detected.** It's likely that this is a small area of remnant paint (approximately 3 square feet) that was missed following the abrasive blasting and repainting of the bridge. The materials sampled for lead-based paint included the steel beams, steel cross bracing, and steel bridge shoes. Results of the XRF analyses are summarized in Table 2 below.

A lead-based paint survey was performed for the I-95 northbound bridge over I-26 in Orangeburg County, South Carolina. **The results of the XRF analyses indicate that readings 28 and 34 (white steel beam flange at bridge's west underside) were positive for lead-based paint.** However, it is likely that the lead-based paint area is a small area (approximately 3 square feet) that was missed during abrasive blasting and repainting of the bridge structure. All other steel bridge components were found not to be coated with lead-based paint. In the event that any suspect painted materials not addressed in this survey are encountered, the materials should be presumed to be coated with lead paint until XRF or laboratory analysis can be conducted.

Lead-based paint was detected in two (2) of the XRF readings at the beam flange on the west underside of the I-95 northbound bridge over I-26 in Orangeburg County.
