I-26 Bridge Assessments

Bridge Assessment Report for Old Hilton Road (S-40-405) over I-26

Prepared for:
The South Carolina Department of Transportation

November 11, 2016

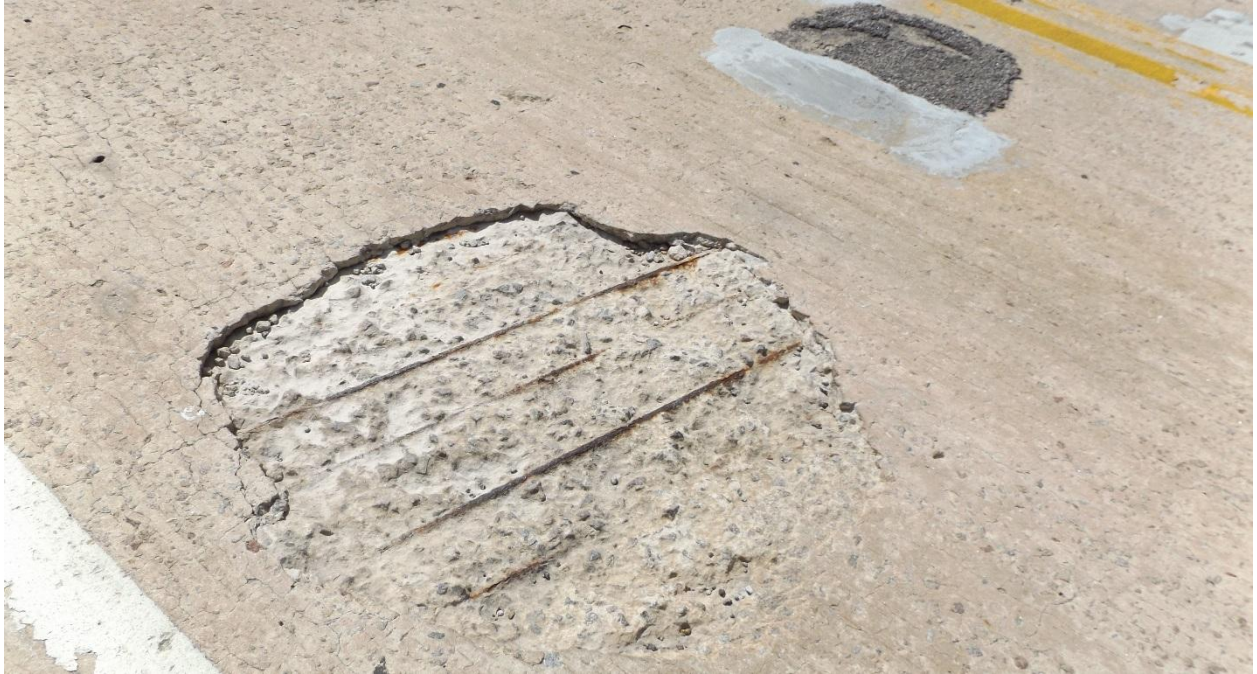
The existing reinforced concrete deck was observed from the shoulder since the roadway wasn't closed. There are several areas on the deck where concrete has spalled off and the reinforcing steel is exposed and corroded (see Figures 4 and 5). Additionally, there are several patched areas of the bridge deck that potentially conceal corroded rebar. The concrete end walls showed very little deterioration.

Figure 4 – Exposed Rebar in Concrete Deck

- Sufficiency rating of 58.2
- Bridge deemed structurally deficient in most recent SI&A Report
- Deck has severe deterioration in multiple locations with rebar exposed. Additionally, several deck locations are patched which likely conceals more compromised rebar. Deck replacement is necessary and would be costly, especially if new deck needs to meet current thickness requirements and beams and substructure would need to be analyzed to see if they can support the extra deck thickness.

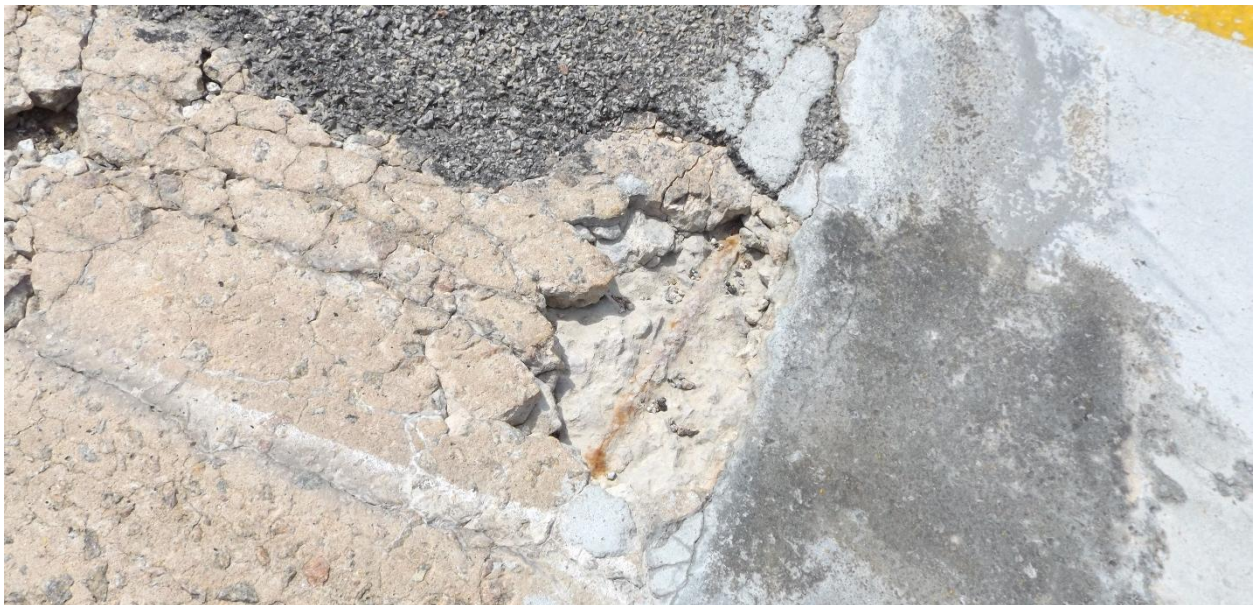
Figure 5 - Exposed Rebar in Concrete Deck

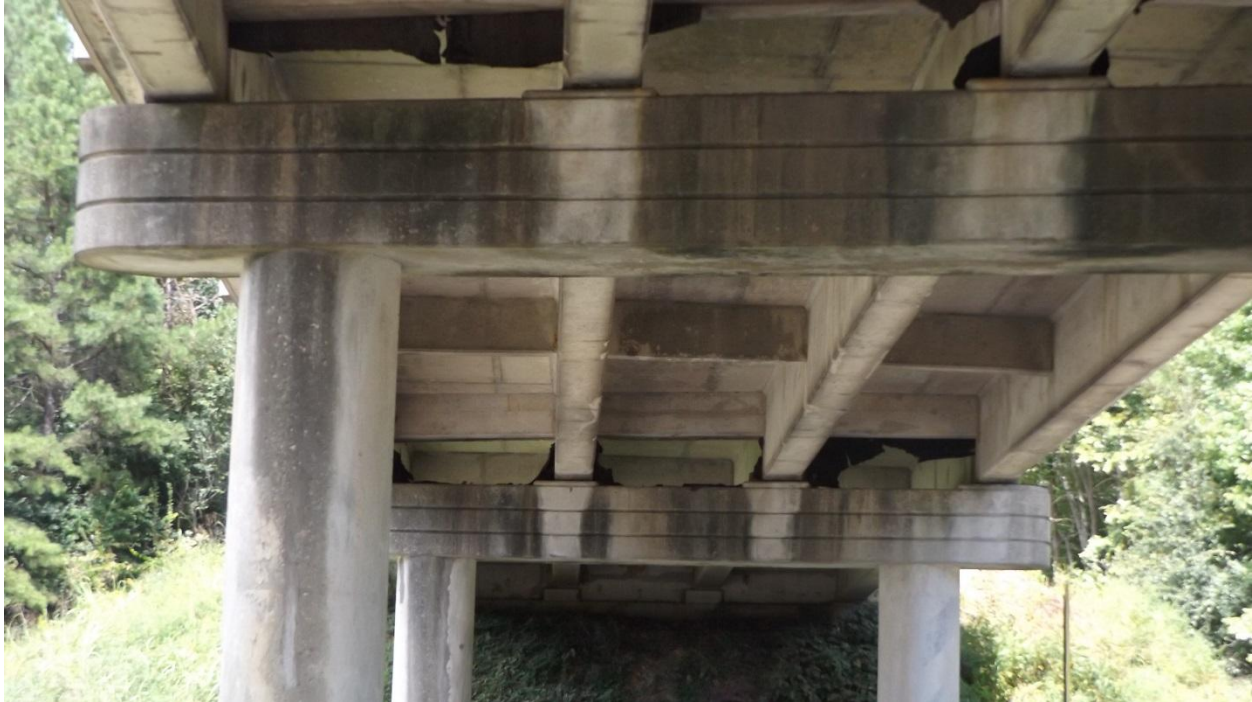
The existing reinforced concrete beams were assessed from accessible areas on the ground for deterioration and cracks. No deterioration or cracks were observed from the ground. The most recent Bridge Inspection Report does document some cracking in the beams.

Figure 6 – Superstructure (from underneath)

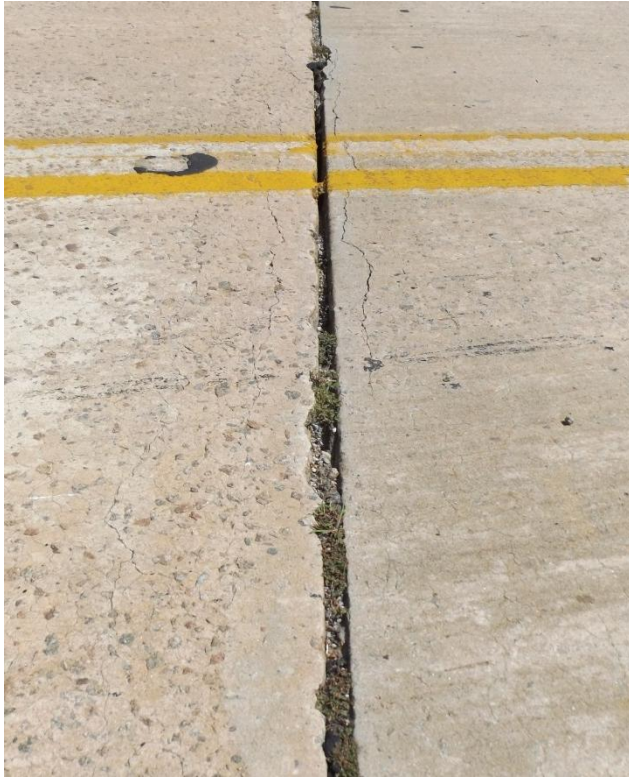
There are three deck expansion joints located within the bridge. They are located at Interior Bent 2, Interior Bent 3, and Interior Bent 4. All three expansion joints were observed from the shoulders due to the roadway not being closed. The joint filler is falling through the opening at several locations (see Figures 7 and 8). Where the joint filler hasn't fallen through, the material is in an advanced state of deterioration.

Figure 7 - Expansion Joint

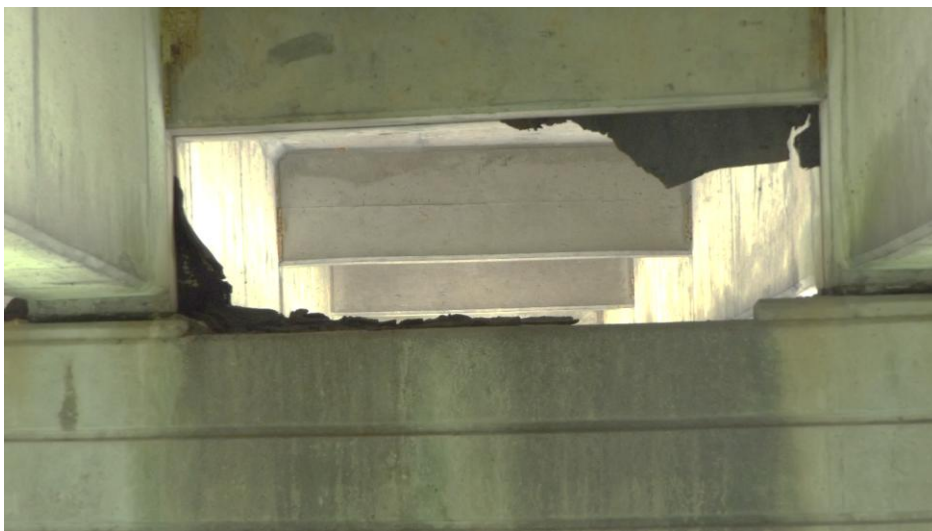
Figure 8 - Expansion Joint material falling through joint opening

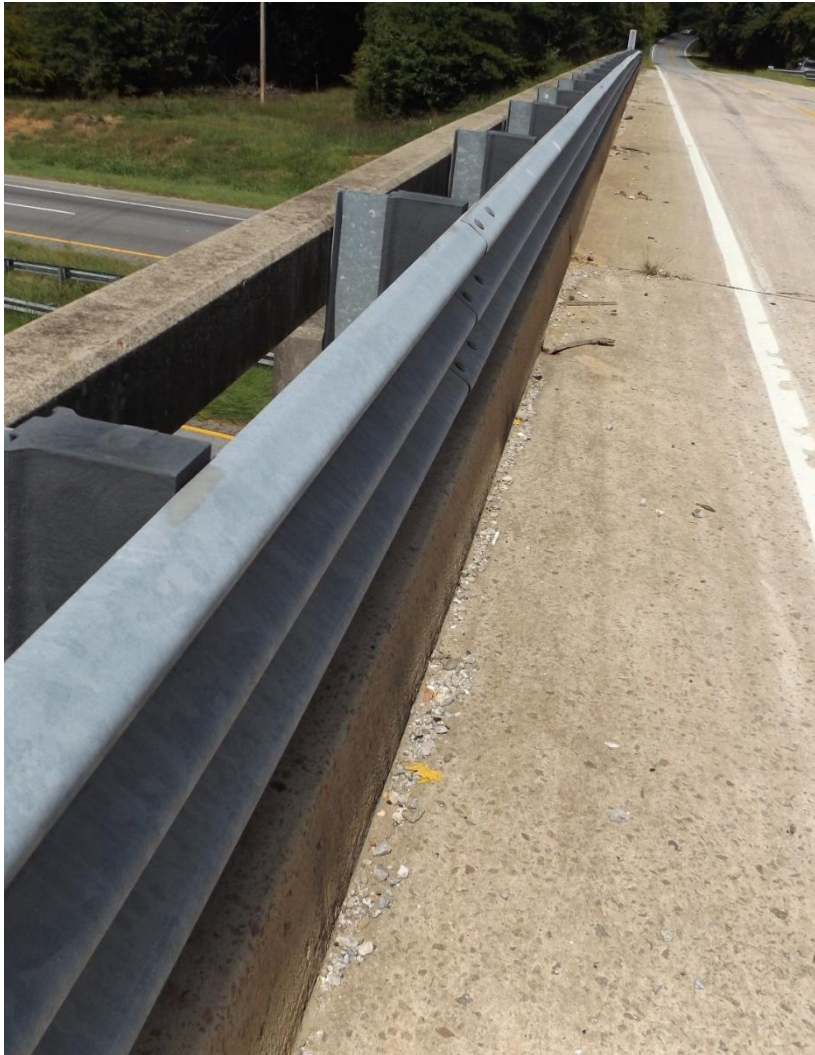
The bridge railing (Figure 9) is a concrete railing on a concrete curb with guardrail attached to it and showed minimal signs of deterioration.

Figure 9 – Bridge Railing

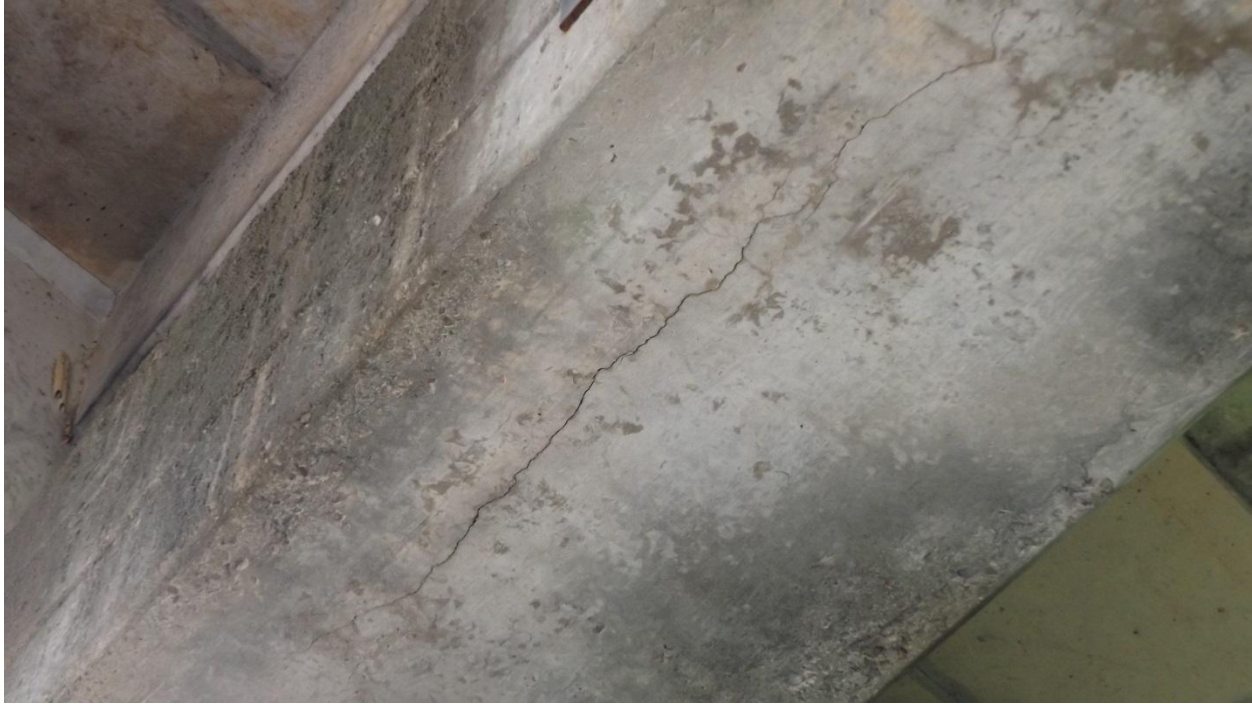
The interior bents show minimal signs of deterioration with the exception of a crack in the bottom of one of the concrete caps (see Figure 10). No delamination or spalling of the pier caps or columns was noticed. The most recent Bridge Inspection Report does document some cracking in the interior bent caps.

Figure 10 - Crack in Bottom of Pier Cap

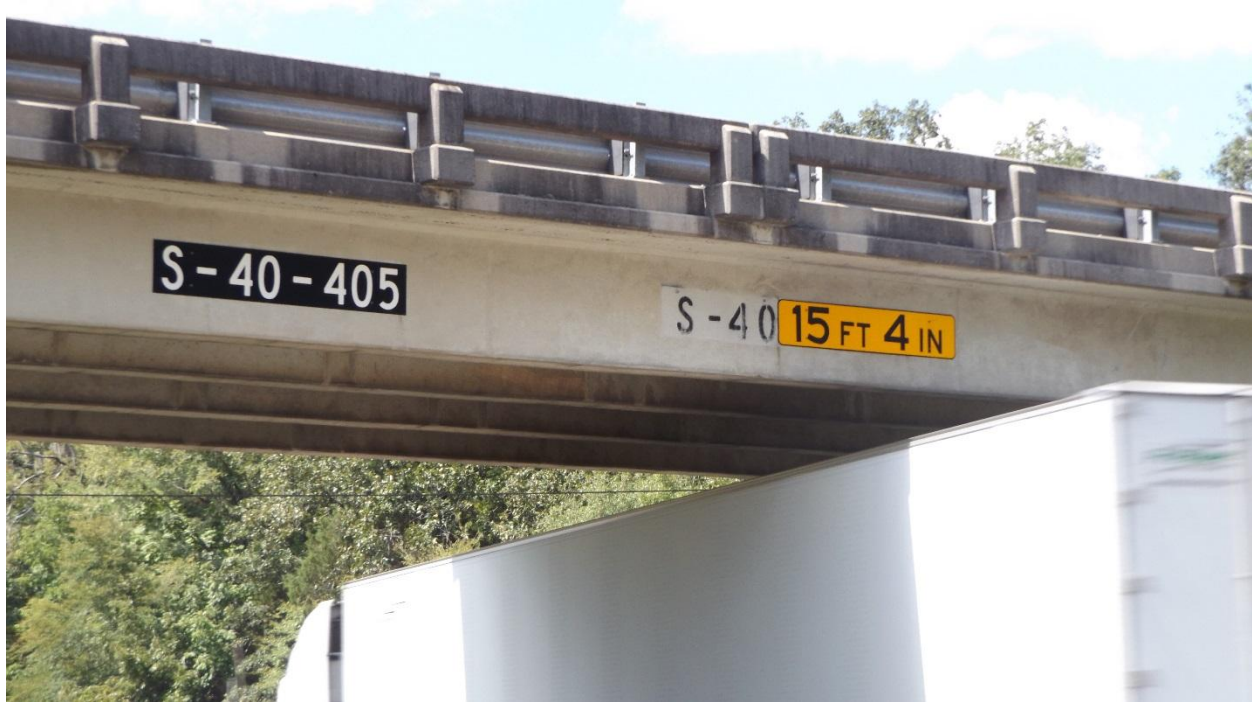
The posted minimum vertical clearance under the existing bridge is 15'-4" (I-26 WB) which does not meet the 16'-0" minimum specified for freeway under existing overpassing bridges in the SCDOT Highway Design Manual. The posted vertical clearance under the existing bridge on I-26 EB is 16'-9".

Figure 11 - Vertical Clearance
