I-26 Bridge Assessments

Bridge Assessment Report for Parr Road (S-36-167) over I-26

Prepared for:
The South Carolina Department of Transportation

November 11, 2016

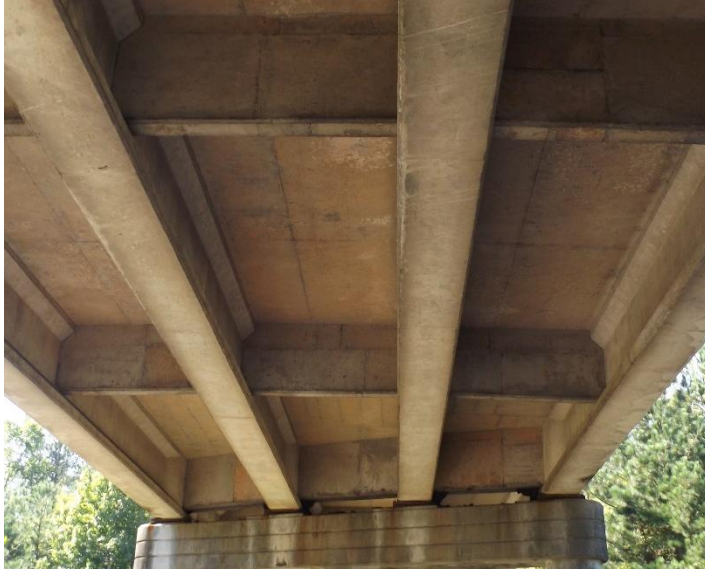
The existing prestressed concrete beams were assessed from accessible areas on the ground for deterioration and cracks. No deterioration or cracks were observed from the ground. The most recent Bridge Inspection Report does document some cracking and spalling in the beams.

Figure 4 – Superstructure (from underneath)

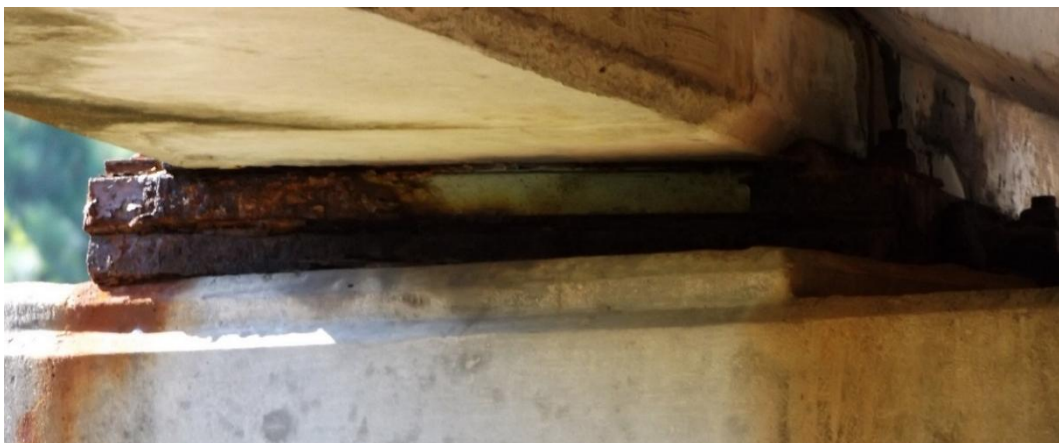
A small portion of the end bent bearings were visible due to the semi-integral end bent and very little deterioration was observed. The exterior bearings showed more deterioration than the interior bearings at the end bents. The interior bent bearings were not accessible from short distance, but were viewed from the ground and appeared to be in a medium state of deterioration with moderate to severe corrosion.

Figure 5 - Bearing Corrosion

- Raise bridge permanently or undercut both I-26 EB and WB to achieve required vertical clearance
- Bearing replacement
- Joint replacement
- Crack and spall repair at various locations throughout the bridge

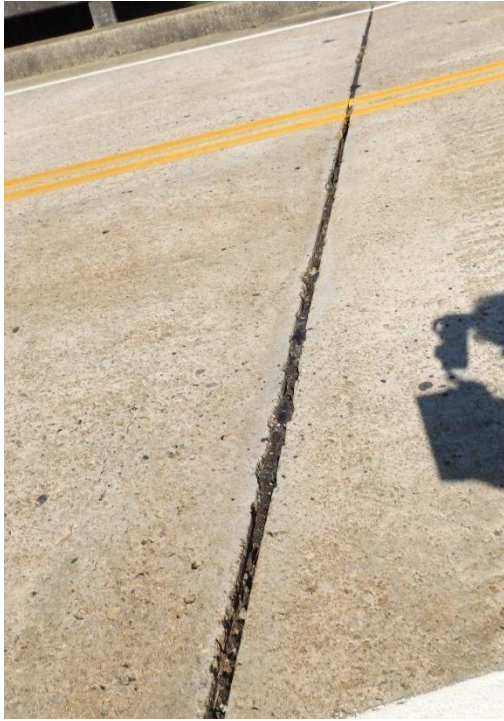
There are three deck expansion joints located within the bridge. They are located at Interior Bent 2, Interior Bent 3, and Interior Bent 4. All three expansion joints were observed from the shoulders due to the roadway not being closed. The joint filler is falling through the opening at several locations (see Figures 6 and 7). Where the joint filler hasn't fallen through, the material is in an advanced state of deterioration.

Figure 6 - Expansion Joint

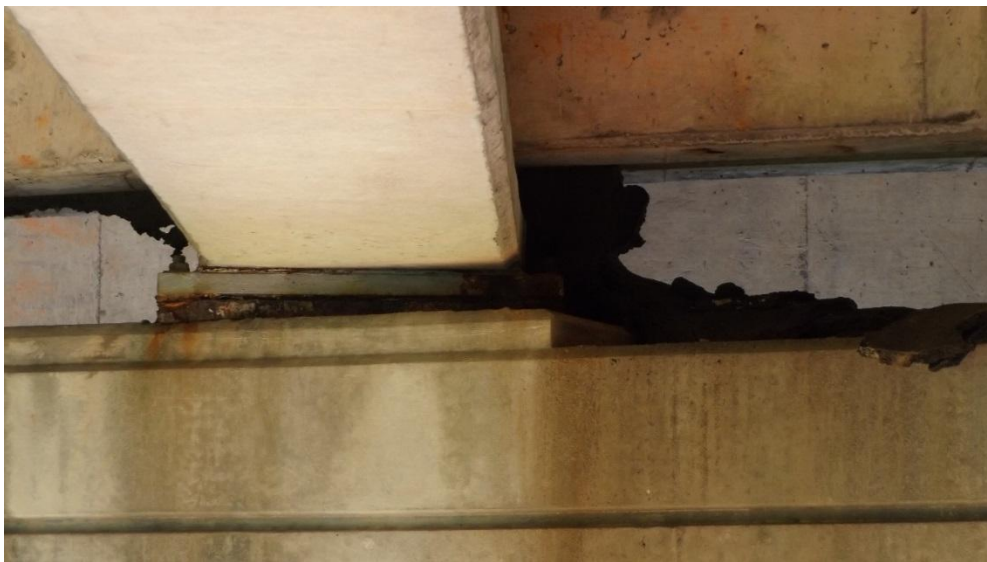
Figure 7 - Expansion Joint material falling through joint opening

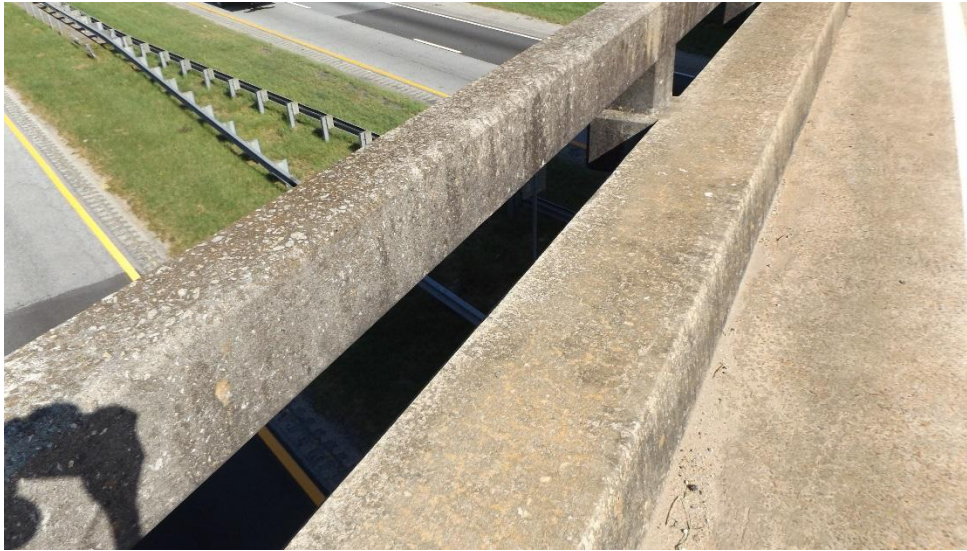
The bridge railing (Figure 8) is a concrete railing on a concrete curb and showed minimal signs of deterioration.

Figure 8 - Bridge Railing

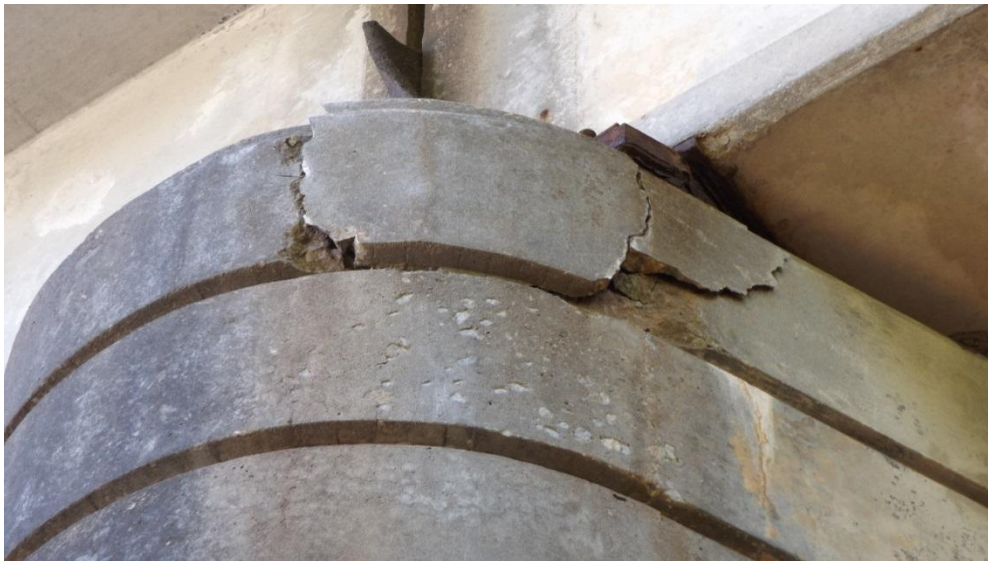
The interior bents show minimal signs of deterioration with the exception of a large spall on the top of one of the concrete caps (see Figure 9). No delamination or spalling of the columns was noticed. The most recent Bridge Inspection Report does document some spalling on the bottom of all interior bent caps.

Figure 9 - Spall on Top of Pier Cap

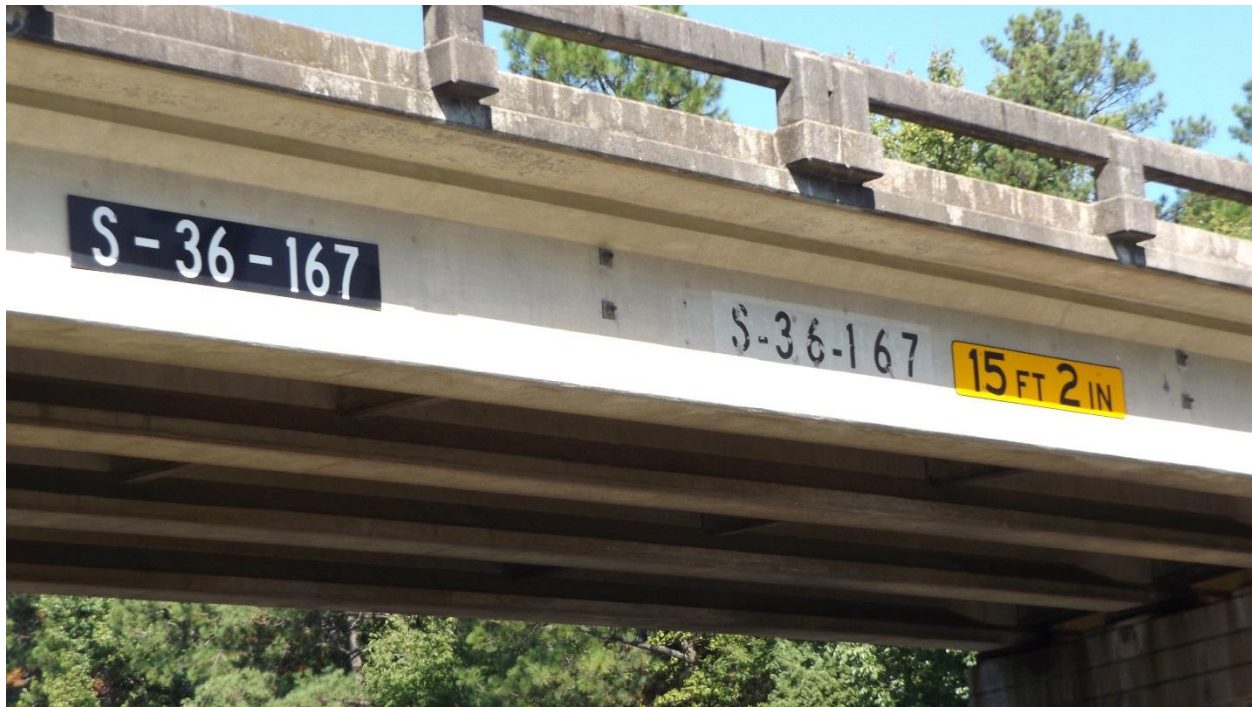
The posted vertical clearances under the existing bridge are 15'-2" (I-26 WB) and 15'-6" (I-26 EB). Neither of these meet the 16'-0" minimum specified for freeway under existing overpassing bridges in the SCDOT Highway Design Manual. The most recent Bridge Inspection Report documents collision damage to the beams that has been repaired.

Figure 10 - Vertical Clearance
