I-26 Bridge Assessments

Richland County, South Carolina

Bridge Assessment Report for Old Hilton Road (S-40-405) over I-26

November 11, 2016

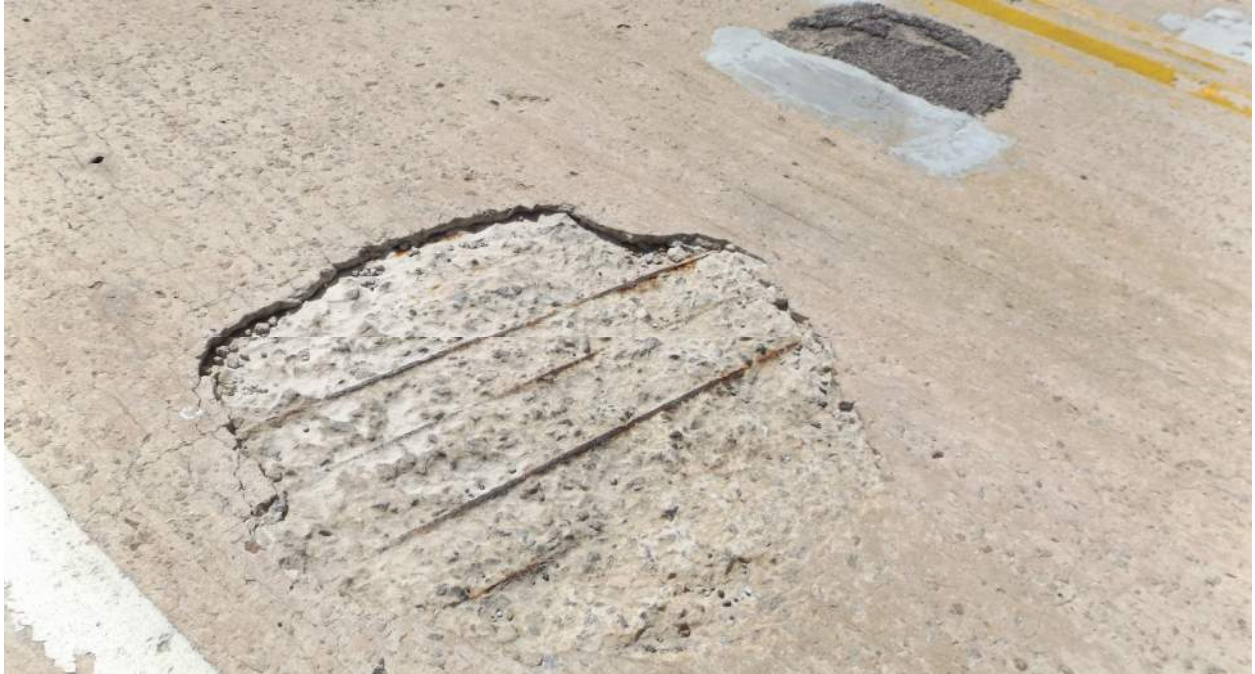
Figure 4 – Exposed Rebar in Concrete Deck

The existing reinforced concrete deck was observed from the shoulder since the roadway wasn't closed. There are several areas on the deck where concrete has spalled off and the reinforcing steel is exposed and corroded (see Figures 4 and 5). Additionally, there are several patched areas of the bridge deck that potentially conceal corroded rebar. The concrete end walls showed very little deterioration.

- Sufficiency rating of 58.2
- Bridge deemed structurally deficient in most recent SI&A Report
- Deck has severe deterioration in multiple locations with rebar exposed. Additionally, several deck locations are patched which likely conceals more compromised rebar. Deck replacement is necessary and would be costly, especially if new deck needs to meet current thickness requirements and beams and substructure would need to be analyzed to see if they can support the extra deck thickness.

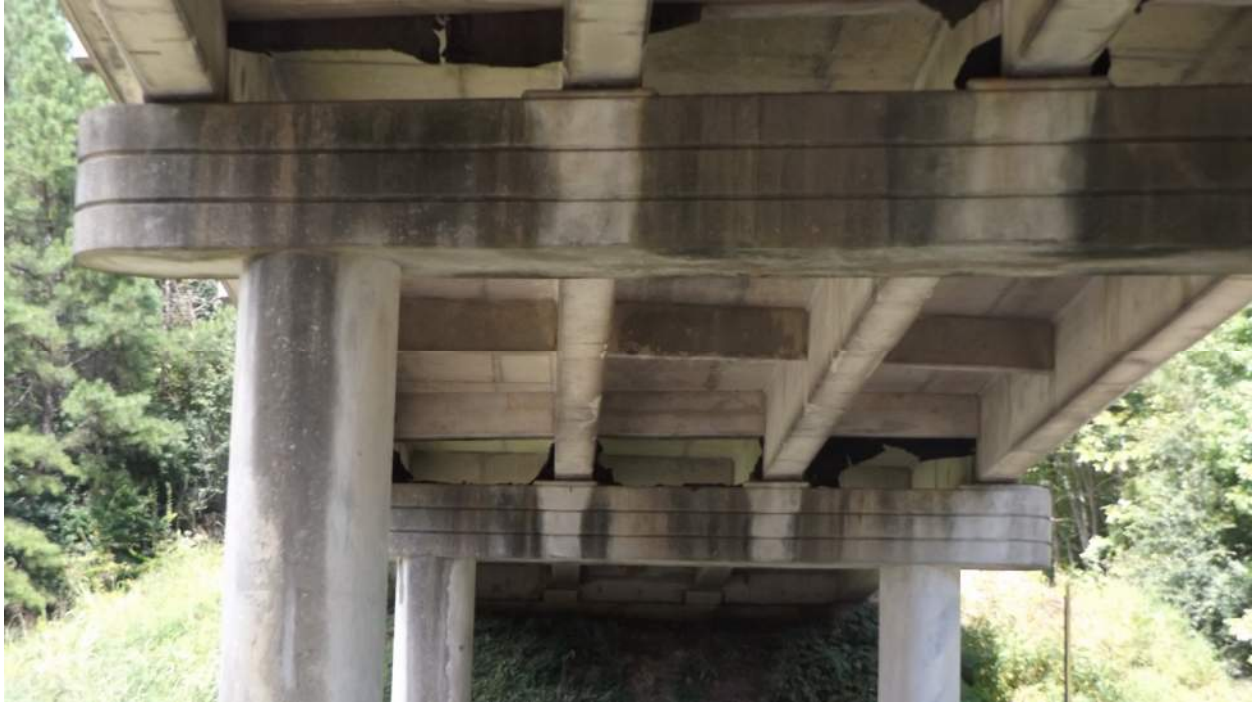
Figure 6 – Superstructure (from underneath)

The existing reinforced concrete beams were assessed from accessible areas on the ground for deterioration and cracks. No deterioration or cracks were observed from the ground. The most recent Bridge Inspection Report does document some cracking in the beams.

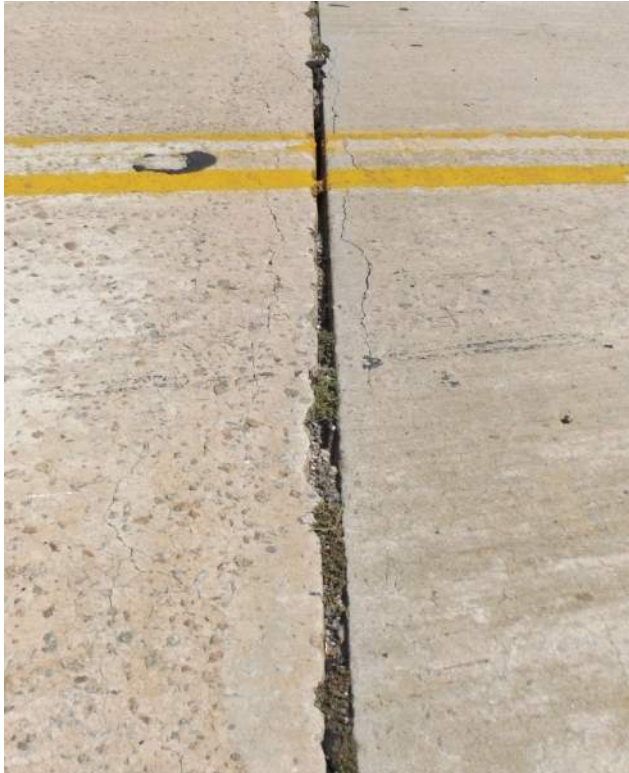
Figure 7 - Expansion Joint

There are three deck expansion joints located within the bridge. They are located at Interior Bent 2, Interior Bent 3, and Interior Bent 4. All three expansion joints were observed from the shoulders due to the roadway not being closed. The joint filler is falling through the opening at several locations (see Figures 7 and 8). Where the joint filler hasn't fallen through, the material is in an advanced state of deterioration.

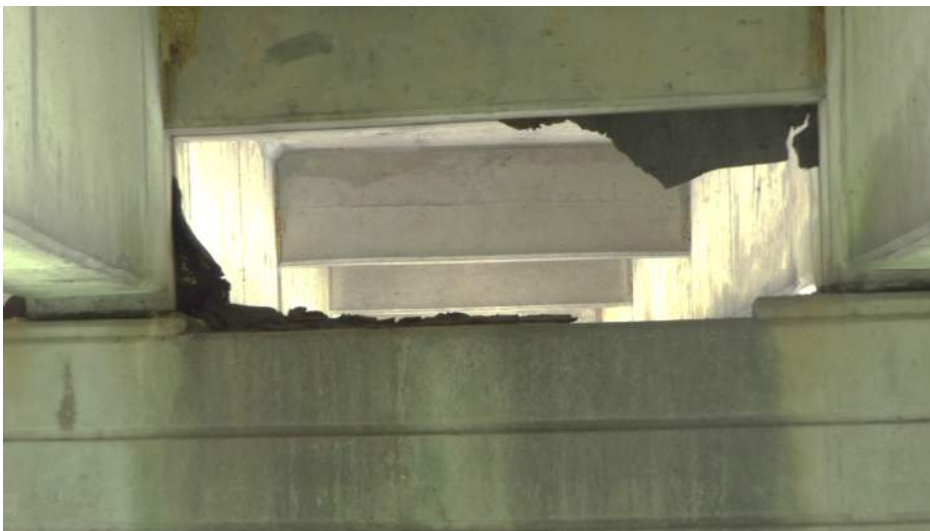
Figure 8 - Expansion Joint material falling through joint opening

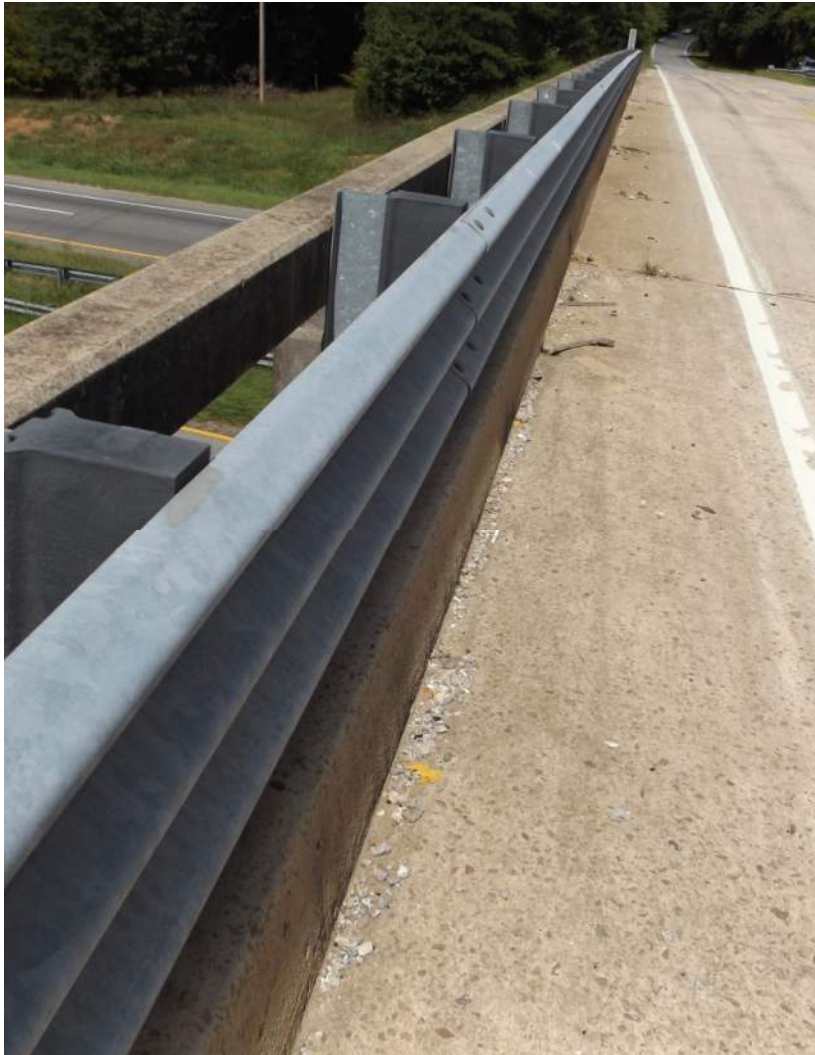
Figure 9 – Bridge Railing

The bridge railing (Figure 9) is a concrete railing on a concrete curb with guardrail attached to it and showed minimal signs of deterioration.

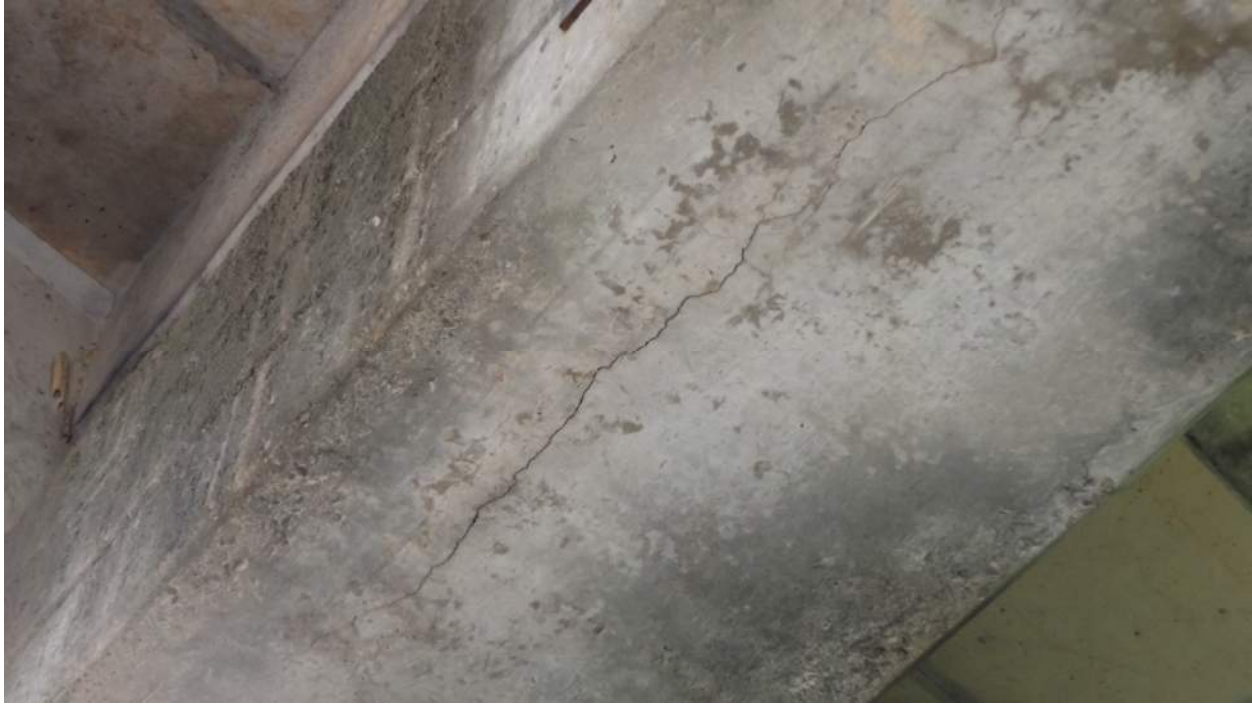
The interior bents show minimal signs of deterioration with the exception of a crack in the bottom of one of the concrete caps (see Figure 10). No delamination or spalling of the pier caps or columns was noticed. The most recent Bridge Inspection Report does document some cracking in the interior bent caps.

Figure 10 - Crack in Bottom of Pier Cap

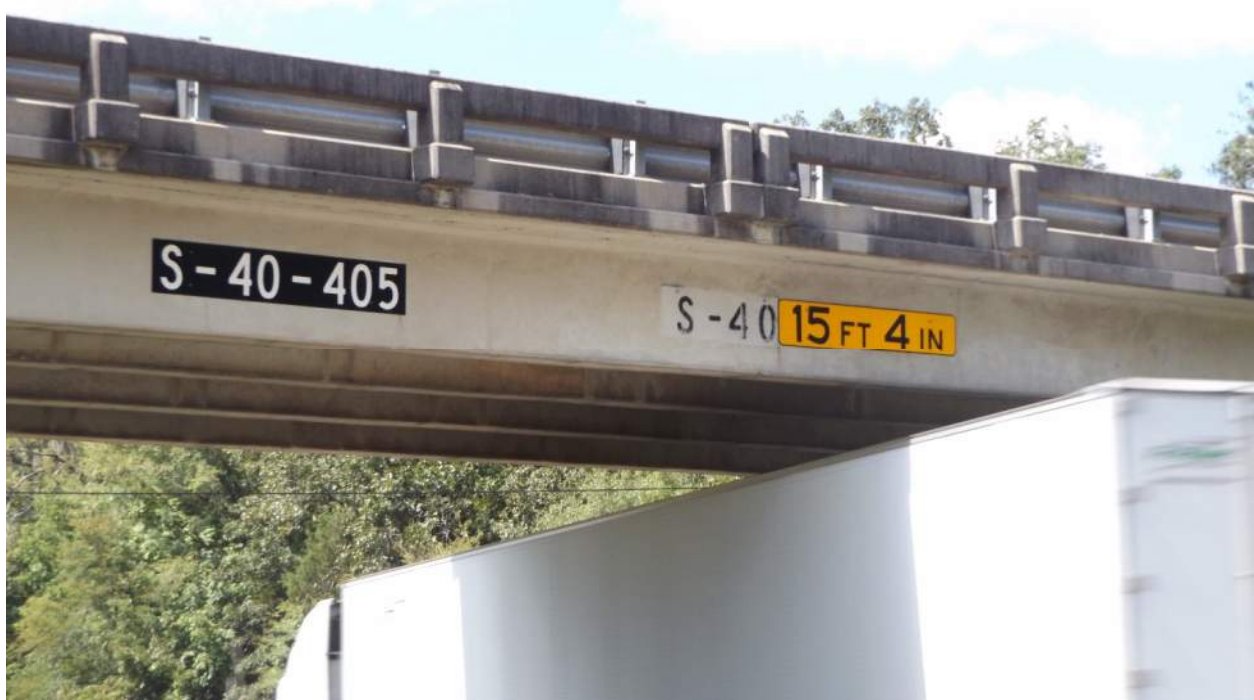
Figure 11 - Vertical Clearance

The posted minimum vertical clearance under the existing bridge is 15'-4" (I-26 WB) which does not meet the 16'-0" minimum specified for freeway under existing overpassing bridges in the SCDOT Highway Design Manual. The posted vertical clearance under the existing bridge on I-26 EB is 16'-9".
