I-26 Bridge Assessments

Bridge Assessment Report for Parr Road (S-36-167) over I-26

Prepared for:
The South Carolina Department of Transportation

November 11, 2016

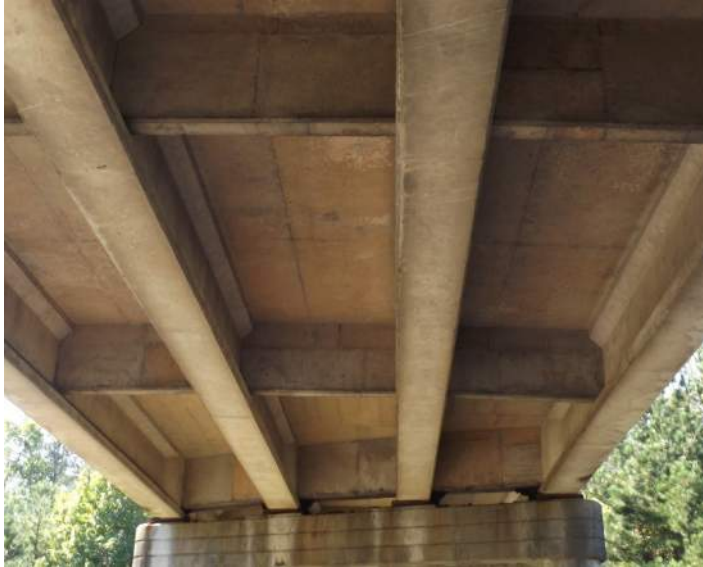
The existing prestressed concrete beams were assessed from accessible areas on the ground for deterioration and cracks. No deterioration or cracks were observed from the ground. The most recent Bridge Inspection Report does document some cracking and spalling in the beams.

Figure 4 – Superstructure (from underneath)

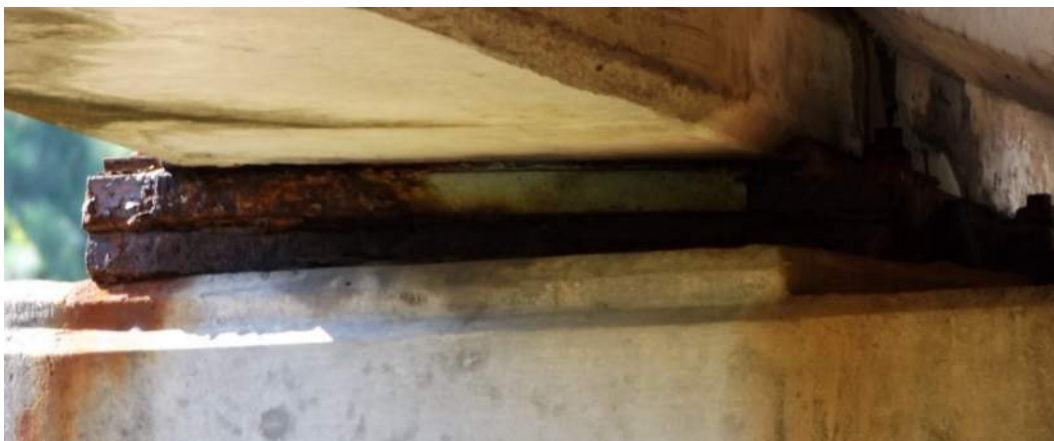
A small portion of the end bent bearings were visible due to the semi-integral end bent and very little deterioration was observed. The exterior bearings showed more deterioration than the interior bearings at the end bents. The interior bent bearings were not accessible from short distance, but were viewed from the ground and appeared to be in a medium state of deterioration with moderate to severe corrosion.

Figure 5 - Bearing Corrosion

- Raise bridge permanently or undercut both I-26 EB and WB to achieve required vertical clearance
- Bearing replacement

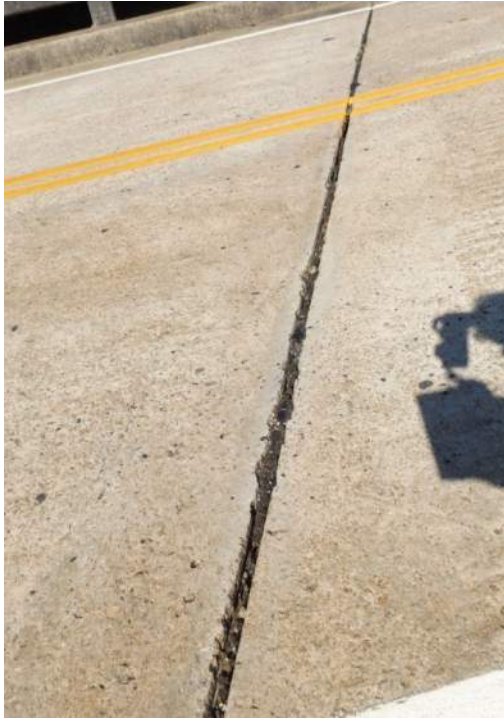
There are three deck expansion joints located within the bridge. They are located at Interior Bent 2, Interior Bent 3, and Interior Bent 4. All three expansion joints were observed from the shoulders due to the roadway not being closed. The joint filler is falling through the opening at several locations (see Figures 6 and 7). Where the joint filler hasn't fallen through, the material is in an advanced state of deterioration.

Figure 6 - Expansion Joint

- Joint replacement
- Crack and spall repair at various locations throughout the bridge
- Potential addition of closed drainage system
- Potential seismic modifications

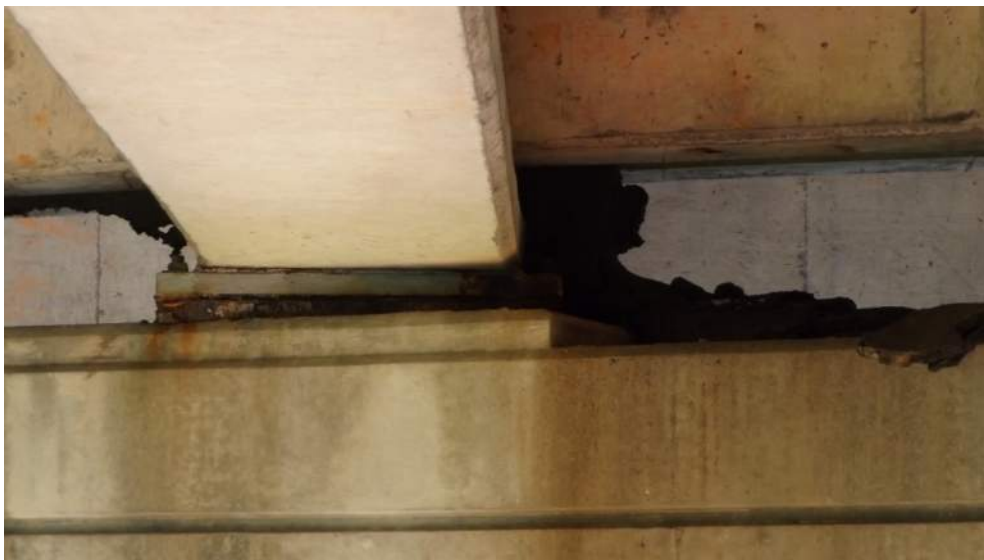
Figure 7 - Expansion Joint material falling through joint opening

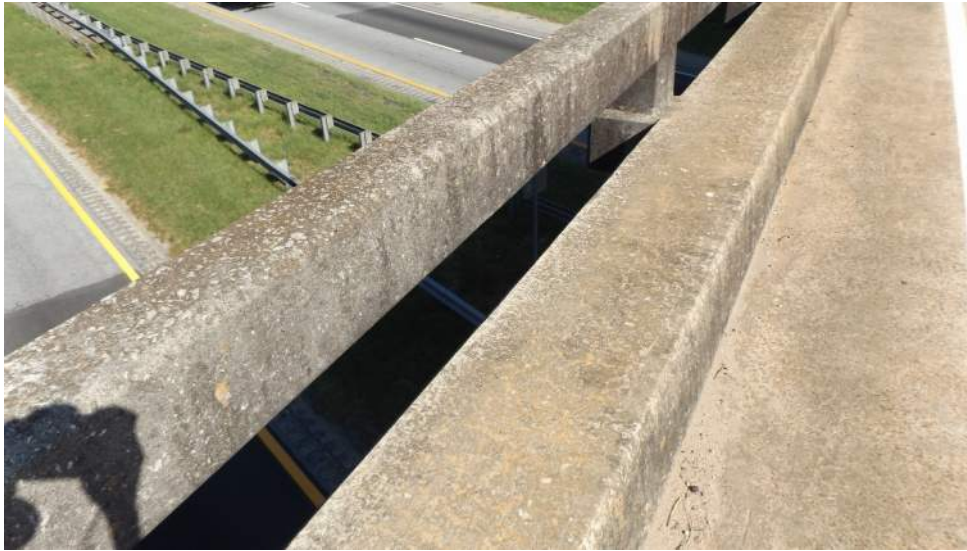
The bridge railing (Figure 8) is a concrete railing on a concrete curb and showed minimal signs of deterioration.

Figure 8 – Bridge Railing

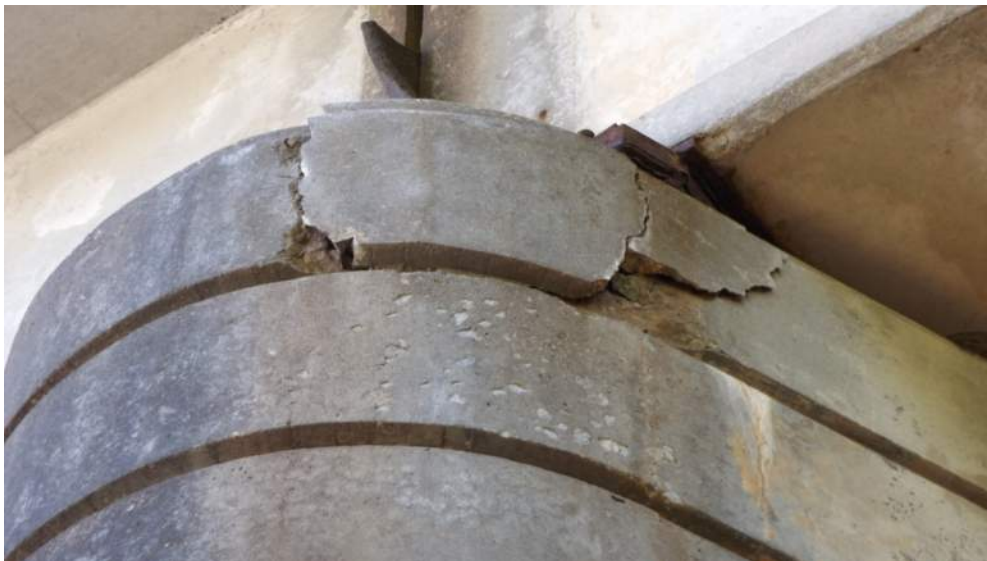
The interior bents show minimal signs of deterioration with the exception of a large spall on the top of one of the concrete caps (see Figure 9). No delamination or spalling of the columns was noticed. The most recent Bridge Inspection Report does document some spalling on the bottom of all interior bent caps.

Figure 9 - Spall on Top of Pier Cap

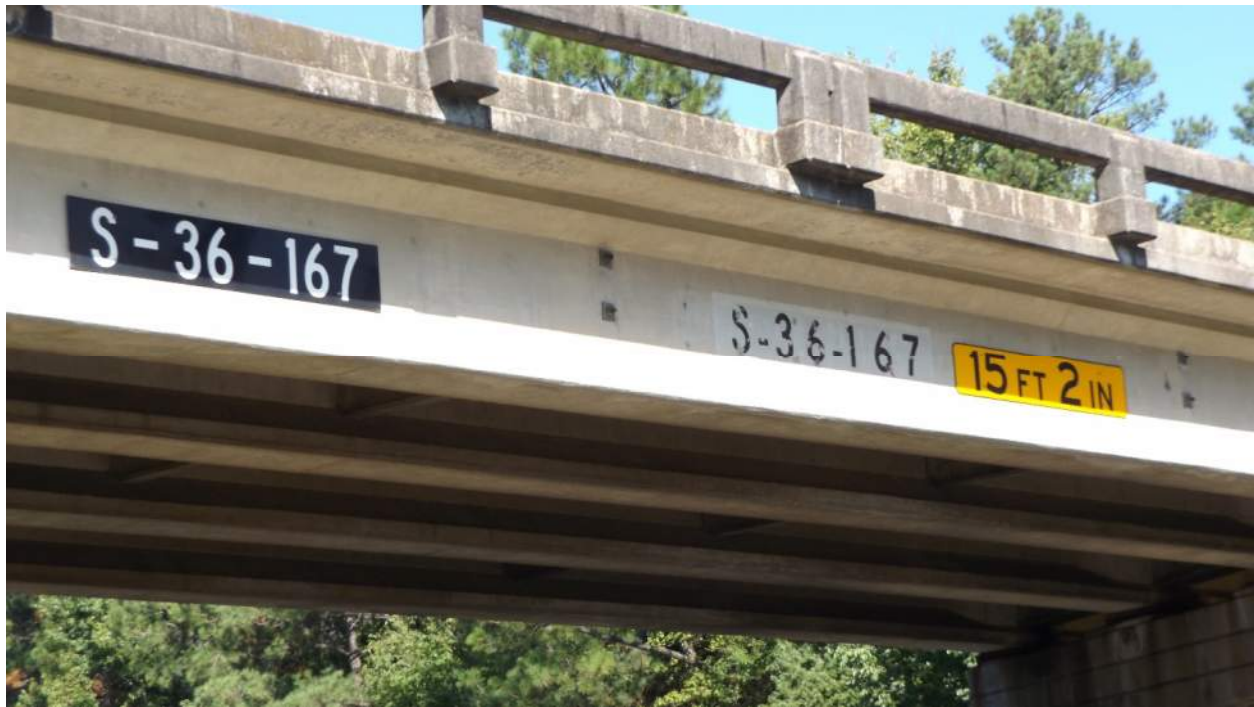
The posted vertical clearances under the existing bridge are 15'-2" (I-26 WB) and 15'-6" (I-26 EB). Neither of these meet the 16'-0" minimum specified for freeway under existing overpassing bridges in the SCDOT Highway Design Manual. The most recent Bridge Inspection Report documents collision damage to the beams that has been repaired.

Figure 10 - Vertical Clearance
