LEAD-BASED PAINT INVESTIGATION REPORT

**SC-32-48 BRIDGE OVER I-26
SCDOT #327004800100
LEXINGTON COUNTY, SOUTH CAROLINA**

Re.: Lead-Based Paint Investigation Report
S-32-48 Bridge over I-26
SCDOT #327004800100
Lexington County, South Carolina
F&ME Project No.: E5350.02

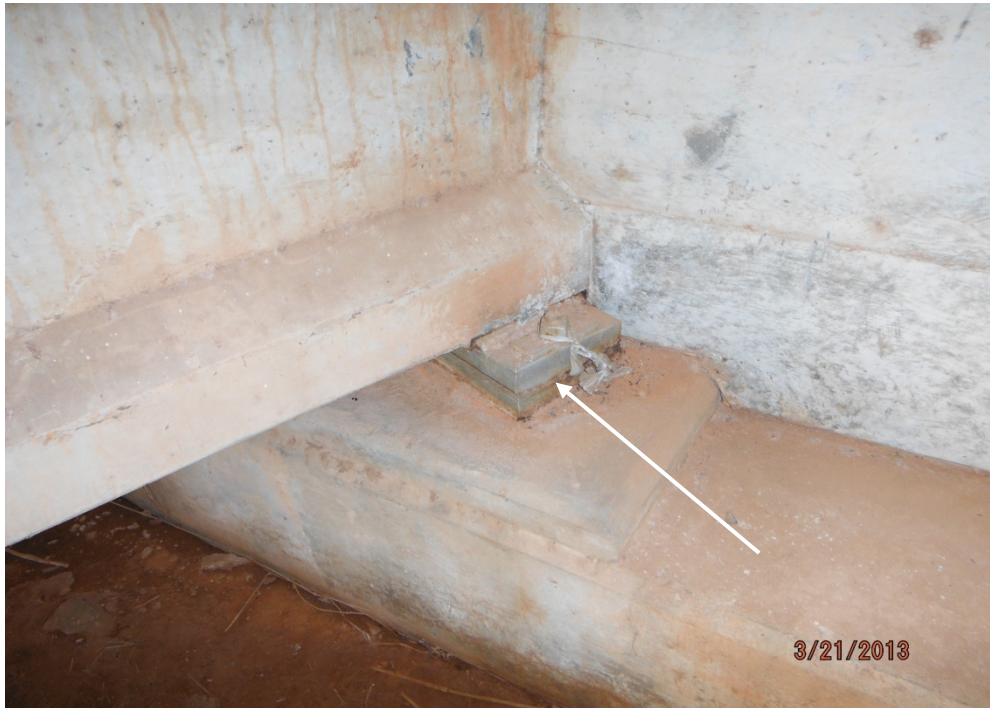
Beam Seat Plates

During the investigation, a suspect silver paint/ coating was observed on two (2) bridge components, the beam tie-rod assemblies and beam seat plates. The XRF results determined that the silver paint is positive for lead content at concentrations $\geq 0.7 \text{ mg/cm}^2$. See Appendix A for the XRF data (Table I) and photographs of the items that tested positive for lead content.

READING NO.	COMPONENT	SUBSTRATE	SIDE	CONDITION	COLOR	SITE	RESULTS	ACTION LEVEL	PbC mg/cm ²
1		Shutter Calibrate						mg/cm ²	NA
2			Calibrate				Positive	0.7	0.7
3			Calibrate				Positive	0.7	0.7
4			Calibrate				Positive	0.7	0.7
5	Tie rod assembly	Metal	B	PEELING	Silver	Bridge #327004800100	Positive	0.7	11.9
6	Tie rod assembly	Metal	B	PEELING	Silver	Bridge #327004800100	Positive	0.7	7.6
7	Tie rod assembly	Metal	B	PEELING	Silver	Bridge #327004800100	Positive	0.7	3.3
8	Tie rod assembly	Metal	B	PEELING	Silver	Bridge #327004800100	Positive	0.7	2.2
9	Tie rod assembly	Metal	B	PEELING	Silver	Bridge #327004800100	Positive	0.7	1
10	Beam seat plate	Metal	B	PEELING	Silver	Bridge #327004800100	Positive	0.7	5
11	Beam seat plate	Metal	Center	PEELING	Silver	Bridge #327004800100	Positive	0.7	10.1
12	Beam seat plate	Metal	D	PEELING	Silver	Bridge #327004800100	Positive	0.7	7.7
13		Shutter Calibrate							NA
14			Calibrate				Positive	0.7	0.7

All lead-based paint covered bridge components that will be affected by the planned demolition/ renovation activities must be carefully removed and properly disposed of by certified personnel experienced in handling and removing lead-based painted materials. All lead waste must be deposited in a SCDHEC-approved landfill. Removal, handling, transportation, storage and disposal shall be in accordance with 40 CFR 260 through 40 CFR 265, and shall also comply with land disposal restriction notification requirements as required by 40 CFR 268. Metal components painted with lead based paint may be recycled if they are taken to a recycling facility that accepts lead-based painted materials.

During demolition activities where lead-based paint may be affected by cutting, grinding or torching, it will be necessary to implement controls to ensure airborne emissions are maintained below OSHA's Action Level of $30\mu\text{g/m}^3$ according to restrictions in 29 CFR 1926.62.
