LEAD-BASED PAINT INVESTIGATION REPORT

**US-176 BRIDGE OVER I-26
SCDOT #402017600300
RICHLAND COUNTY, SOUTH CAROLINA**

March 21, 2013

Re.: Lead-Based Paint Investigation Report
US-176 Bridge over I-26
SCDOT #402017600300
Richland County, South Carolina
F&ME Project No.: E5350.02

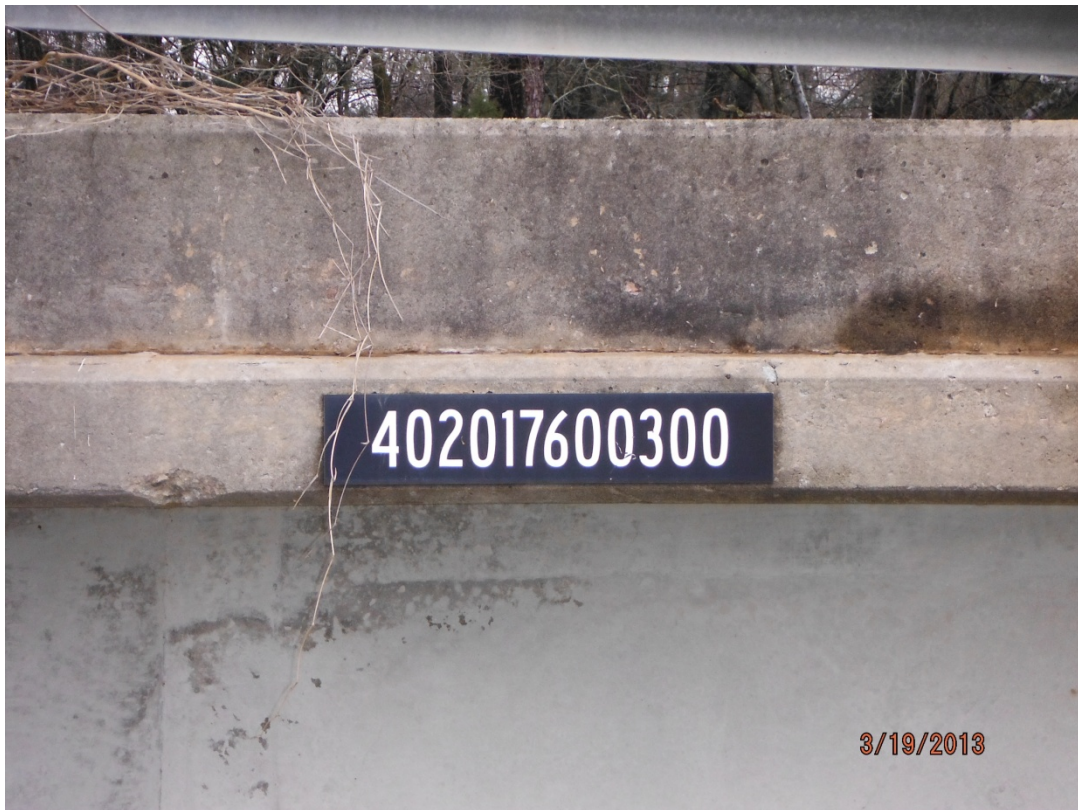
Bridge Identification Number

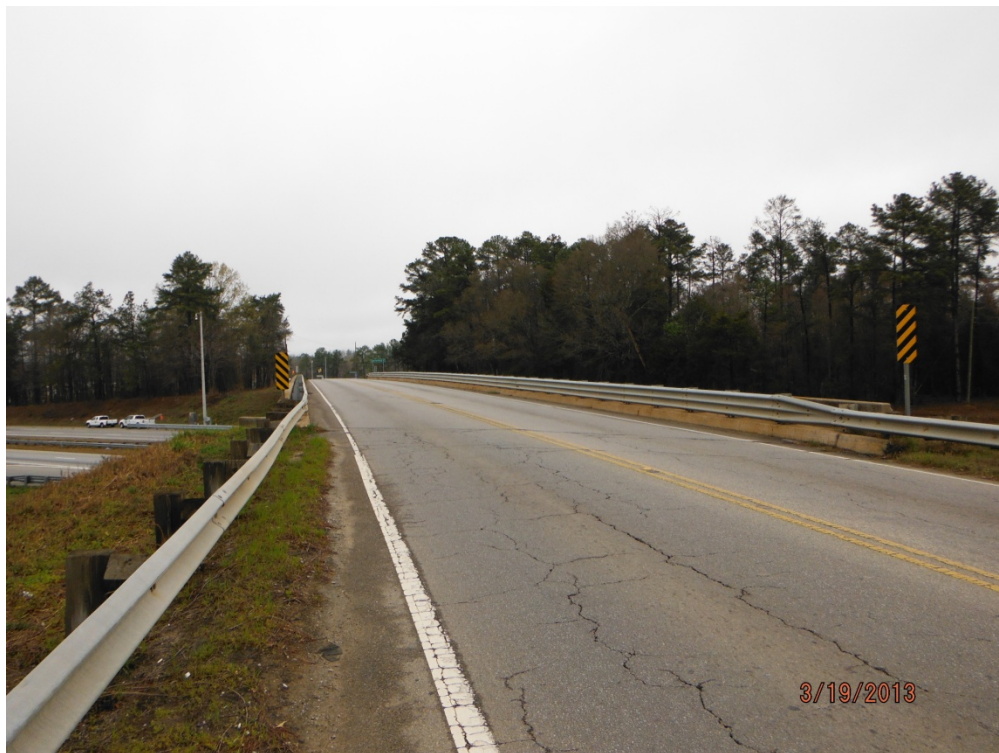
Top of Bridge

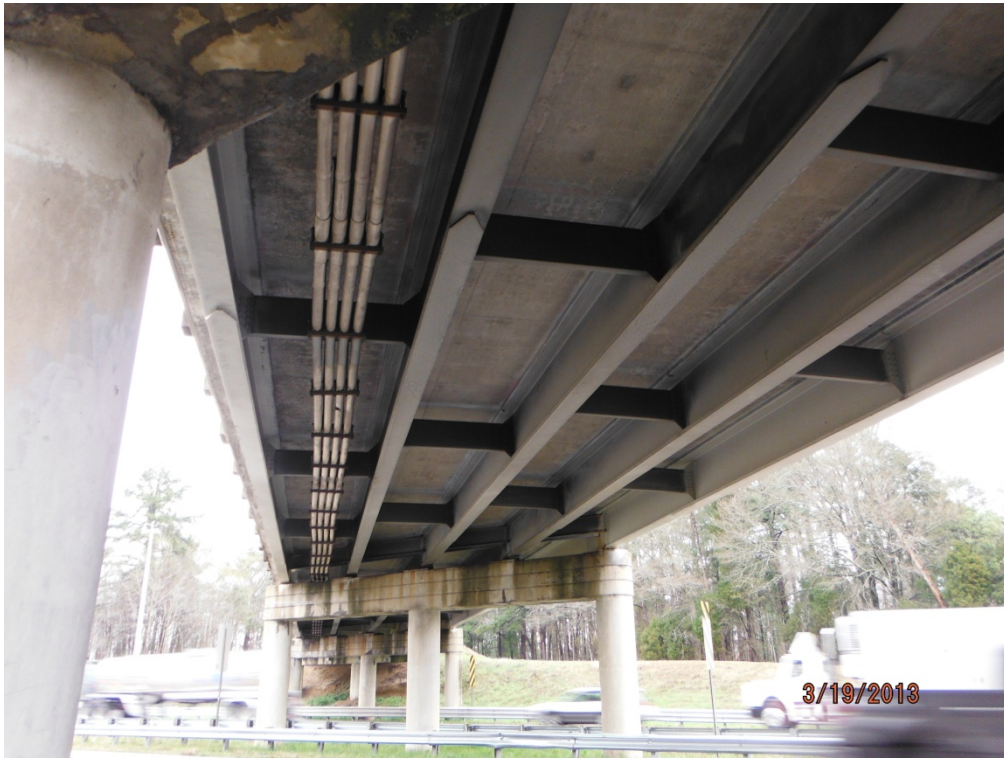
Underside of bridge span with steel beams and diaphragms

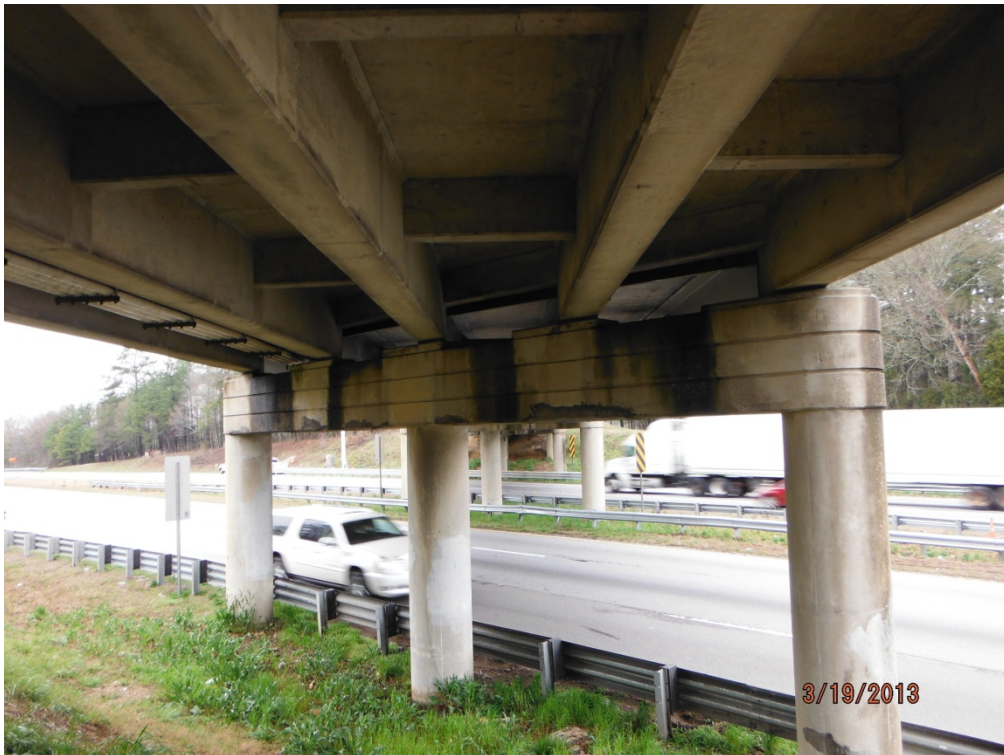
Underside of bridge with concrete beams and diaphragms

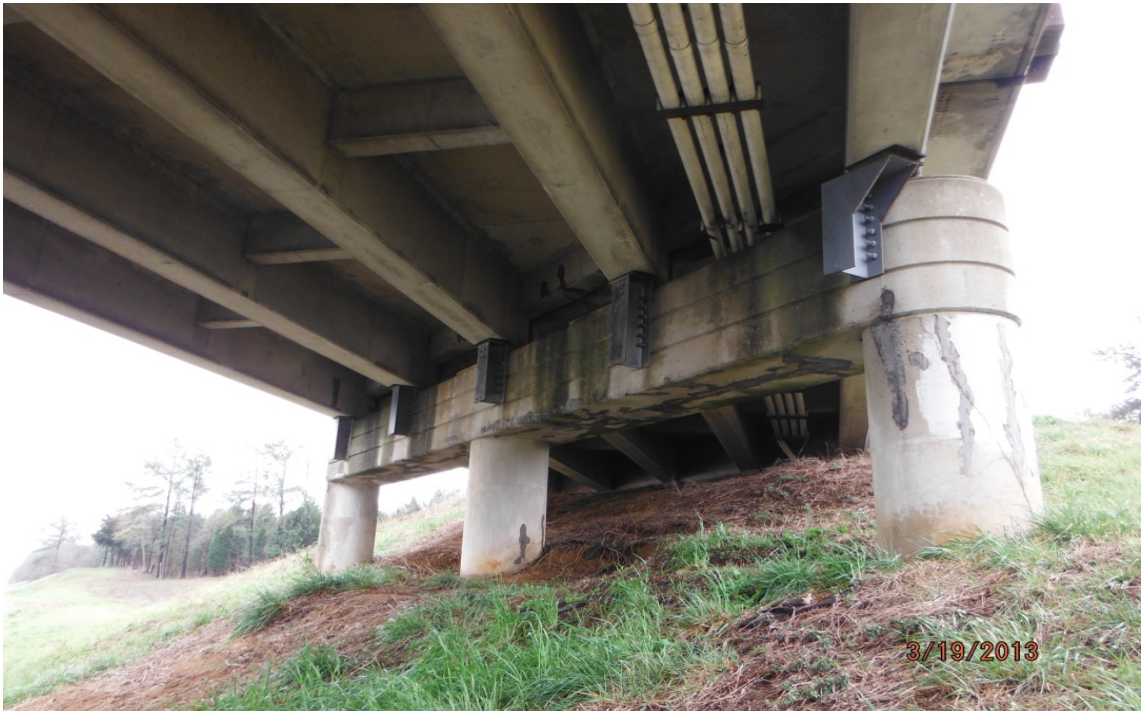
Interior bent cap with silver-painted I-beam sections

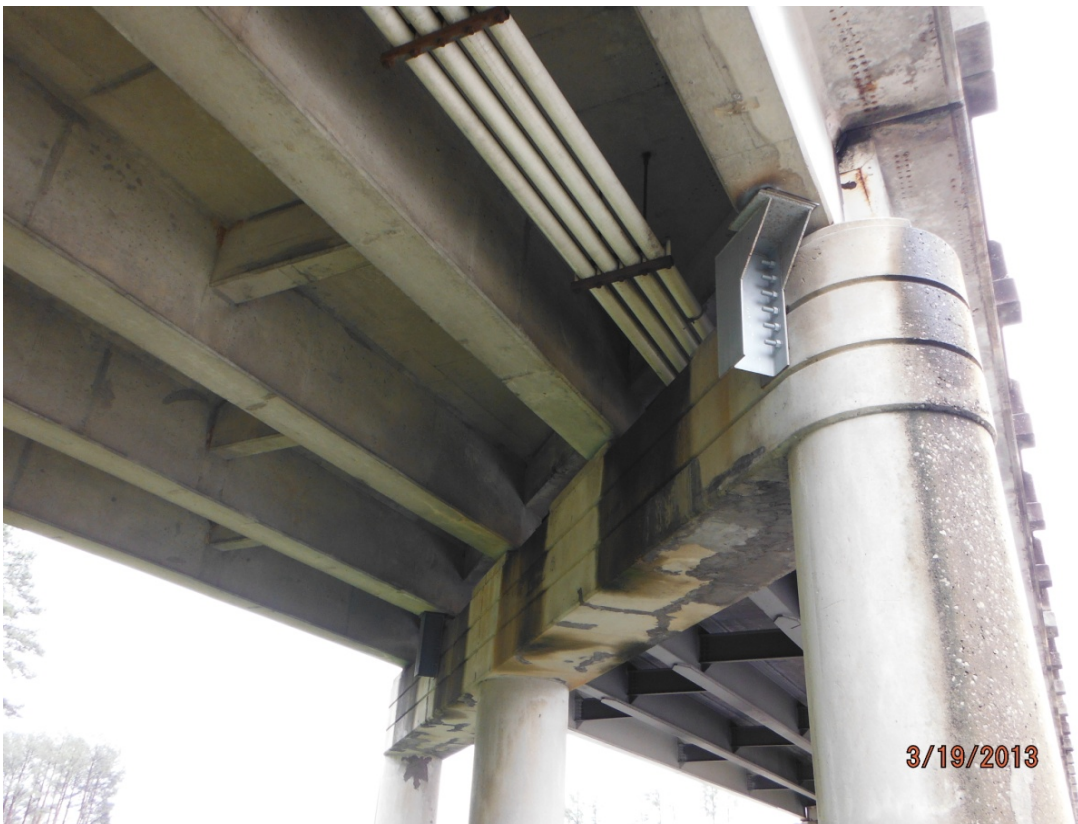
Interior bent cap with gray-painted I-beam sections
