**ASBESTOS & LEAD-BASED PAINT  
ASSESSMENT REPORT  
I-77 BRIDGES OVER I-20 & I-20 RAMP  
STRUCTURE NOS. 4010007731400 AND 4010007711400  
COLUMBIA, RICHLAND COUNTY, SOUTH CAROLINA  
S&ME Project No. 1461-14-046**

December 2, 2014

**Reference: Asbestos and Lead-Based Paint Assessment Report**  
I-77 Bridges Over I-20 & I-20 Ramp  
Structure Nos. 4010007731400 and 4010007711400  
Columbia, Richland County, South Carolina  
S&ME Project No. 1461-14-046

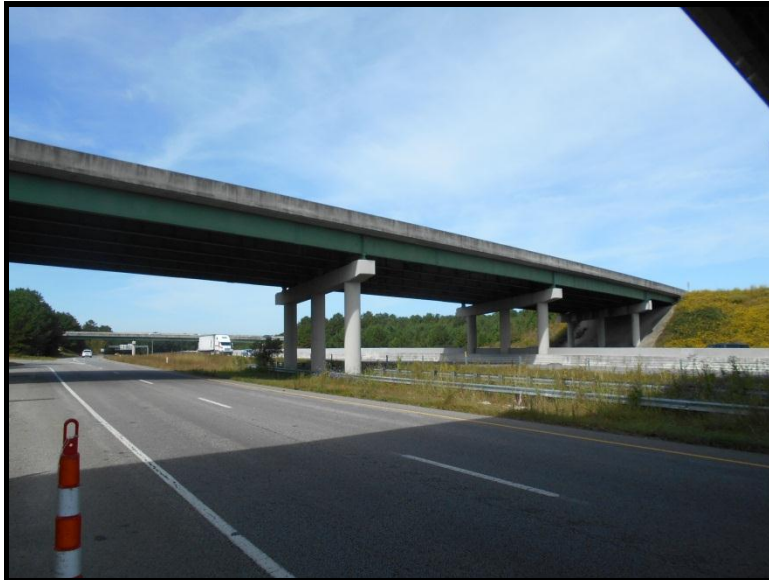
1 View of the southbound I-77 bridge over I-20 and I-20 Ramp.

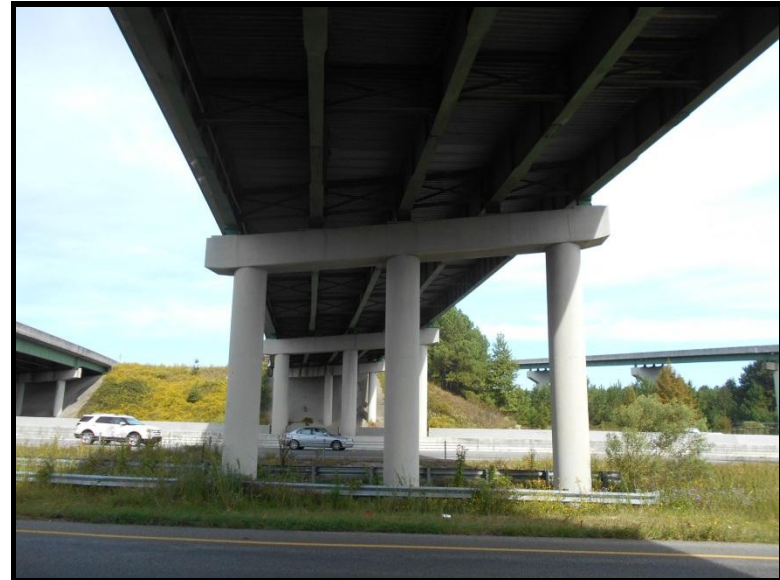
2 View of the northbound I-77 bridge over I-20 and I-20 Ramp.

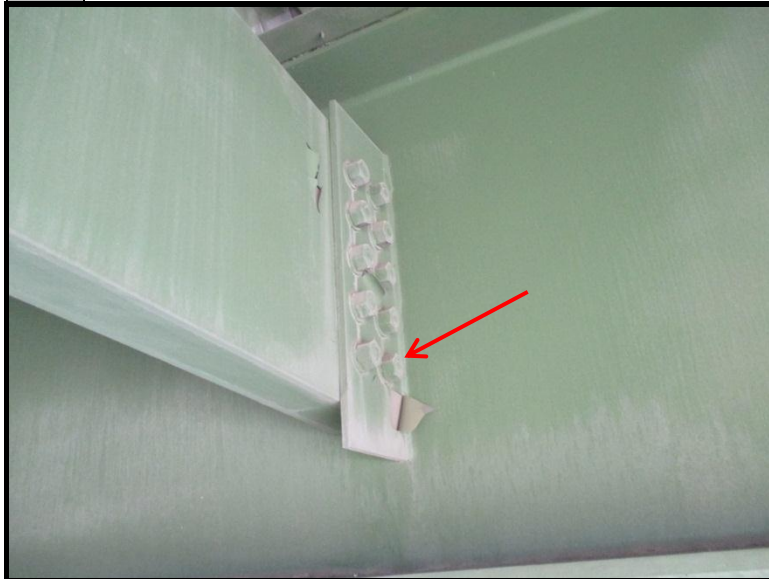
The **green painted bolt plates and I-beam braces** were identified as containing lead levels exceeding the SCDHEC disposal limit of  $0.7 \text{ mg/cm}^2$ . It is currently presumed the traffic striping on the I-77 roadway contains lead levels exceeding the SCDHEC disposal limit of  $0.7 \text{ mg/cm}^2$ . Additionally, painted components coated with lead containing paint applicable to OSHA regulation 29 CFR 1926.62 (Lead in Construction) was also detected. Destructive actions (sanding, burning, demolition, component removal, paint preparation) to the lead-containing paint surfaces will require the contractor to comply with the standards of SCDHEC and OSHA, including but not limited to proper disposal, initial exposure monitoring, the use of personal protective equipment, and medical surveillance. If additional painted components are discovered during renovation activities, the paint should be tested prior to any destructive actions (sanding, burning, demolition, component removal, paint preparation) or disposal.

3 The green paint on the I-beam brace tested positive for lead-based paint (0.7-0.8 mg/cm<sup>2</sup>).

SCDHEC Regulation 61-107.19 permits demolition materials painted with lead-based paint ( $\geq 0.7 \text{ mg/cm}^2$ ) to be disposed in a permitted Class Two (C&D) or Class Three Subtitle D, Municipal Solid Waste (MSW) landfill. However, accumulations of paint waste (chips, dust, or flakes) from the identified areas of lead-based paint may be classified as hazardous waste, which requires disposal in a Subtitle C (hazardous waste) landfill. The hazardous waste regulations include Title 40 Code of Federal Regulations parts 260 through 272. A sample of accumulated paint waste should be collected for analysis via Toxicity Characteristic Leaching Procedure (TCLP) to determine the waste's lead content and hazardous waste characteristics.

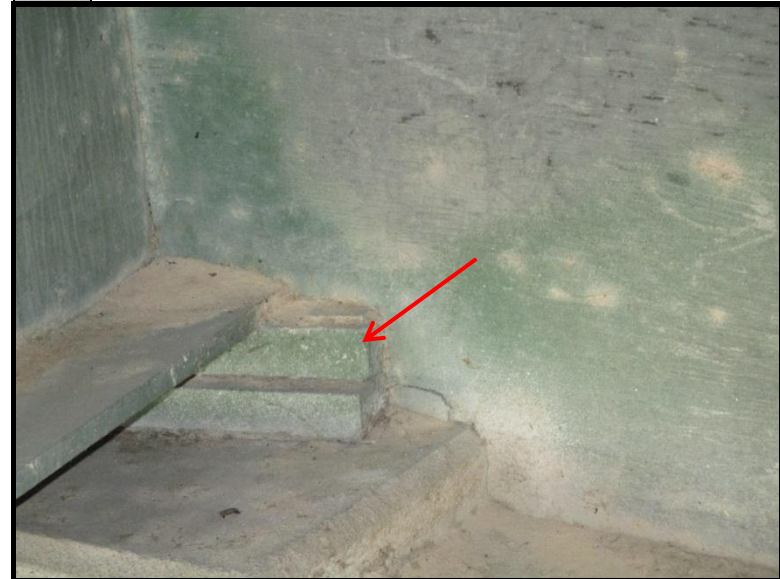
4 The green paint on the bolt plate tested positive for lead-based paint (1.4-2.6 mg/cm<sup>2</sup>).
