**ASBESTOS & LEAD-BASED PAINT  
ASSESSMENT REPORT  
I-77 BRIDGEs OVER EDGEWATER DRIVE  
STRUCTURE NOS. 4010007731800 AND 4010007711800  
COLUMBIA, RICHLAND COUNTY, SOUTH CAROLINA  
S&ME Project No. 1461-14-046**

**Reference: Asbestos and Lead-Based Paint Assessment Report**  
I-77 Bridges Over Edgewater Drive  
Structure Nos. 4010007731800 and 4010007711800  
Columbia, Richland County, South Carolina  
S&ME Project No. 1461-14-046

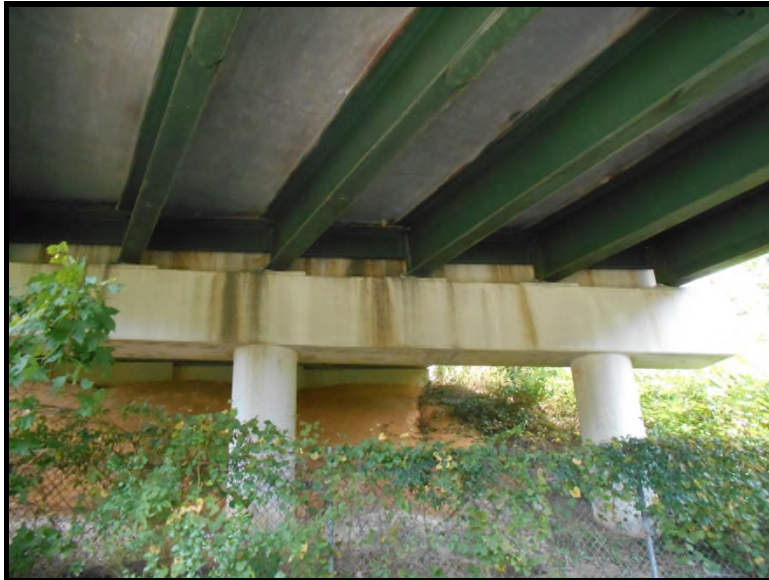
**1** View of the north side of the north bound I-77 bridge over Edgewater Drive.

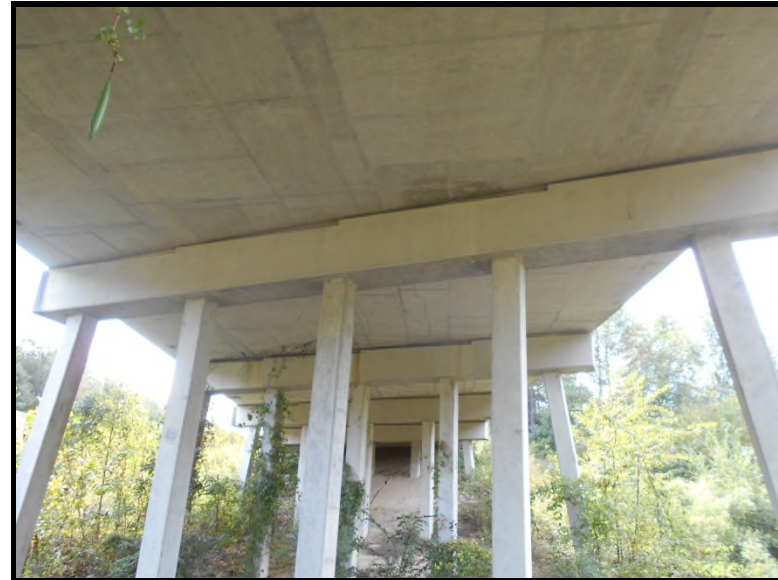
**2** View of the center portion of the I-77 bridge over Edgewater Drive.

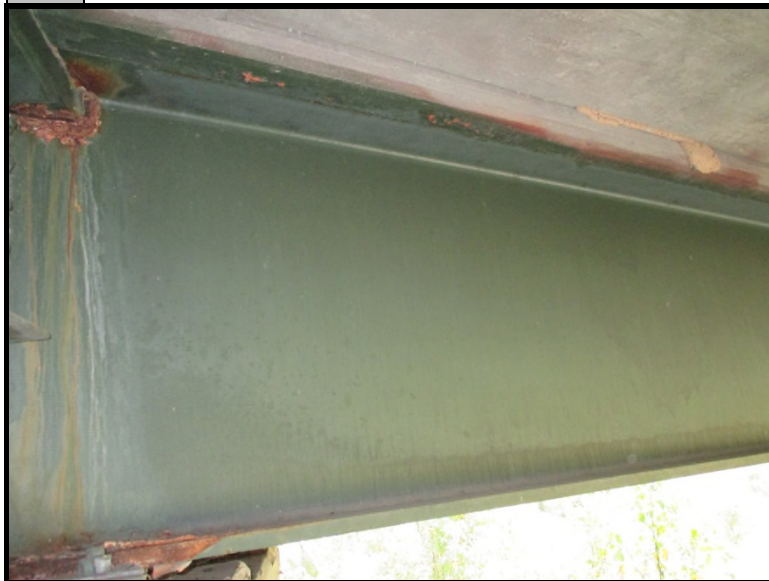
For the purpose of this assessment, painted surfaces exceeding the SCDHEC disposal limit of  $0.7 \text{ mg/cm}^2$  are considered lead-based paint and are applicable to OSHA regulation. Lead in concentrations applicable to SCDHEC disposal regulations was identified in the **green painted bolt plates, I-Beams and braces**. We were unable to test the white and yellow lane striping on the I-77 roadway for traffic safety reasons. Consequently, the traffic striping on the south bound and north bound bridges are presumed to contain lead until such time they can be safely tested. Disturbance of these materials is regulated by the OSHA regulation 29 CFR 1926.62 (Lead in Construction). XRF testing data is included in Appendix D.

The **green painted bolt plates, I-beams and braces** were identified as containing lead levels exceeding the SCDHEC disposal limit of  $0.7 \text{ mg/cm}^2$ . It is currently presumed the traffic striping on the I-77 roadway contains lead levels exceeding the SCDHEC disposal limit of  $0.7 \text{ mg/cm}^2$ . Additionally, painted components coated with lead containing paint applicable to OSHA regulation 29 CFR 1926.62 (Lead in Construction) was also detected. Destructive actions (sanding, burning, demolition, component removal, paint preparation) to the lead-containing paint surfaces will require the contractor to comply with the standards of SCDHEC and OSHA, including but not limited to proper disposal, initial exposure monitoring, the use of personal protective equipment, and medical surveillance. If additional painted components are discovered during renovation activities, the paint should be tested prior to any destructive actions (sanding, burning, demolition, component removal, paint preparation) or disposal.

**3** The green painted I-beams, bolt plates and braces tested positive for lead-based paint.

SCDHEC Regulation 61-107.19 permits demolition materials painted with lead-based paint ( $\geq 0.7 \text{ mg/cm}^2$ ) to be disposed in a permitted Class Two (C&D) or Class Three Subtitle D, Municipal Solid Waste (MSW) landfill. However, accumulations of paint waste (chips, dust, or flakes) from the identified areas of lead-based paint may be classified as hazardous waste, which requires disposal in a Subtitle C (hazardous waste) landfill. The hazardous waste regulations include Title 40 Code of Federal Regulations parts 260 through 272. A sample of accumulated paint waste should be collected for analysis via Toxicity Characteristic Leaching Procedure (TCLP) to determine the waste's lead content and hazardous waste characteristics.

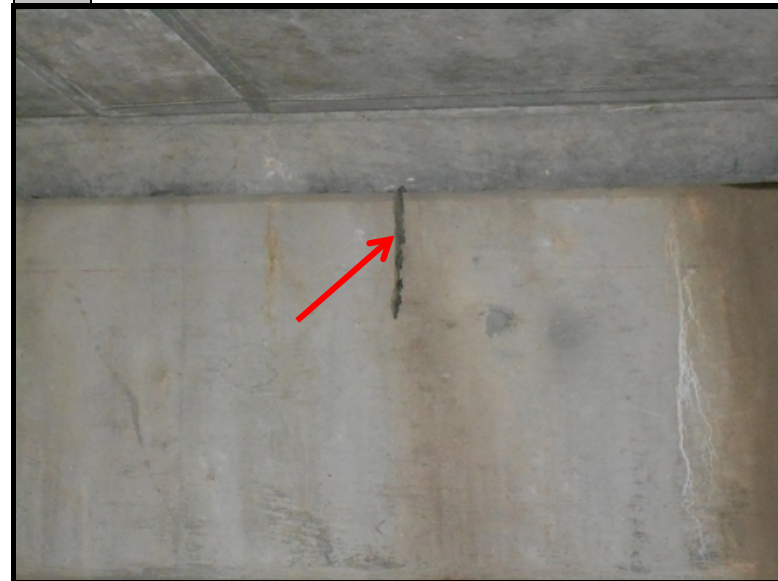
The TEM analyses reported <0.1% chrysotile is present in the tar paper.

Of the representative materials sampled and analyzed during this assessment, asbestos in concentrations >1% was **not** identified.

**4** The tar paper associated with the bridge tested negative for asbestos.

The asbestos and lead-based paint assessment conducted on the north and south bound I-77 Bridges over Edgewater in Columbia, Richland County, South Carolina, **did not** identify asbestos-containing materials. If additional suspect materials are discovered during the planned renovation activities, bulk samples must be collected and analyzed for asbestos content prior to continuation of work. A copy of this report should be provided to the contractor(s) to assist with compliance with applicable State and Federal regulations.
