**ASBESTOS & LEAD-BASED PAINT
ASSESSMENT REPORT
I-77 BRIDGES OVER WINDSOR LAKE BOULEVARD
STRUCTURE NOS. 4010007711600 AND 4010007731600
COLUMBIA RICHLAND COUNTY, SOUTH CAROLINA
S&ME Project No. 1461-14-046**

Reference: Asbestos and Lead-Based Paint Assessment Report
I-77 Bridges Over Windsor Lake Boulevard
Structure Nos. 4010007711600 and 4010007731600
Columbia Richland County, South Carolina
S&ME Project No. 1461-14-046

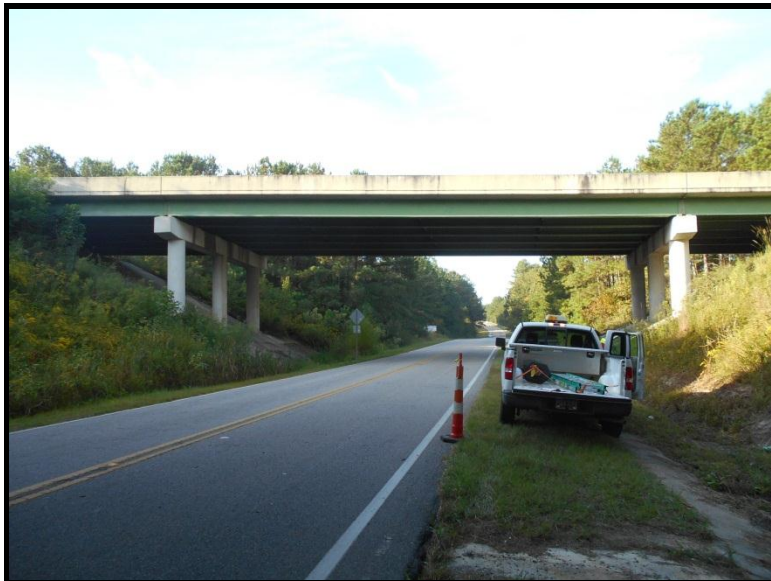
1 View of the southbound I-77 bridge over Windsor Lake Boulevard.

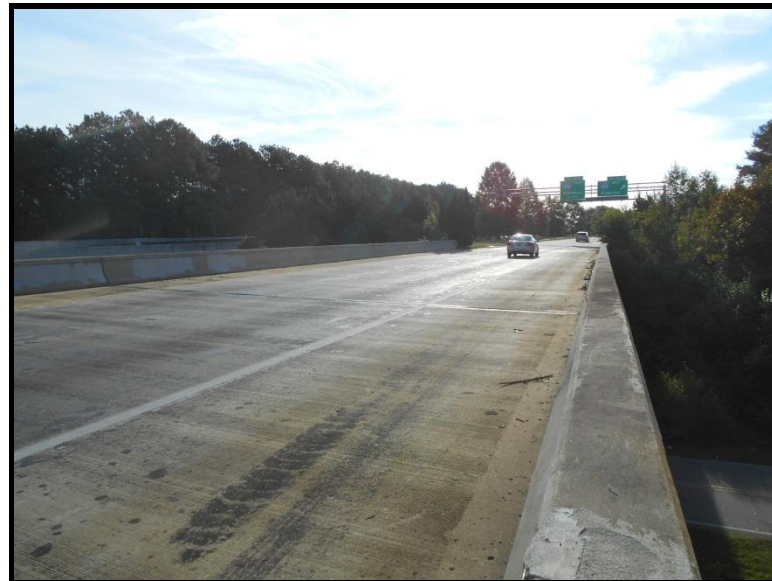
2 View of the I-77 bridge over Windsor Lake Boulevard.

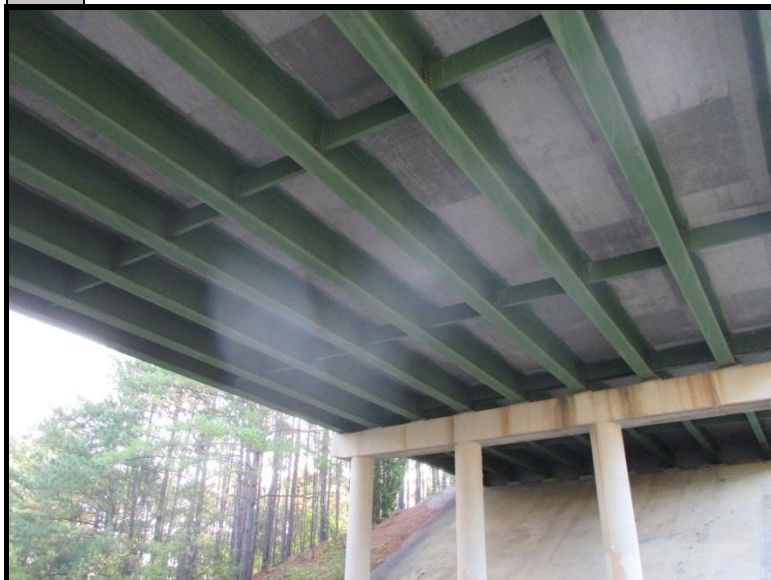
3 View of the underside of the I-77 bridge over Windsor Lake Boulevard.

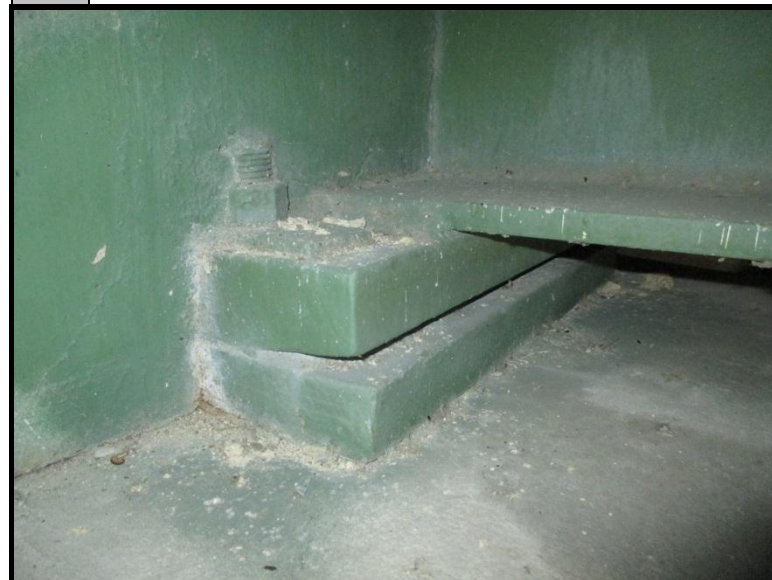
The **green painted bolt plates** were identified as containing lead levels exceeding the SCDHEC disposal limit of 0.7 mg/cm^2 . It is currently presumed the traffic striping on the I-77 roadway contains lead levels exceeding the SCDHEC disposal limit of 0.7 mg/cm^2 . Additionally, painted components coated with lead containing paint applicable to OSHA regulation 29 CFR 1926.62 (Lead in Construction) was also detected. Destructive actions (sanding, burning, demolition, component removal, paint preparation) to the lead-containing paint surfaces will require the contractor to comply with the standards of SCDHEC and OSHA, including but not limited to proper disposal, initial exposure monitoring, the use of personal protective equipment, and medical surveillance. If additional painted components are discovered during renovation activities, the paint should be tested prior to any destructive actions (sanding, burning, demolition, component removal, paint preparation) or disposal.

4 The green paint on the bolt plate tested positive for lead-based paint (0.8 – 1.2 mg/cm²).

SCDHEC Regulation 61-107.19 permits demolition materials painted with lead-based paint ($\geq 0.7 \text{ mg/cm}^2$) to be disposed in a permitted Class Two (C&D) or Class Three Subtitle D, Municipal Solid Waste (MSW) landfill. However, accumulations of paint waste (chips, dust, or flakes) from the identified areas of lead-based paint may be classified as hazardous waste, which requires disposal in a Subtitle C (hazardous waste) landfill. The hazardous waste regulations include Title 40 Code of Federal Regulations parts 260 through 272. A sample of accumulated paint waste should be collected for analysis via Toxicity Characteristic Leaching Procedure (TCLP) to determine the waste's lead content and hazardous waste characteristics.
