Appendix V – Mitigation Credit Sheets/Stream Assessment Forms

SAC 2019-00924

S&ME Project 4261-19-077

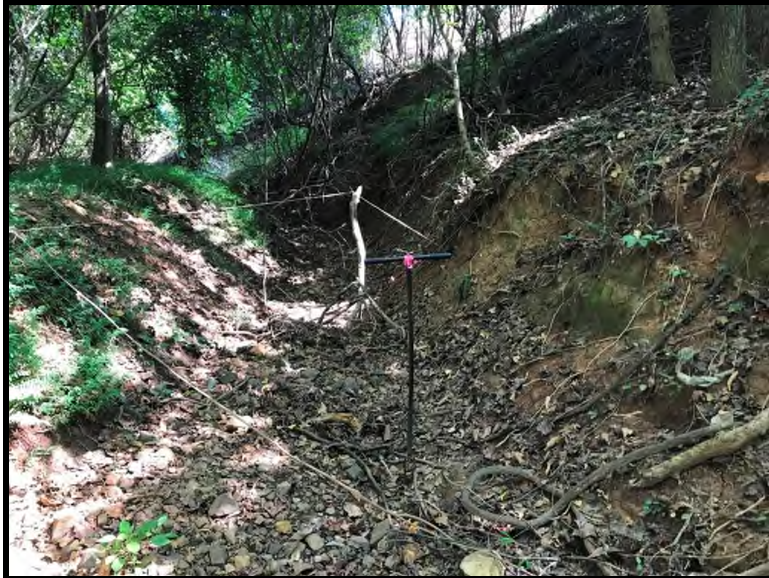
NOTES/COMMENTS: Dry channel (intermittent); culverts (2); bank erosion (40-50%); large powerline easement; incised channel in many locations below culvert. Invasive species (*Microstegium vimineum*, *Ligustrum sinense*, *Elaeagnus pungens*, and *Elaeagnus umbellata*) within and adjacent to channel.

1 NWW-1. Southern portion. Eroding banks typical of areas around slopes.

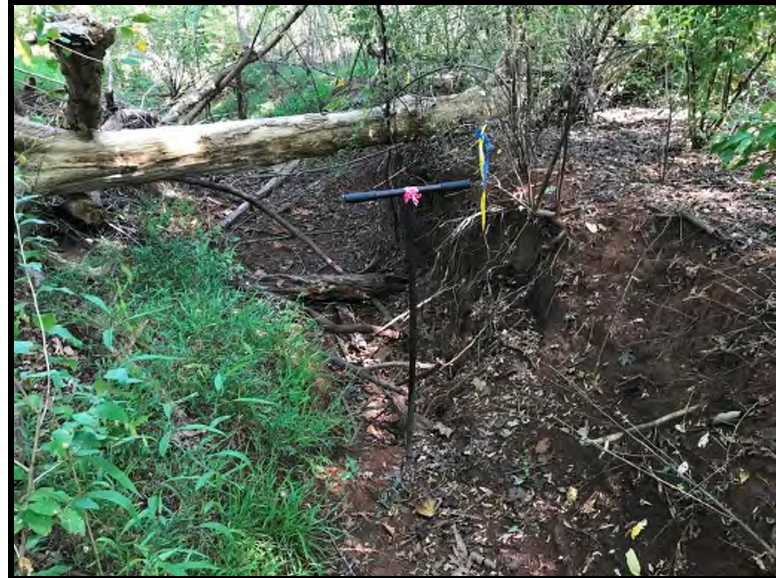
2 NWW-1. Between culvert and property boundary. Eroding banks typical of areas around slopes. Channel is also incised.

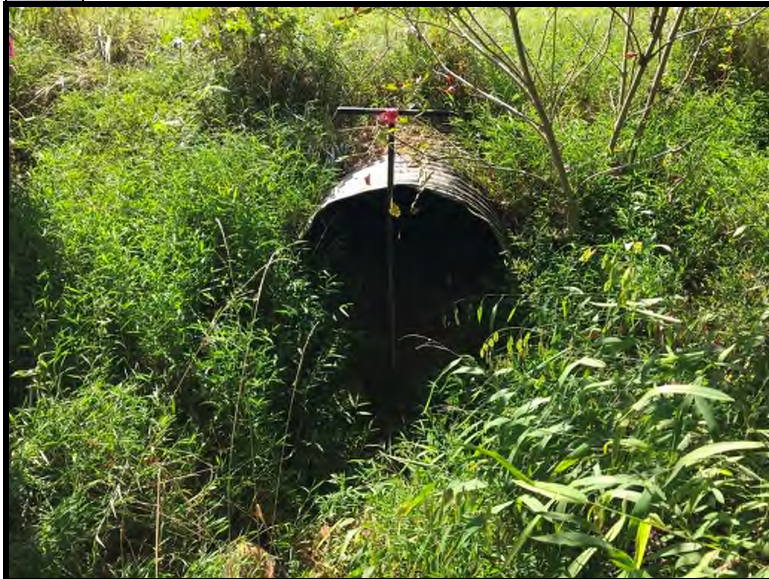
3 NWW-1. Culvert in channel near powerline easement.

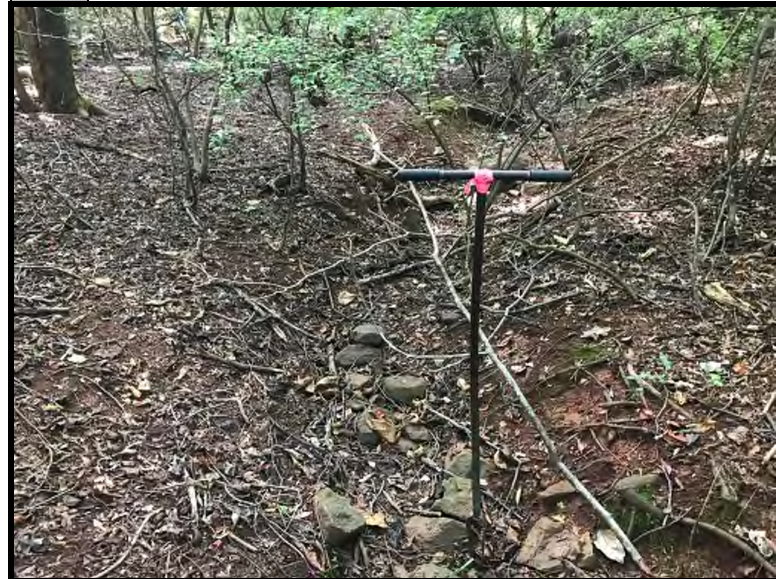
4 NWW-1. Upper portions.

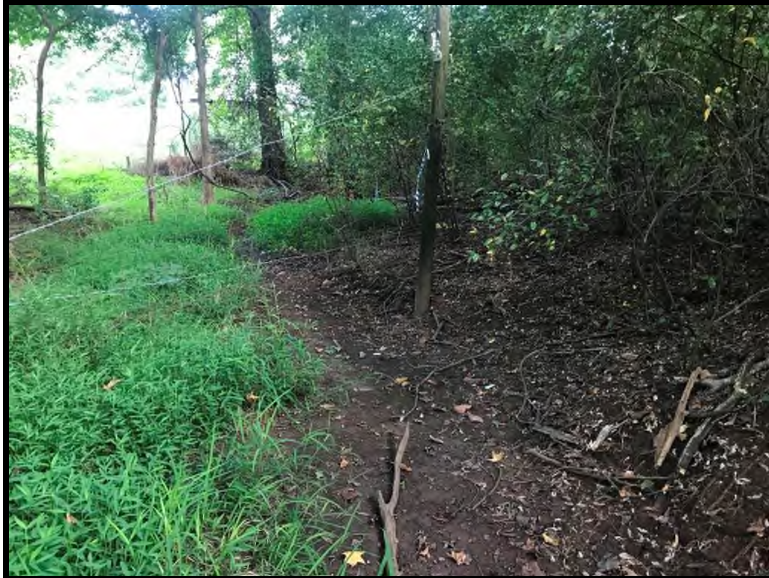
NOTES/COMMENTS: Dry channel (intermittent); culvert; bank erosion (40-50%); powerline easement; incised channel in many locations. Invasive species (*Microstegium vimineum*, *Ligustrum sinense*, *Elaeagnus pungens*, and *Elaeagnus umbellata*) within and adjacent to channel.

5 NWW-2. Western portion near culvert at I-77. Channel is spread out and less defined.

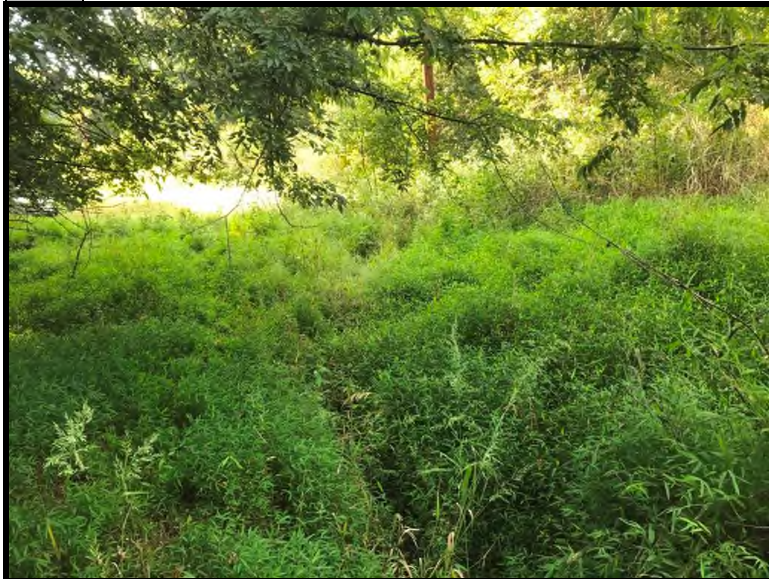
7 NWW-2. Within powerline easement. Channel is lined with Japanese stiltgrass.

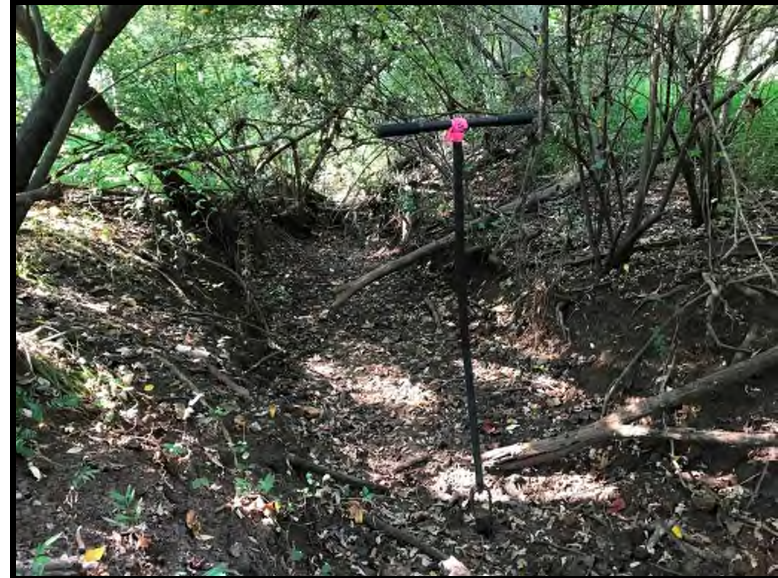
6 NWW-2. Central portion. Stream is incised and appears to have been channelized below powerline easement.

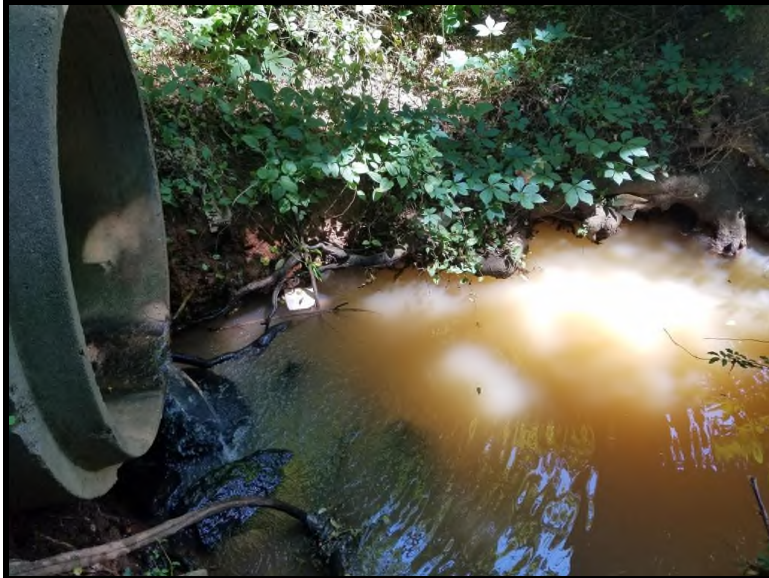
NOTES/COMMENTS: Partially dry channel (intermittent); culverts (3); bank erosion (40-50%); powerline easement; incised channel in many locations. Invasive species (*Microstegium vimineum*, *Ligustrum sinense*, *Elaeagnus pungens*, and *Elaeagnus umbellata*) within and adjacent to channel. One culvert does not allow aquatic passage on downstream opening. Heavy trash, sediment, and debris from adjacent highway.

9 NWW-2A. Culvert just east I-77. No upstream aquatic passage due to position of culvert above streambed.

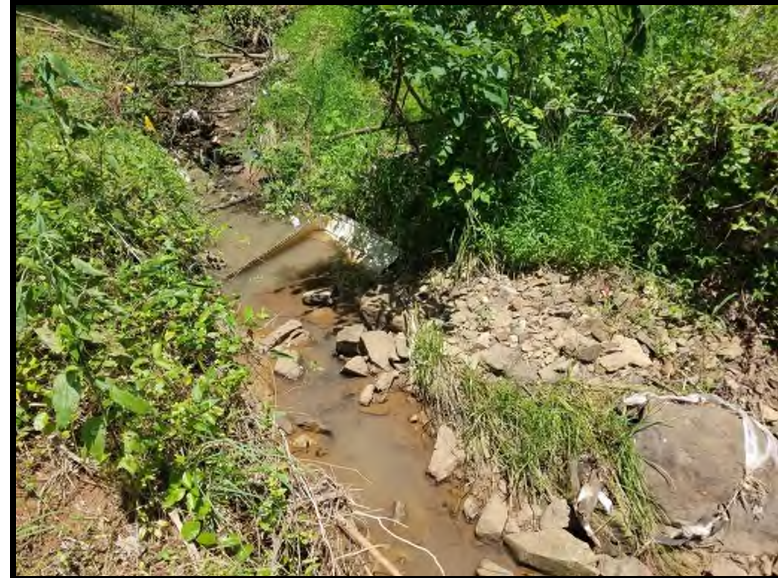
10 NWW-2A. Scour, incision, and debris from adjacent interstate.

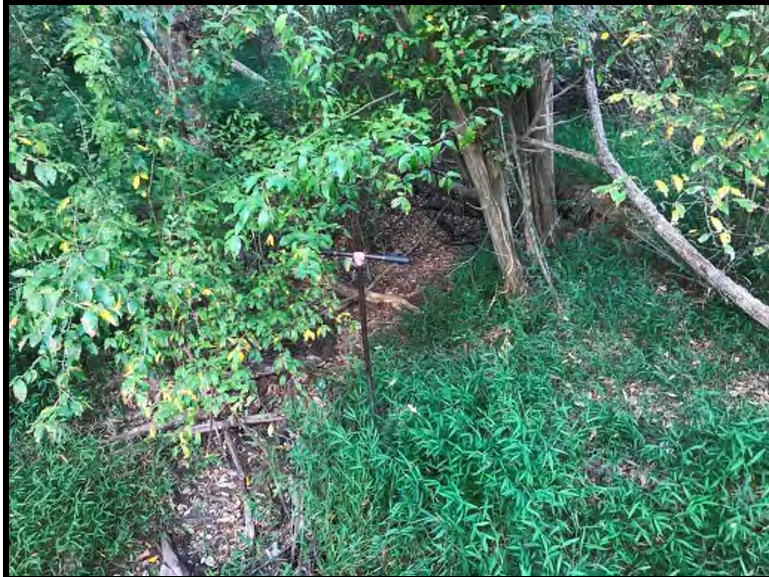
NOTES/COMMENTS: Dry channel (intermittent); bank erosion (40-50%); incised channel at lower end. Riparian area has been partially cut at headwater of stream. Stream appears to have been straightened in the past. Invasive species (*Microstegium vimineum*, *Ligustrum sinense*, *Elaeagnus pungens*, and *Elaeagnus umbellata*) within and adjacent to channel.

11 NWW-3. Channel has been straightened.

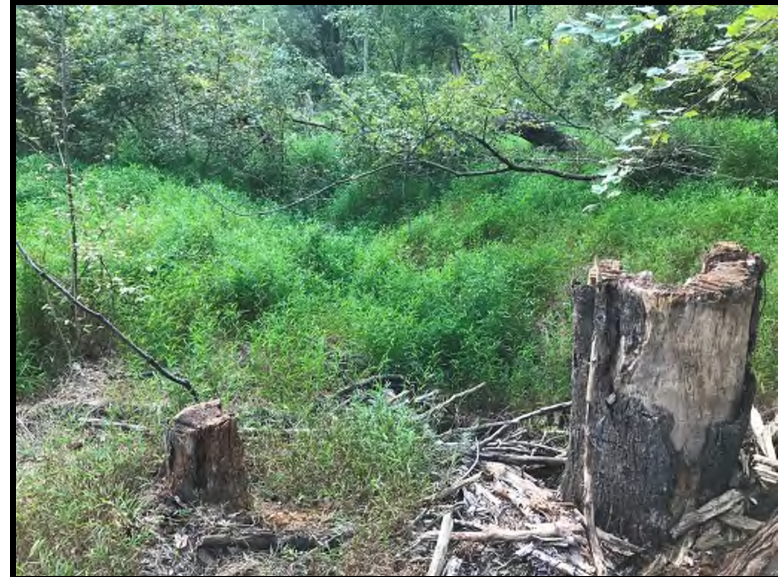
12 NWW-3. Upper portion. Riparian buffer has been primarily cut. Channel is lined with Japanese stiltgrass.

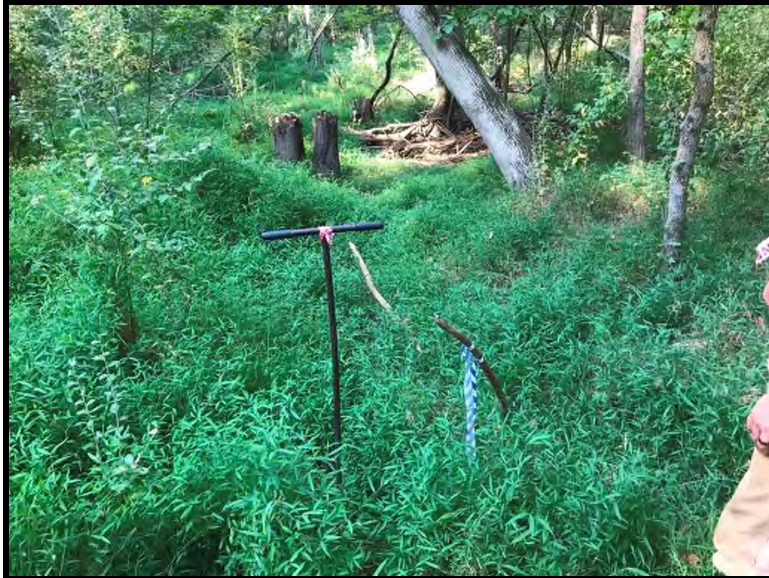
NOTES/COMMENTS: Dry channel (intermittent); culvert at highway, bank erosion (40-50%); incised channel at lower end after former pond bottom. Invasive species (*Microstegium vimineum*, *Ligustrum sinense*, *Elaeagnus pungens*, and *Elaeagnus umbellata*) within and adjacent to channel. Channel ends in former pond bottom and restarts after cut in former dam. Braiding of stream as it nears I-77.

13 NWW-4. Upper portion. Channel is lined with Japanese stiltgrass.

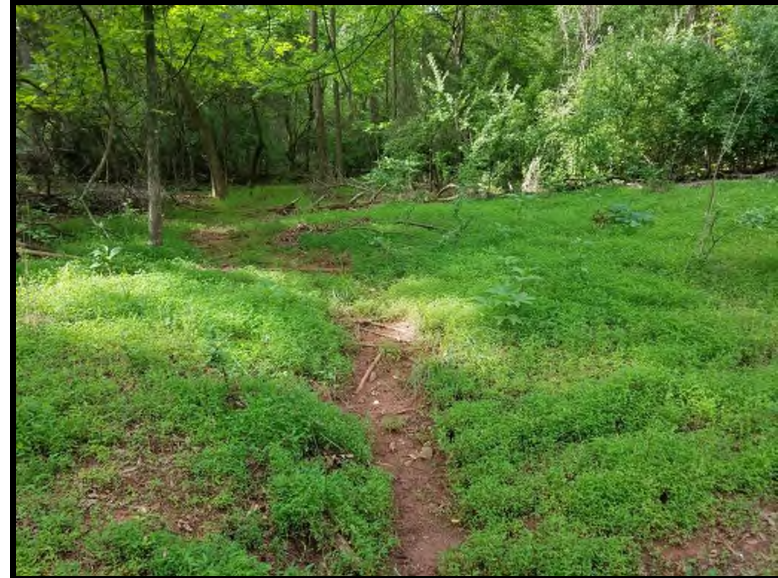
14 NWW-4. Upper portion. Channel is lined with Japanese stiltgrass.

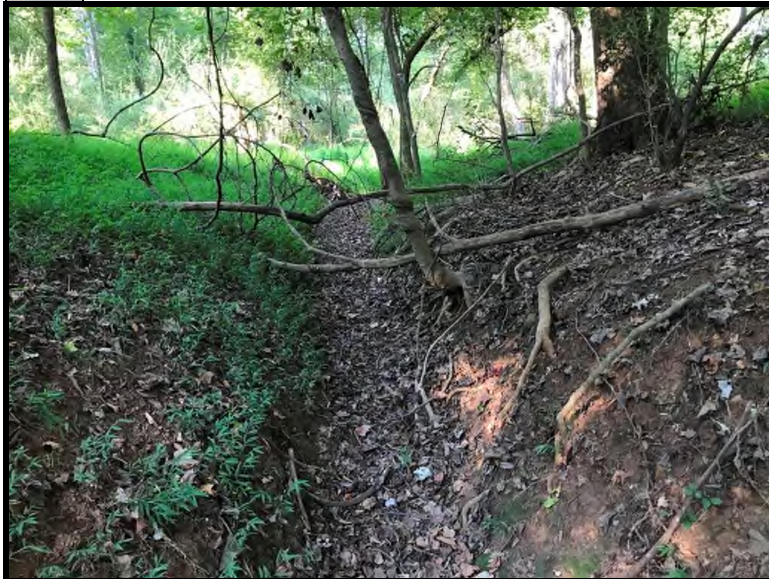
15 NWW-4: Below former pond bottom. Stream has been channelized in this portion.

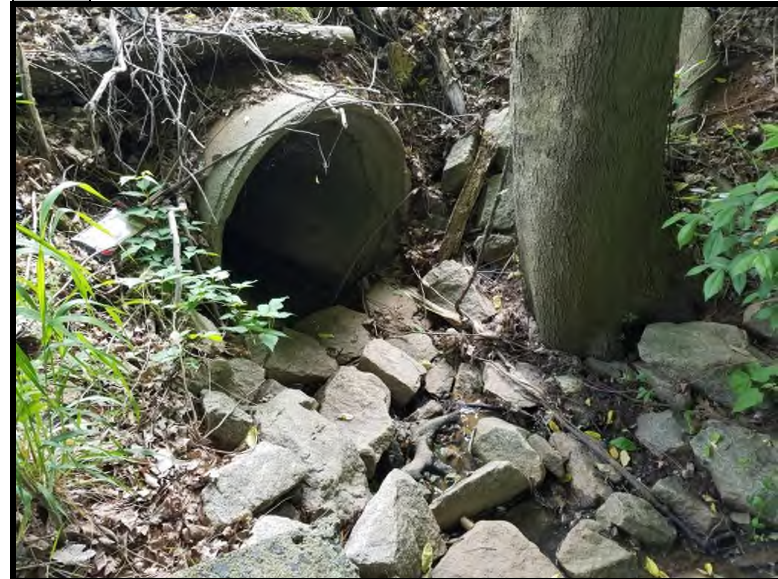
16 NWW-4. Culvert in stream at I-77.
