Video Pipe Detail Report

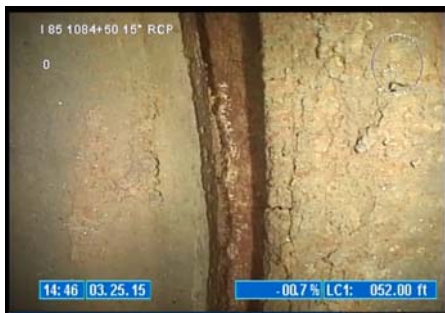
Damage Type: Gapped Joint
Location of Damage (ft): 58
Crack/Break Width (in): N/A
Video Cue Time: 0:09:45

Comments: Gap

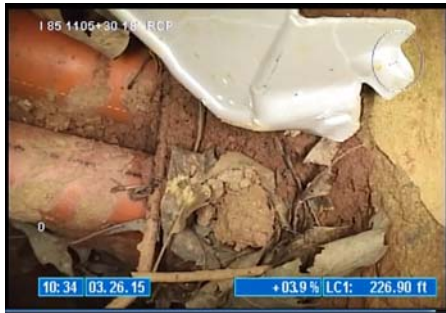
Damage Type:	N/A
Location of Damage (ft):	227
Crack/Break Width (in):	N/A
Video Cue Time:	0:35:00

Comments: Pipe broken. Fiber line appears to have been drilled through pipe.

41	A-73,A-74	1089+00	18"	160	3/25/2015	Remove pipe from 66' back from NB end.	Listed as 1189+00
42	A-75,A-76,A-77,A-100	1105+30	18"	184	3/26/2015	Replace line starting at 227'. Seal cracks at drop inlet.	Fiber line through pipe
43a	A-78,A-79,A-80,A-101	1113+00 (I-85)	24"	336	3/26/2015	Seal cracks and clean drop inlet.	
43b	A-78,A-79,A-80,A-101	1113+00	24"	336	3/26/2015	Slip line pipe due to joint issues.	
44a	A-81	1125+60 NB	18"	144	3/10/2015	Remove debris from pipe.	
44b	A-82	1125+60 SB	18"	144	3/10/2015	Slip line pipe due to joint issues and remove debris from pipe.	
45	A-83,A-84,A-87	1157+00	30"	144	3/26/2015	Clean drop inlet. Pipe in good condition.	
46	A-88,A-89,A-90,A-91	1166+50	24"	152	3/26/2015	Clean drop inlet. Pipe in good condition.	
47	A-92,A-93,A-94,A-95	1171+75	36"	240	4/2/2015	Replace section of pipe at failure under NB frontage road.	
48	B-1	1184+75	18"	176	3/17/2015	Clean pipe and drop inlet. Seal any cracks.

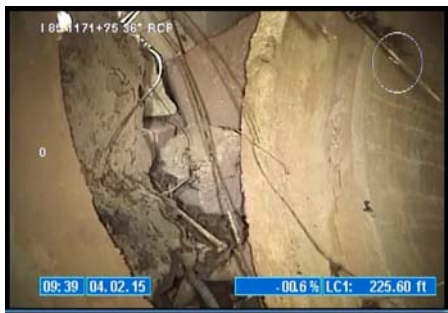
Damage Type: Dislocation
Location of Damage (ft): 226
Crack/Break Width (in): N/A
Video Cue Time: 0:35:15

Comments: Complete joint break under NB frontage road. End of Pipe

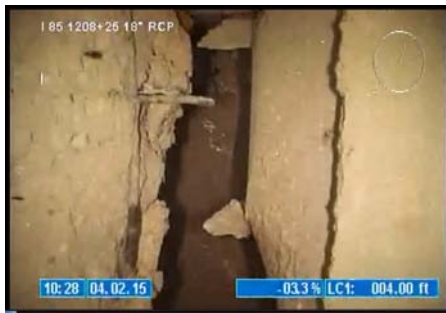
Damage Type:	Dislocation
Location of Damage (ft):	4
Crack/Break Width (in):	3.1
Video Cue Time:	0:00:00

Comments: Joint dislocation at 12 o'clock

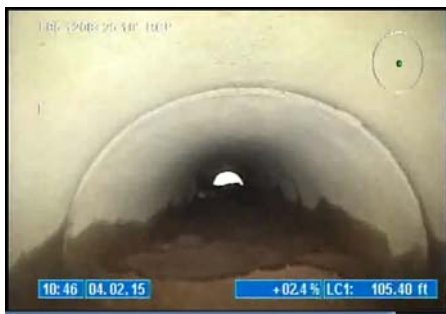
Damage Type:	N/A
Location of Damage (ft):	108
Crack/Break Width (in):	N/A
Video Cue Time:	0:18:25

Comments: Pipe over half full of sediment. Cannot go forward. It appears that the remaining twenty feet of pipe is intact.

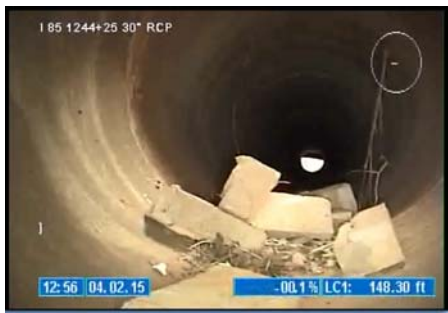
Damage Type:	N/A
Location of Damage (ft):	148
Crack/Break Width (in):	N/A
Video Cue Time:	0:08:30

Comments: Drop inlet on NB side of Highway.
Bricks are in way of all pipes, but
pipes appear to be functional.

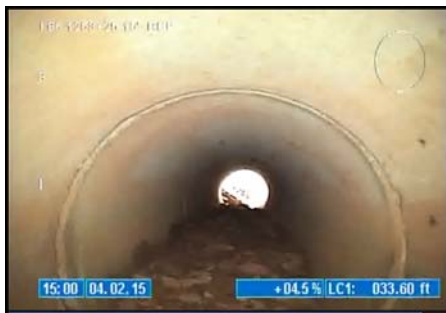
Damage Type:	N/A
Location of Damage (ft):	34
Crack/Break Width (in):	N/A
Video Cue Time:	0:05:11

Comments: Pipe half full of sediment. Cannot continue. Pipe under frontage road appears to be functional.

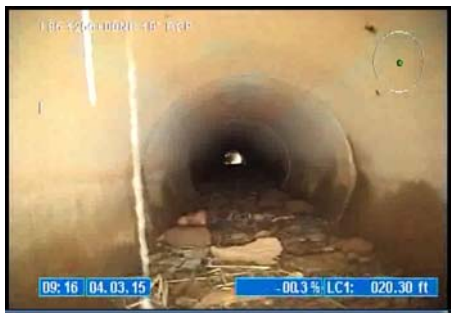
Damage Type:	N/A
Location of Damage (ft):	44
Crack/Break Width (in):	N/A
Video Cue Time:	N/A

Comments: Pipe full of sediment. Couldn't continue. Rest of pipe appears to be functional.

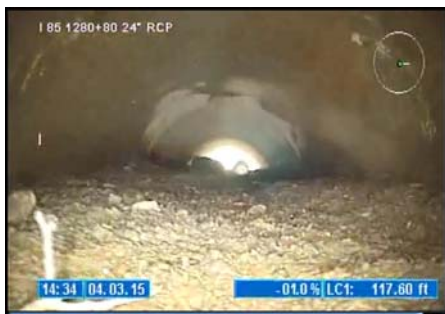
Damage Type:	N/A
Location of Damage (ft):	119
Crack/Break Width (in):	N/A
Video Cue Time:	0:14:00

Comments: From 119' to end of pipe: 3/4 full of sediment. Pipe appears to end at 128' or 132'.

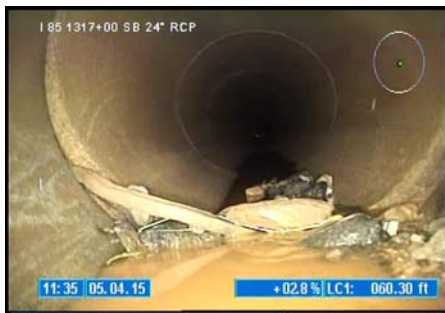
Damage Type:	N/A
Location of Damage (ft):	64
Crack/Break Width (in):	N/A
Video Cue Time:	0:04:20

Comments: Can't continue due to debris. Rest of SB pipe appears to be intact.

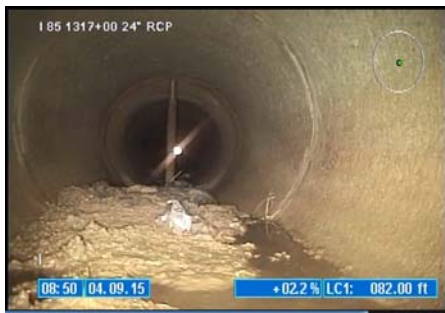
Damage Type:	N/A
Location of Damage (ft):	86
Crack/Break Width (in):	N/A
Video Cue Time:	0:10:20

Comments: Cannot continue due to rebar

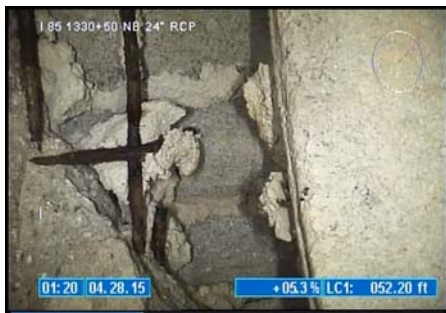
Damage Type:	N/A
Location of Damage (ft):	52
Crack/Break Width (in):	N/A
Video Cue Time:	0:06:35

Comments: Gap in joint but it appears that it is bricked in.

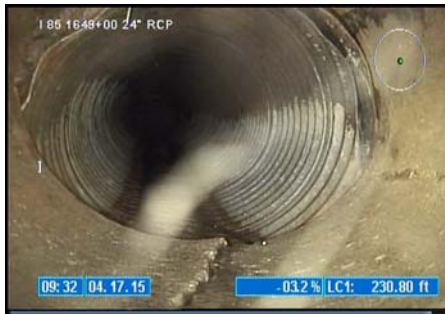
Damage Type:	N/A
Location of Damage (ft):	232
Crack/Break Width (in):	N/A
Video Cue Time:	0:32:35

Comments: Concrete pipe turns into corrugated pipe at NB Frontage Road.

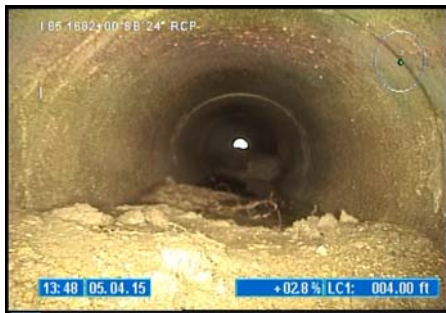
Damage Type:	N/A
Location of Damage (ft):	4
Crack/Break Width (in):	N/A
Video Cue Time:	0:00:00

Comments: Could not video pipe. Sediment still remained after cleaning. Pipe appears to be intact.

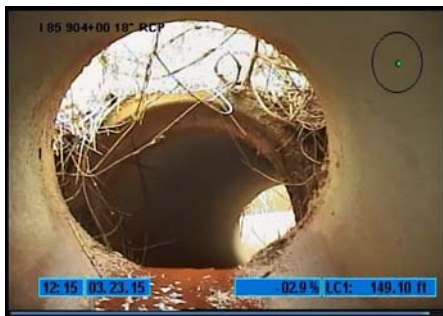
Damage Type:	N/A
Location of Damage (ft):	152
Crack/Break Width (in):	N/A
Video Cue Time:	0:23:45

Comments: Pipe Broken outside of structural area

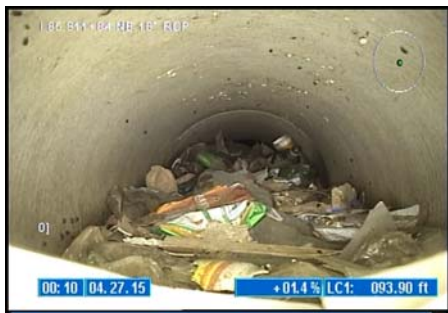
Damage Type:	N/A
Location of Damage (ft):	92
Crack/Break Width (in):	N/A
Video Cue Time:	0:13:14

Comments: Pipe full of debris. Could not continue.

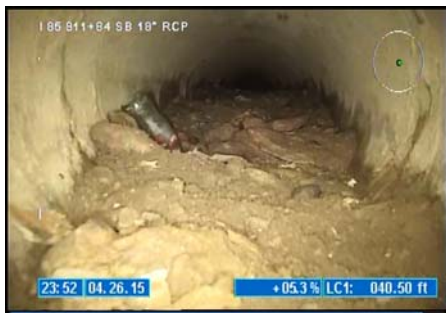
Damage Type:	N/A
Location of Damage (ft):	44
Crack/Break Width (in):	N/A
Video Cue Time:	0:06:10

Comments: Cannot continue due to excessive sediment.

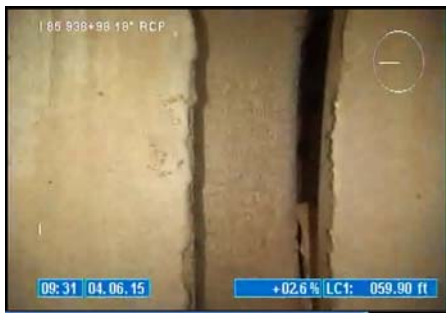
Damage Type:	Dislocation
Location of Damage (ft):	60
Crack/Break Width (in):	N/A
Video Cue Time:	0:09:10

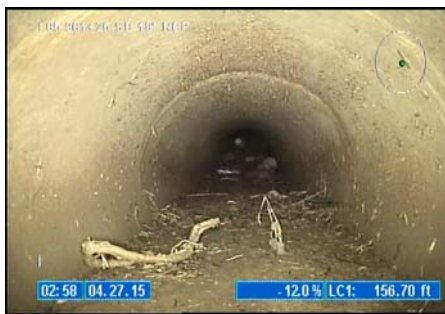
Damage Type: N/A
Location of Damage (ft): 156
Crack/Break Width (in): N/A
Video Cue Time: 0:18:22

Comments: Cannot continue due to sediment.
Pipe under highway is acceptable.

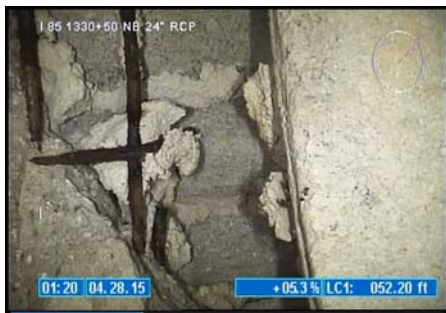
Damage Type: N/A

Location of Damage (ft): 52

Comments: Gap in joint but it appears that it is bricked in.

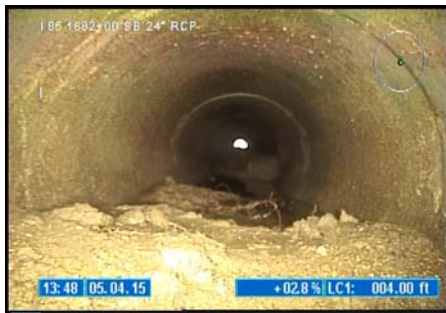
Damage Type:	N/A
Location of Damage (ft):	4
Crack/Break Width (in):	N/A
Video Cue Time:	0:00:00

Comments: Could not video pipe. Sediment still remained after cleaning. Pipe appears to be intact.

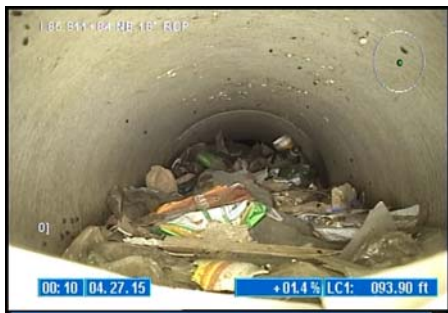
Damage Type:	N/A
Location of Damage (ft):	92
Crack/Break Width (in):	N/A
Video Cue Time:	0:13:14

Comments: Pipe full of debris. Could not continue.

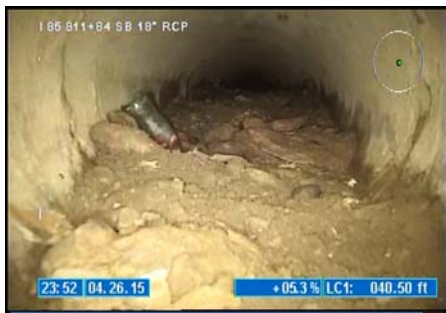
Damage Type:	N/A
Location of Damage (ft):	44
Crack/Break Width (in):	N/A
Video Cue Time:	0:06:10

Comments: Cannot continue due to excessive sediment.

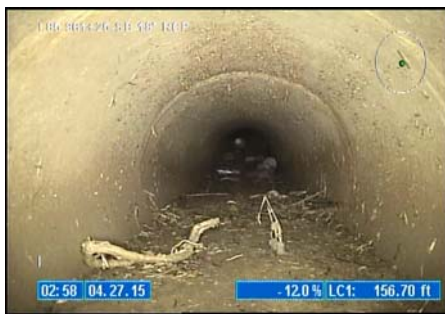
Damage Type: N/A
Location of Damage (ft): 156
Crack/Break Width (in): N/A
Video Cue Time: 0:18:22

Comments: Cannot continue due to sediment.
Pipe under highway is acceptable.
