# Bridge Assessment Report

## I-85 Over Thicketty Creek

Project ID: P027114

February 26, 2016

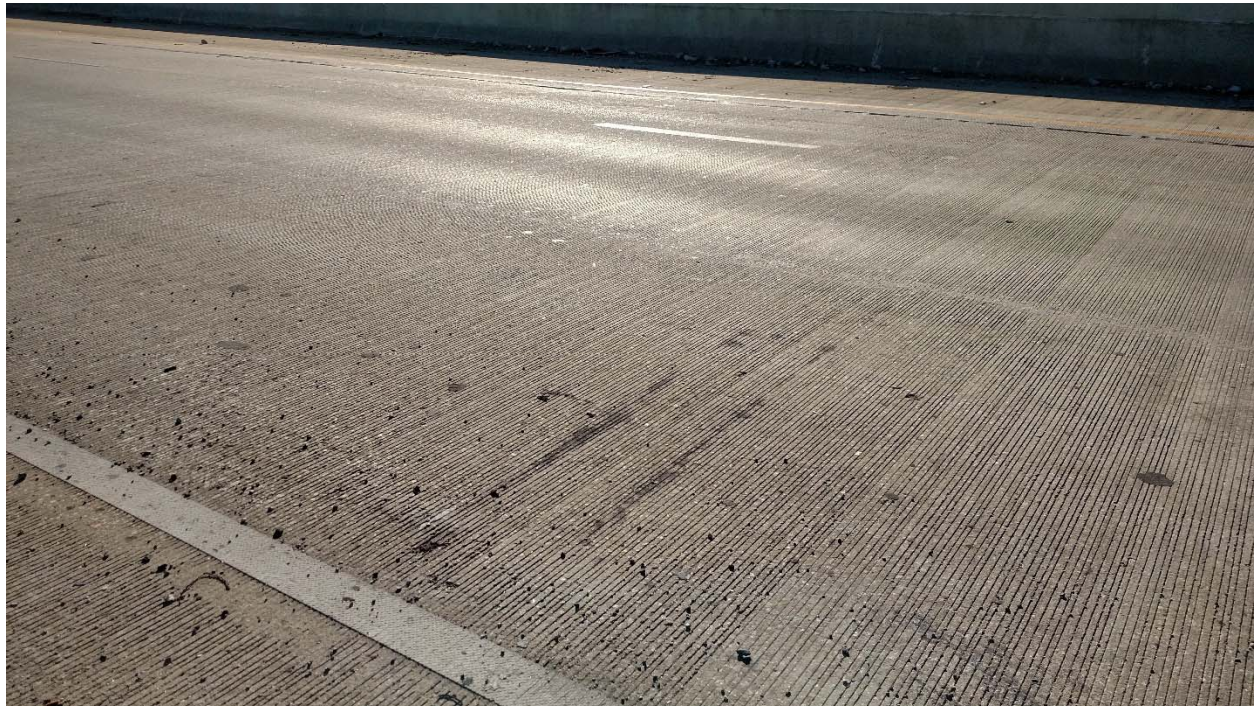
The existing composite, reinforced concrete deck was visually inspected from the shoulder since the roadway wasn't closed. A majority of the existing deck was in good condition (Figure 4) except at the closure pours on the two end spans of the southbound bridge. The closure pour for the interior span was

**Figure 4 – Existing Concrete Deck**

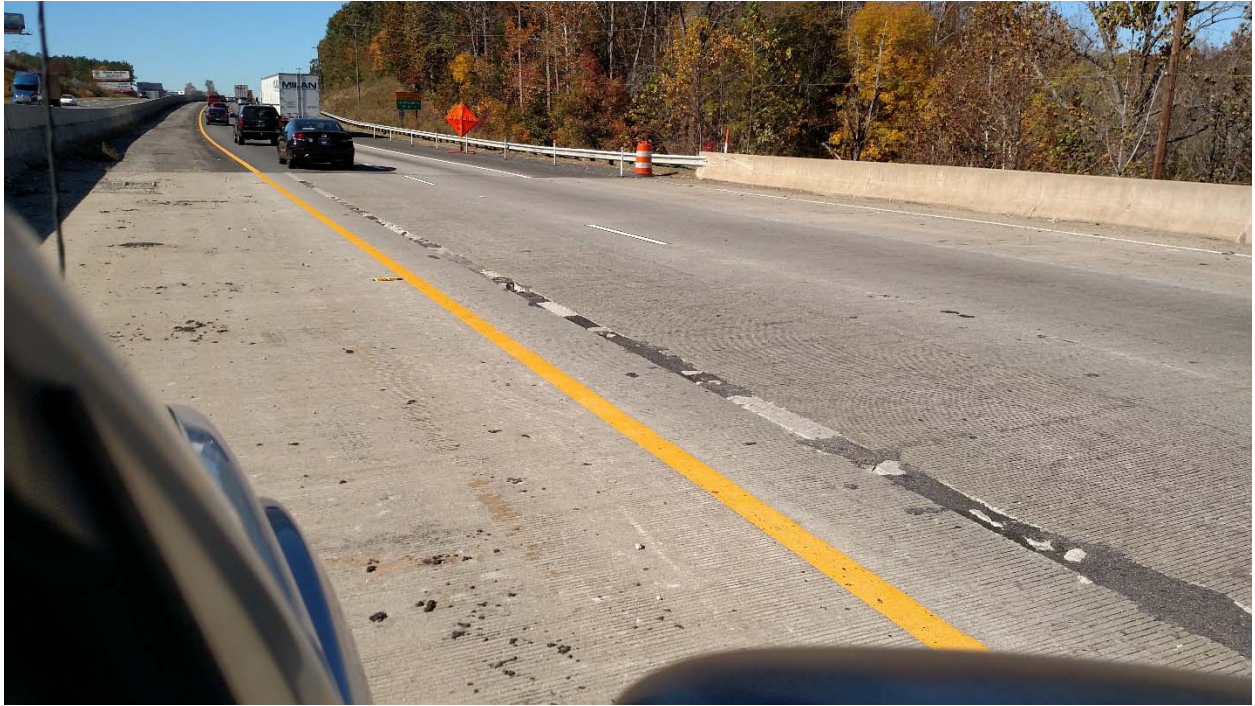
in good condition. There are several areas at the end spans where a portion of the concrete deck was missing and the reinforcing steel was exposed (See Figures 5 and 6). It was also noticed during the inspection of the underside of the deck (which had efflorescence) that water has been penetrating the deck of the southbound side (Figures 10 and 11) and eroding the earthen embankment below. Images of the earthen embankments can be found in subsequent figures located in the “Substructure Condition” section of this report. The closure pour areas of the southbound bridge are to be repaired per the details in Part III below. The concrete end walls are generally in good condition, except there is water penetration occurring at the closure pour locations (Figures 7 and 8). Only one area is experiencing water penetration at the end walls in between the plate girders and away from the closure pours (Figure 9). The end walls are generally in good condition except in locations stated above. The end wall at Bent 4 shall have epoxy repair of the crack as listed in Part III. Some minor repair of the asphalt roadway is necessary at the southbound deflection joint at End Bent 1 (Figure 13) as listed in Part III.

Figure 5 – Closure Pour (Southbound)

- The existing closure pour shall be repaired per the details and notes provided in the attached "Deck Repair Details". The closure pour shall be repaired for the entire length of the bridge between end bent deflection joints. The southbound traffic shall be maintained at all times along the outside of the bridge as shown in the attached details.

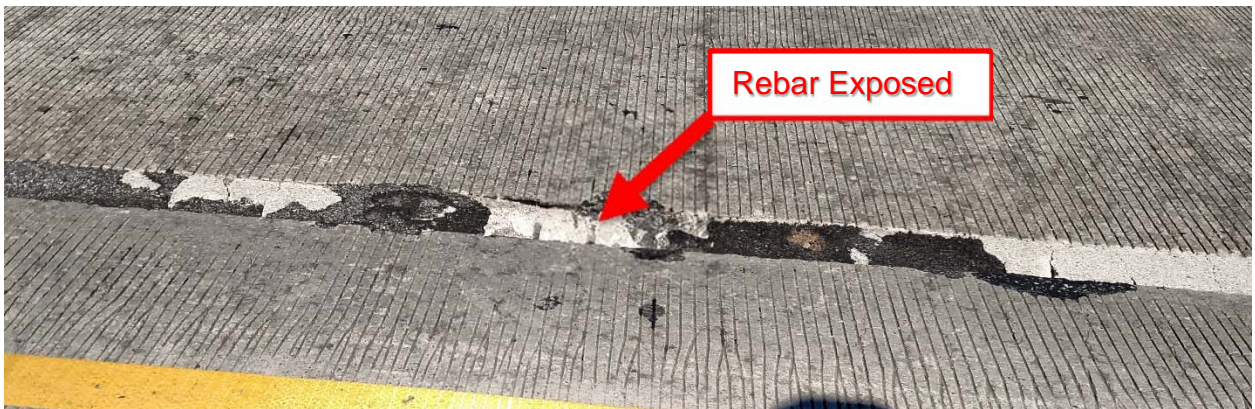
Figure 6 – Closure Pour (Southbound)

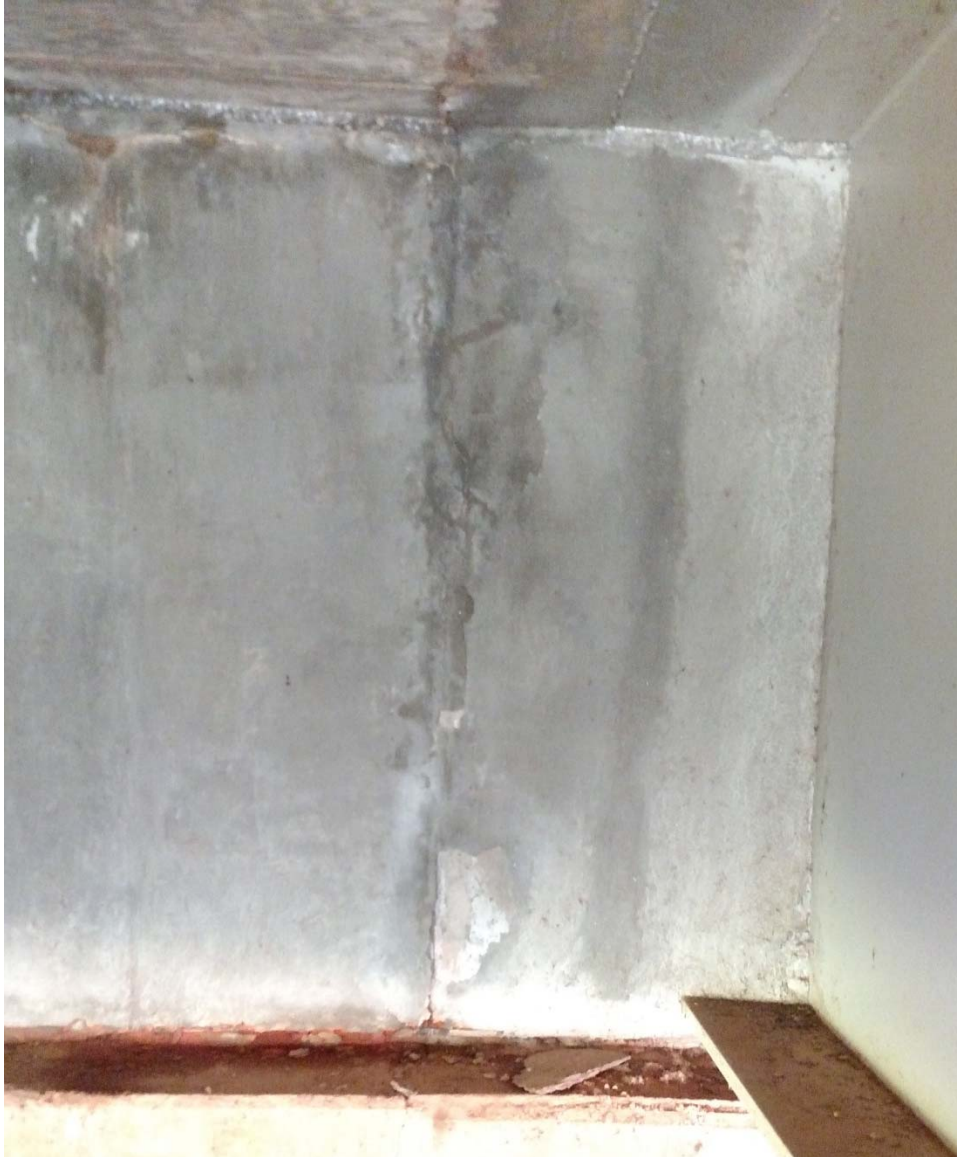
Figure 7 – End Wall at Closure Pour (Northbound)

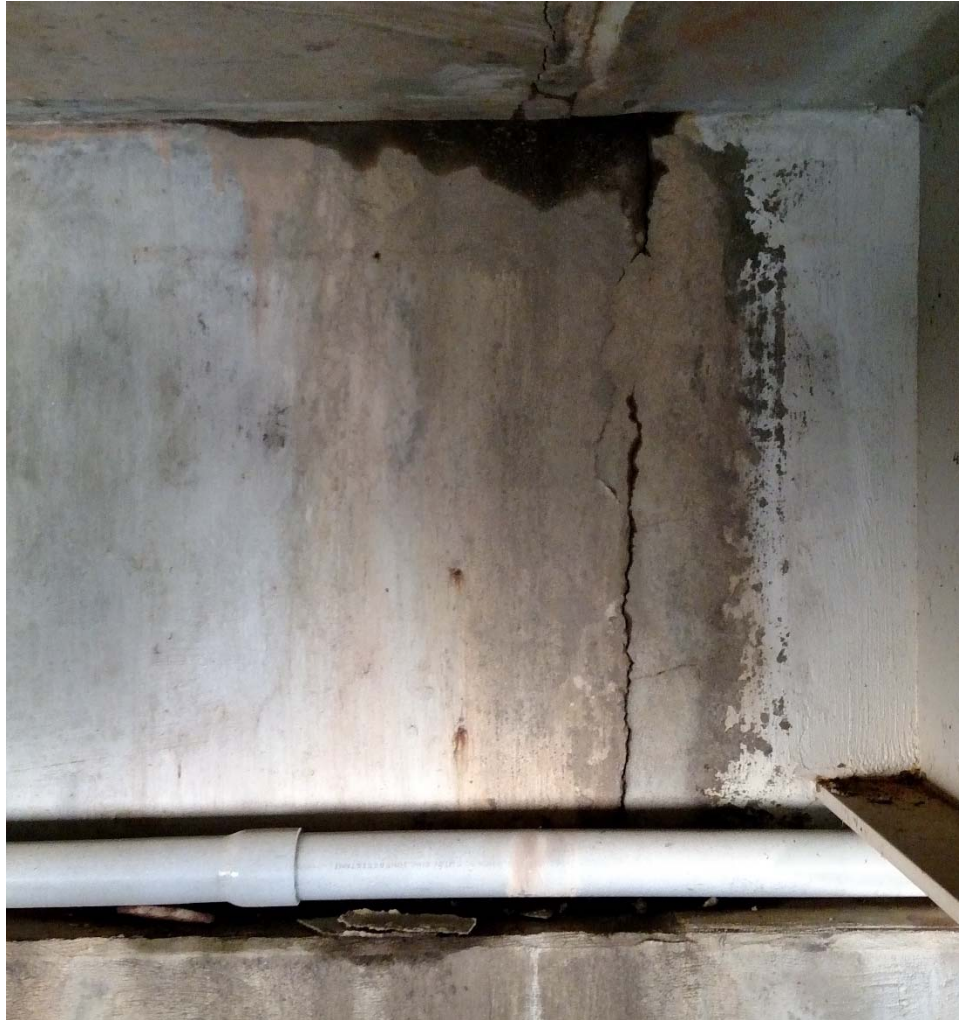
**Figure 8 – Bent 4 End Wall at Closure Pour (Southbound)**

- At the existing stage construction joint at End Bent 4 (southbound side), after the repair of the closure pour, the crack in the end wall shall be filled with an epoxy compound.
- The existing joint is to be cleaned and all loose concrete removed. Immediately after cleaning, while the vertical edge surface is dry, and the air temperature and concrete surface temperature are between 50°F and 80°F, apply an approved moisture resilient epoxy bonding compound meeting the requirements of ASTM C 881 or AASHTO M 235 in accordance with the manufacturer's recommendations to all vertical edges of the repair area.

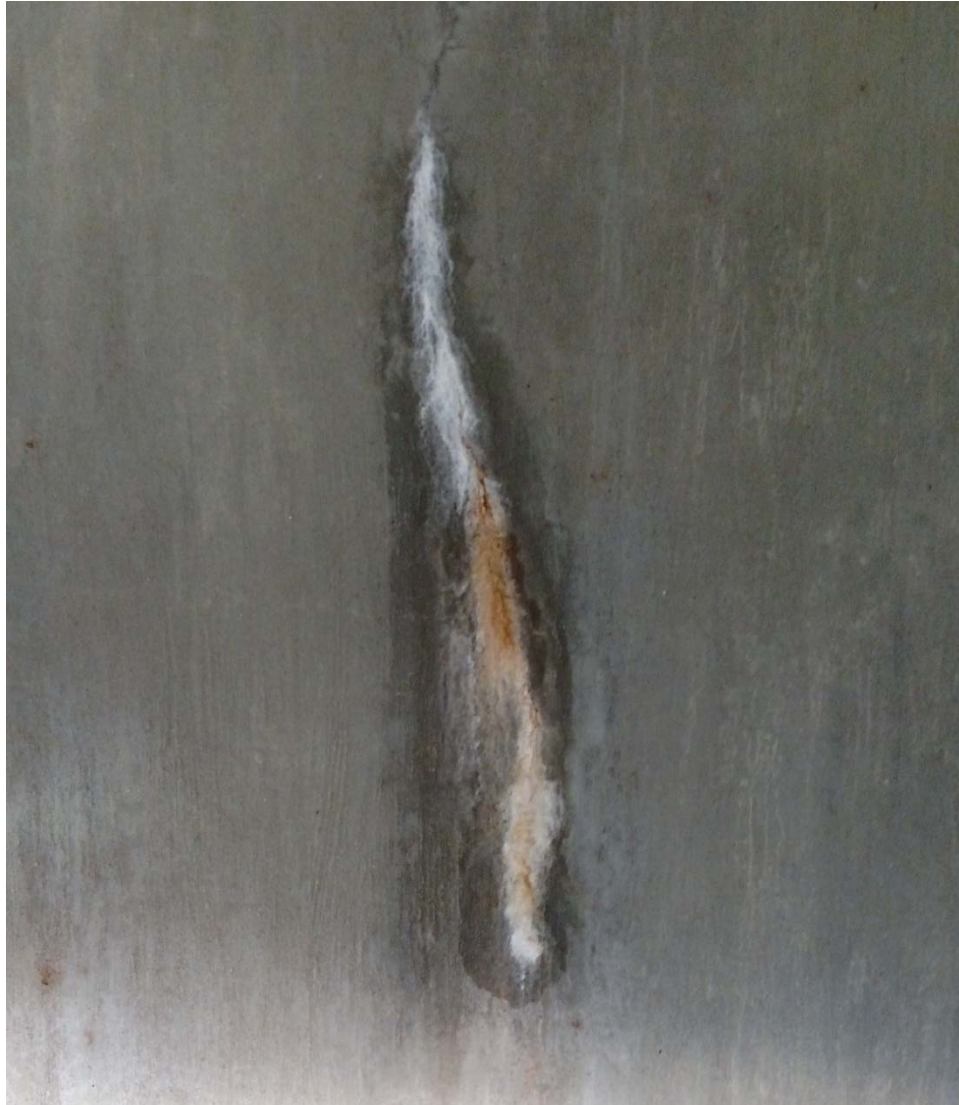
**Figure 9 – Water Penetration at End Wall (Southbound)**

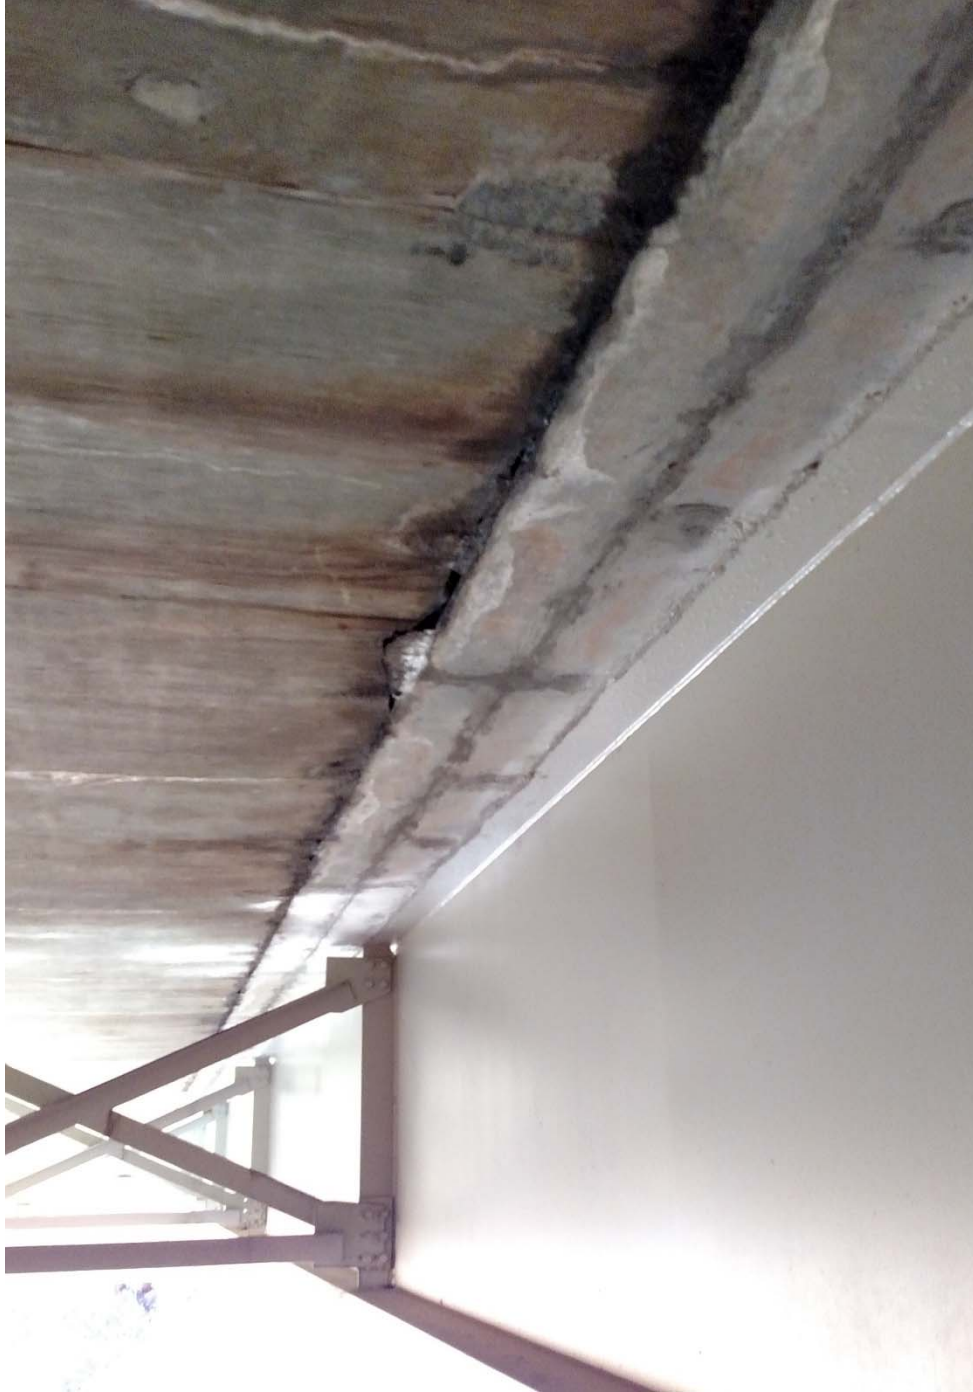
Figure 10 – Closure Pour (Southbound)

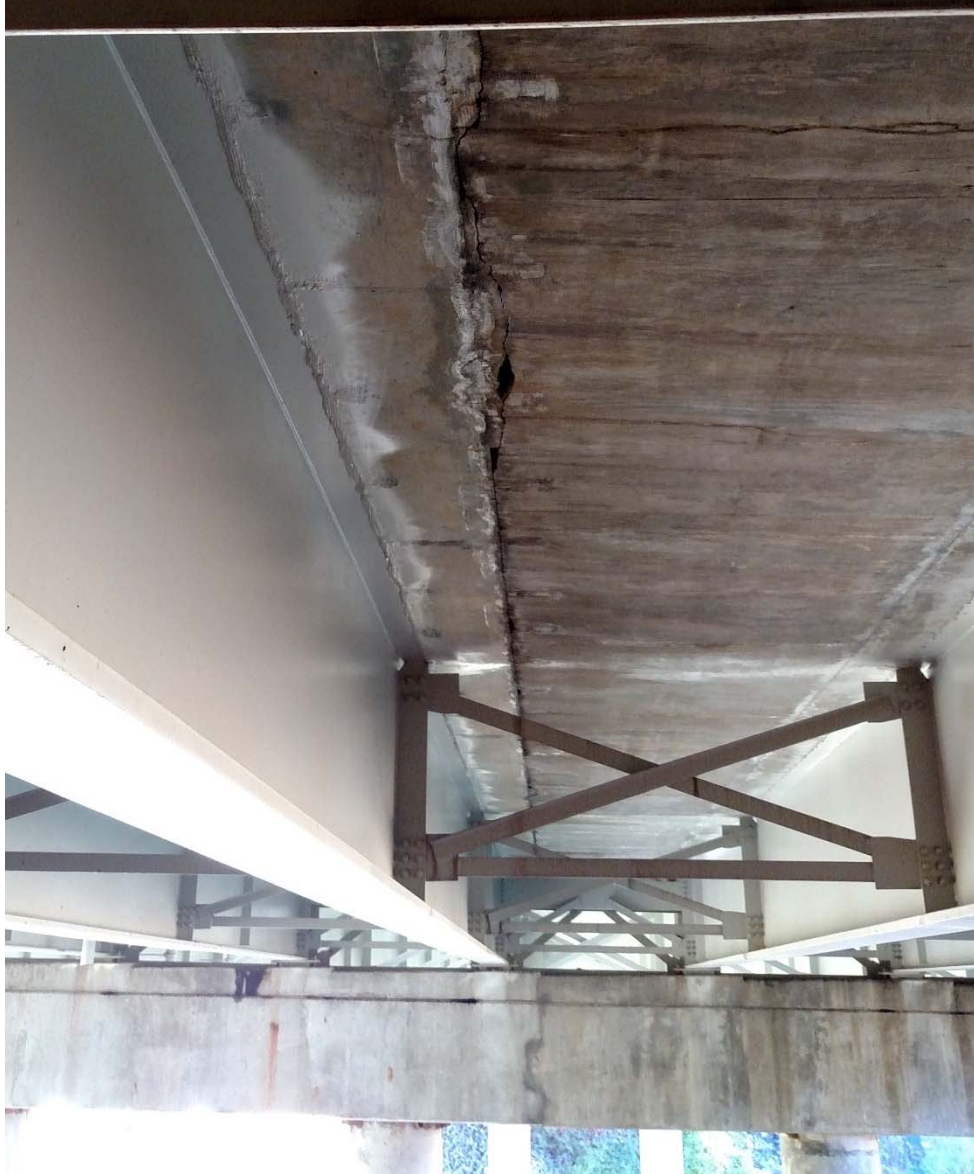
Figure 11 – Closure Pour (Southbound)

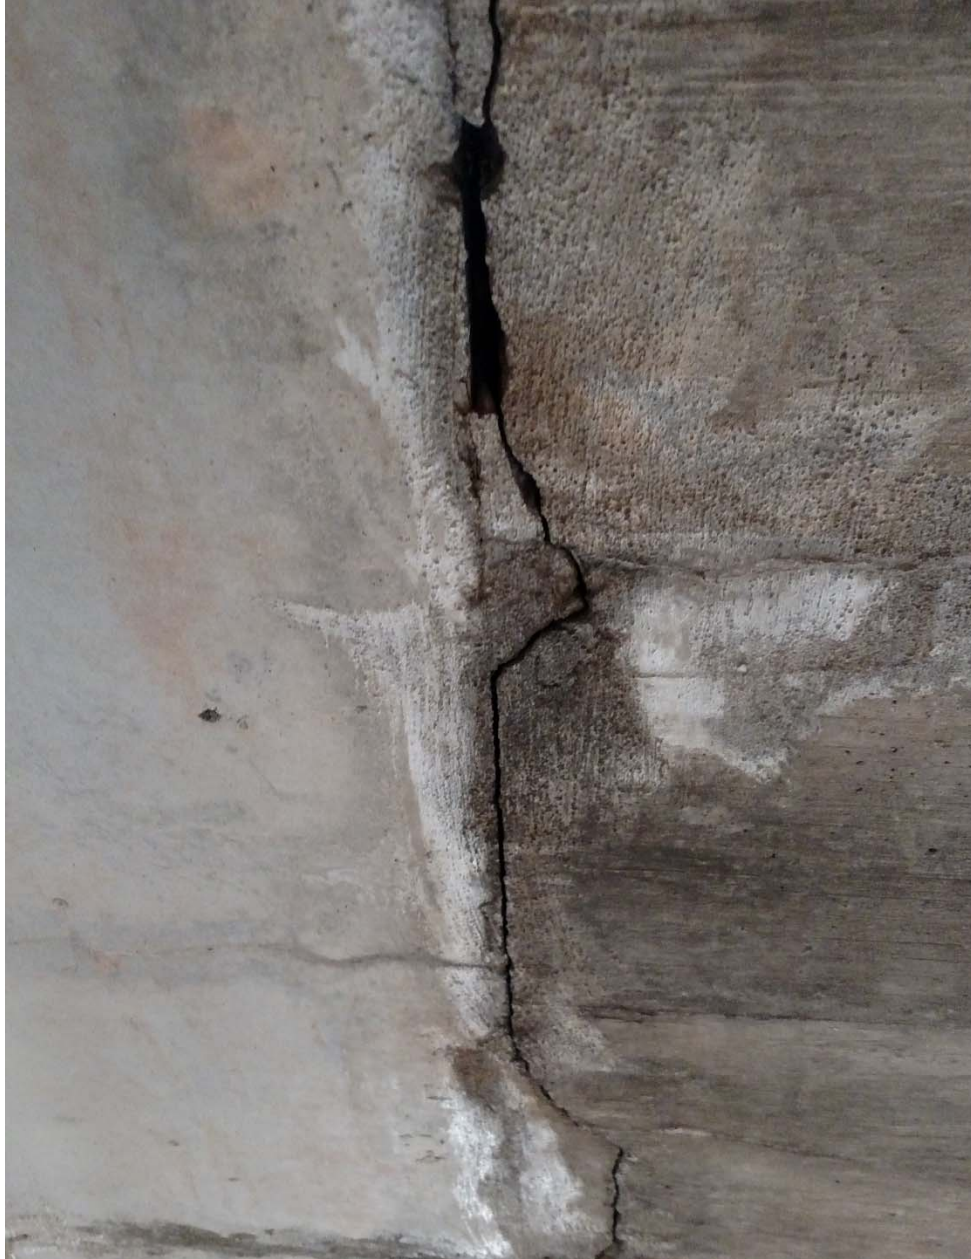
Figure 12 – Closure Pour (Southbound)

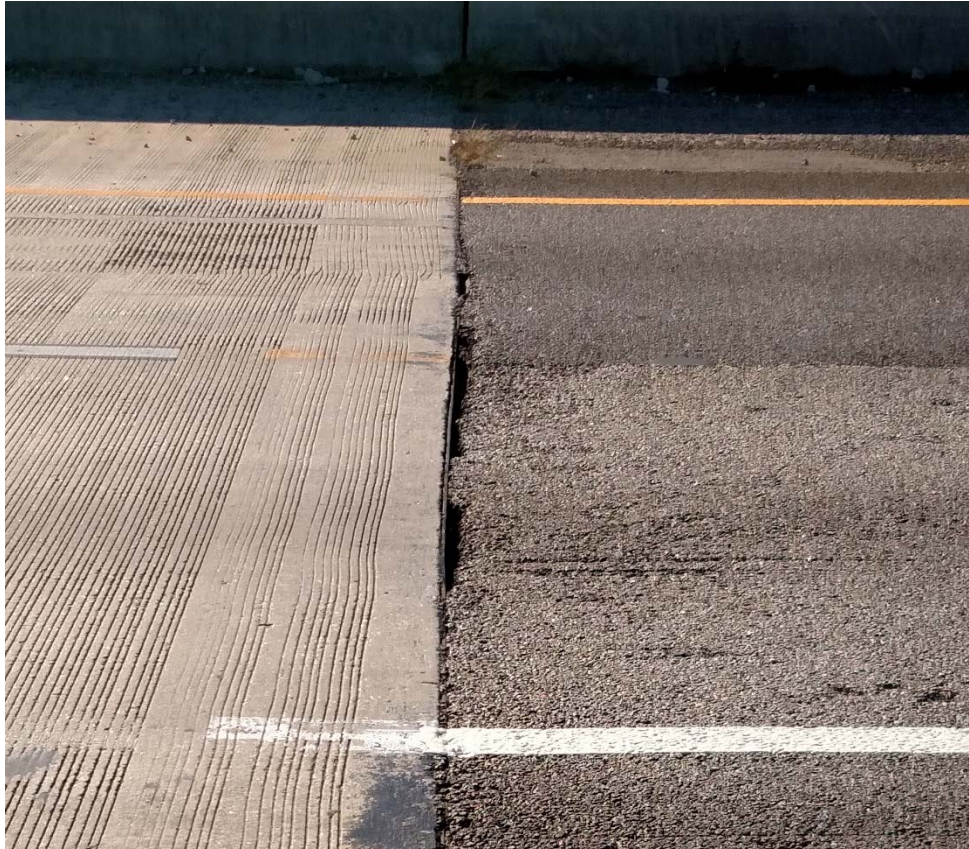
Figure 13 – Deflection Joint (Southbound)

- The existing strip seal gland at Bent 2 shall be replaced. The seal shall be sized based on the existing opening and conform to the requirements of SCDOT Bridge Drawings & Details.
- The existing compression seal gland at Bent 3 shall be replaced. The seal shall be sized based on the existing opening and conform to the requirements of SCDOT Bridge Drawings & Details.
- The asphalt on the approach slab at the deflection joint of the Southbound Lanes at End Bent 1 shall be repaired/patched as directed by the RCE.

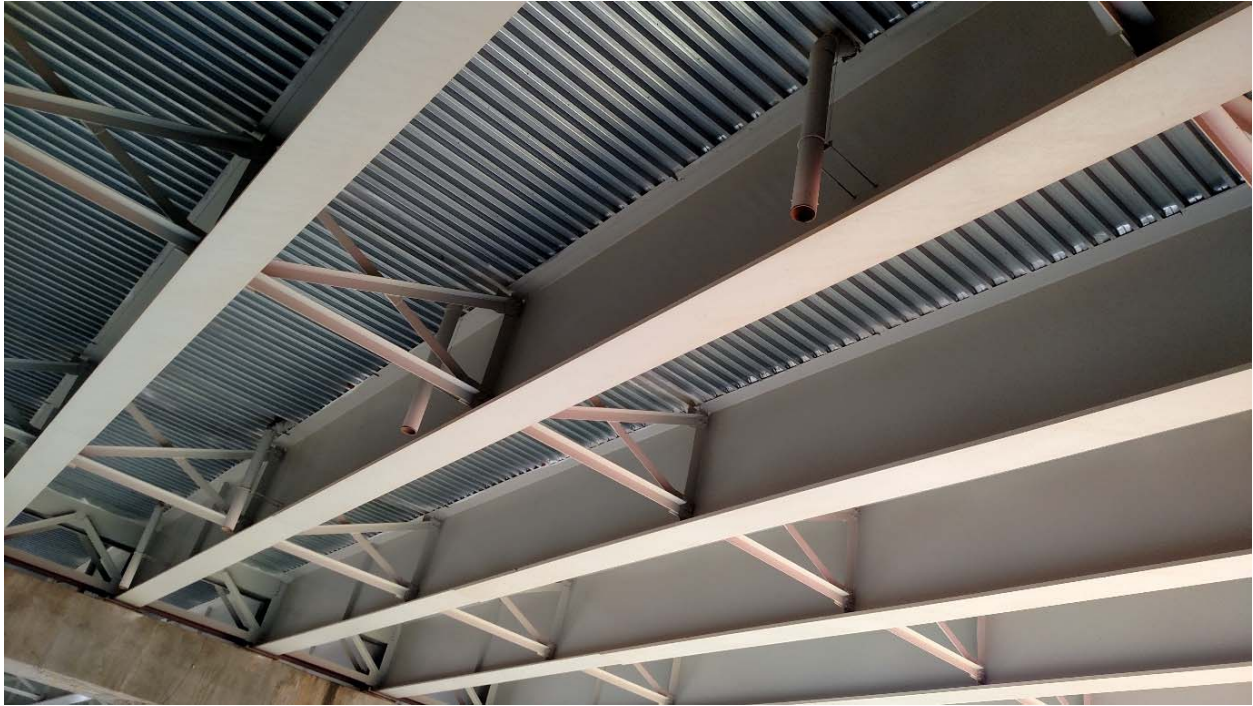
The existing welded plate girders were visually inspected in accessible areas at the end bents or from the ground for deterioration, section loss of built-up members, and cracks along all weld locations and stiffeners. The overall condition of the girders is very good. Only very minor surface rust is occurring near the closure pours where the water is penetrating the concrete deck.

Figure 14 – Superstructure

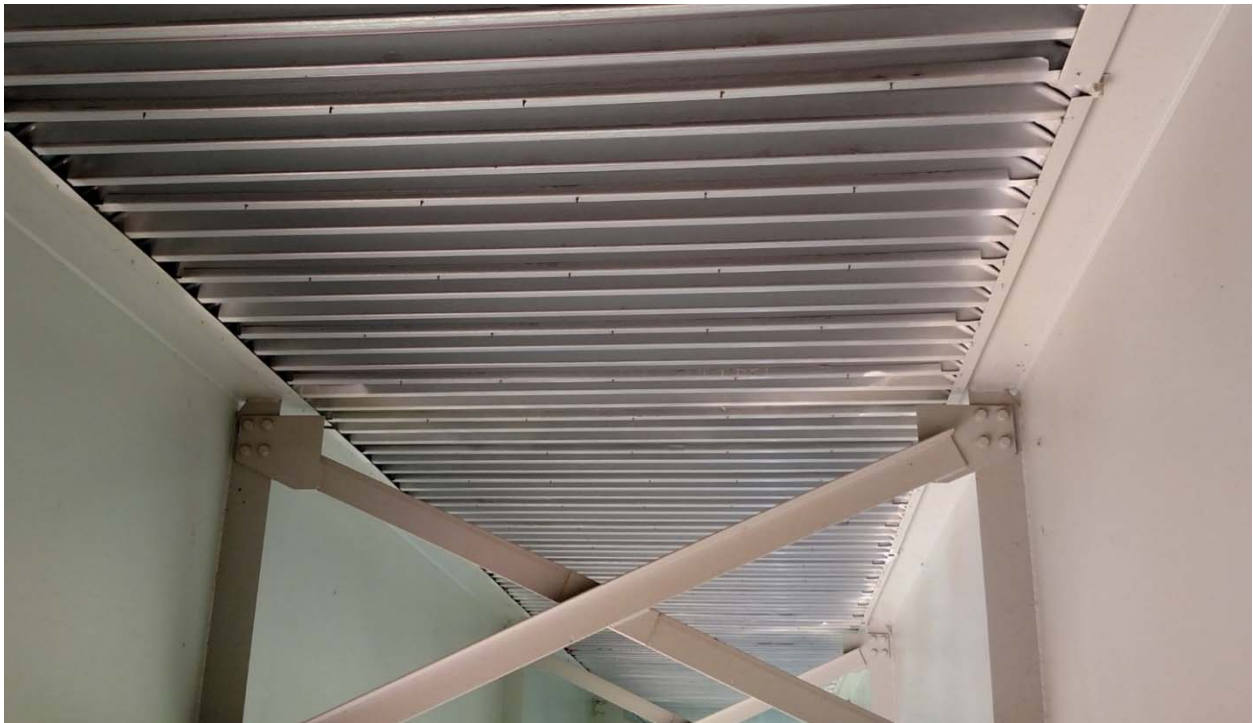
The interior and end support cross frames were visually inspected in accessible areas and were found to be in good condition with no noticeable surface rust or weld cracks or missing bolts.

Figure 15 – Cross Frame

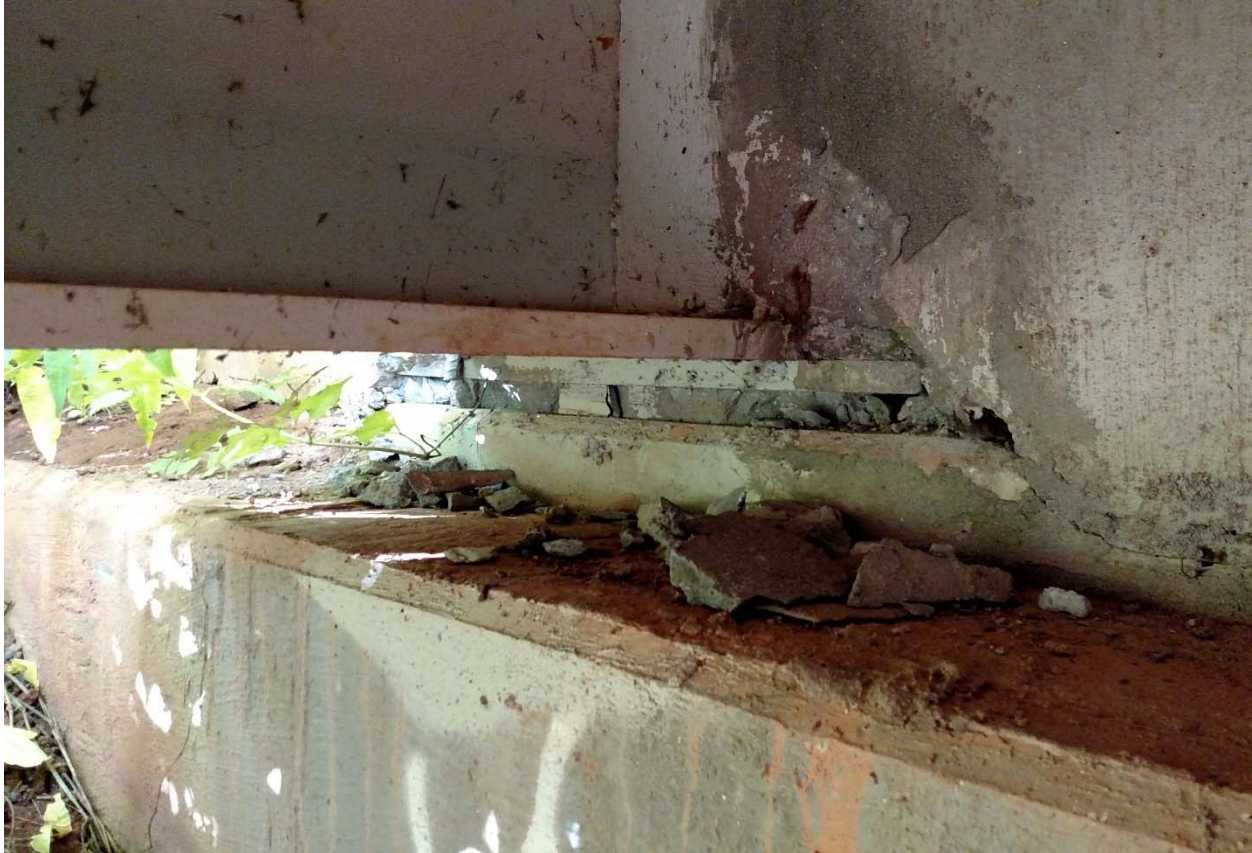
The end and interior bearings were not accessible and were not inspected. Only some of the outer faces of the load plates at the end bent bearings were visible due to the concrete end walls (integral end bents). A few areas have minor spalling of concrete and it appears the original contractor did not block out the bearings as directed in the original bridge construction plans. No work is anticipated at the bearing locations.

**Figure 16 – Bearing at End Bent**

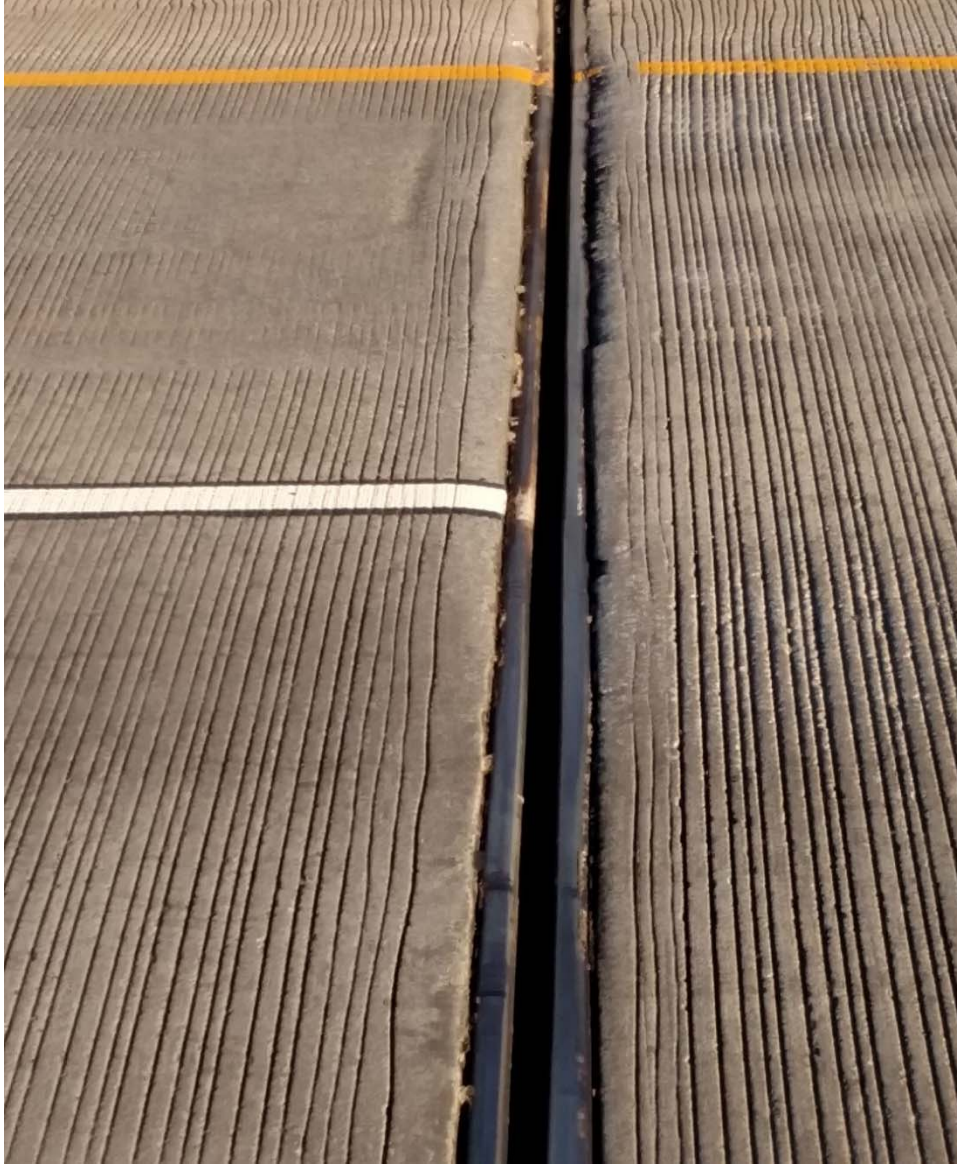
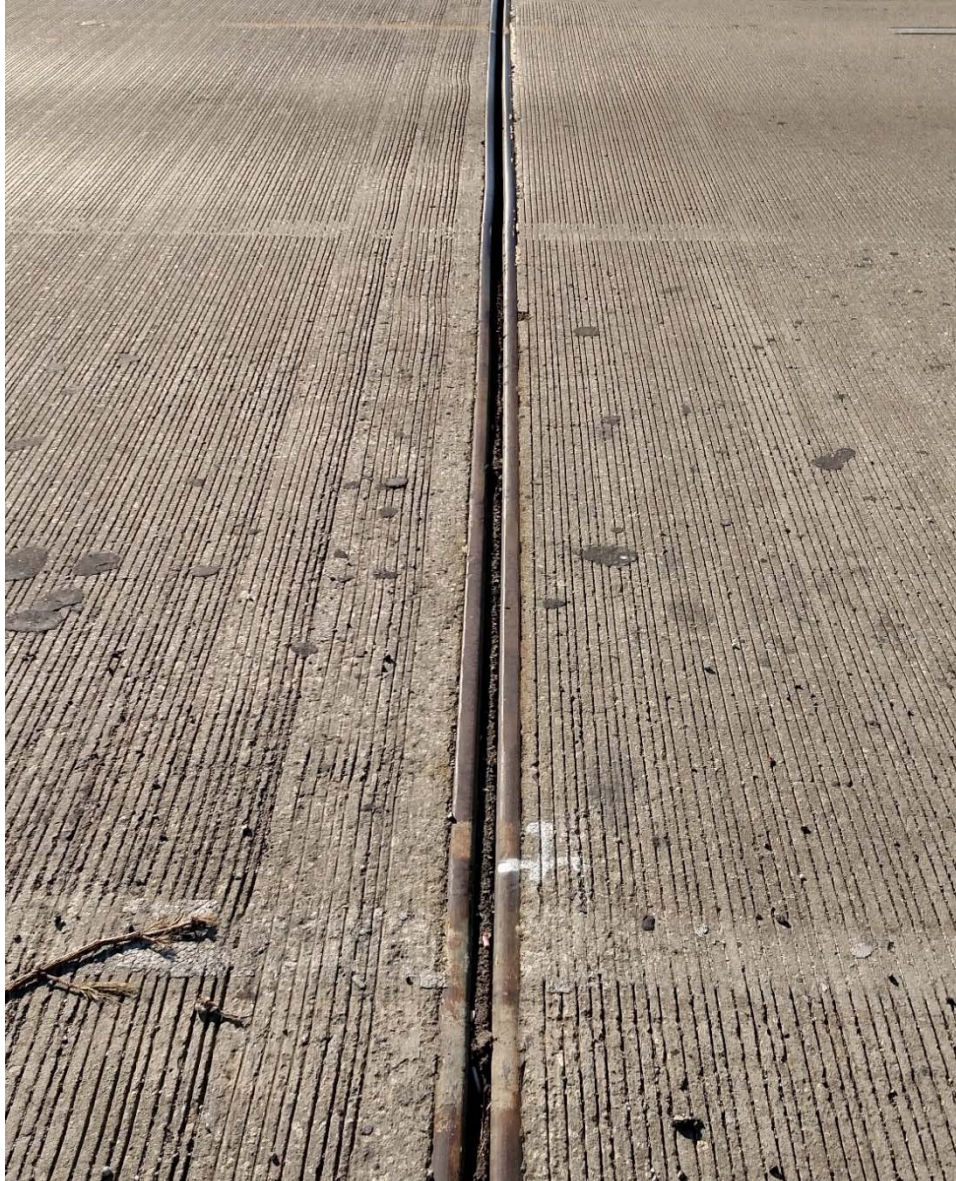
There are two deck expansion joints located within the bridge. They are located at Bent 2 (strip seal) and at Bent 3 (compression seal). Both expansion joints were visually inspected from the shoulders due to the roadway not being closed. The strip seal expansion joint at Bent 2 has debris lodged in it at several locations (Figures 17 and 18). The visible and accessible portions of the steel extrusion and the strip seal appear to be in fair condition. It is recommended that the strip seal gland be replaced. The compression seal joint at Bent 3 also has debris lodged in it at several locations (primarily on the shoulders) and the seal on the southbound bridge has dropped and water is penetrating the joint and falling onto the substructure below (Figures 19 and 20). The visible and accessible portions of the steel armor plates appear to be in fair condition. It is recommended that the compression seals glands be replaced. Refer to Part III below for the full summary of work.

Figure 17 – Strip Seal Expansion Joint (Northbound)

Figure 18 – Strip Seal Expansion Joint (Southbound)

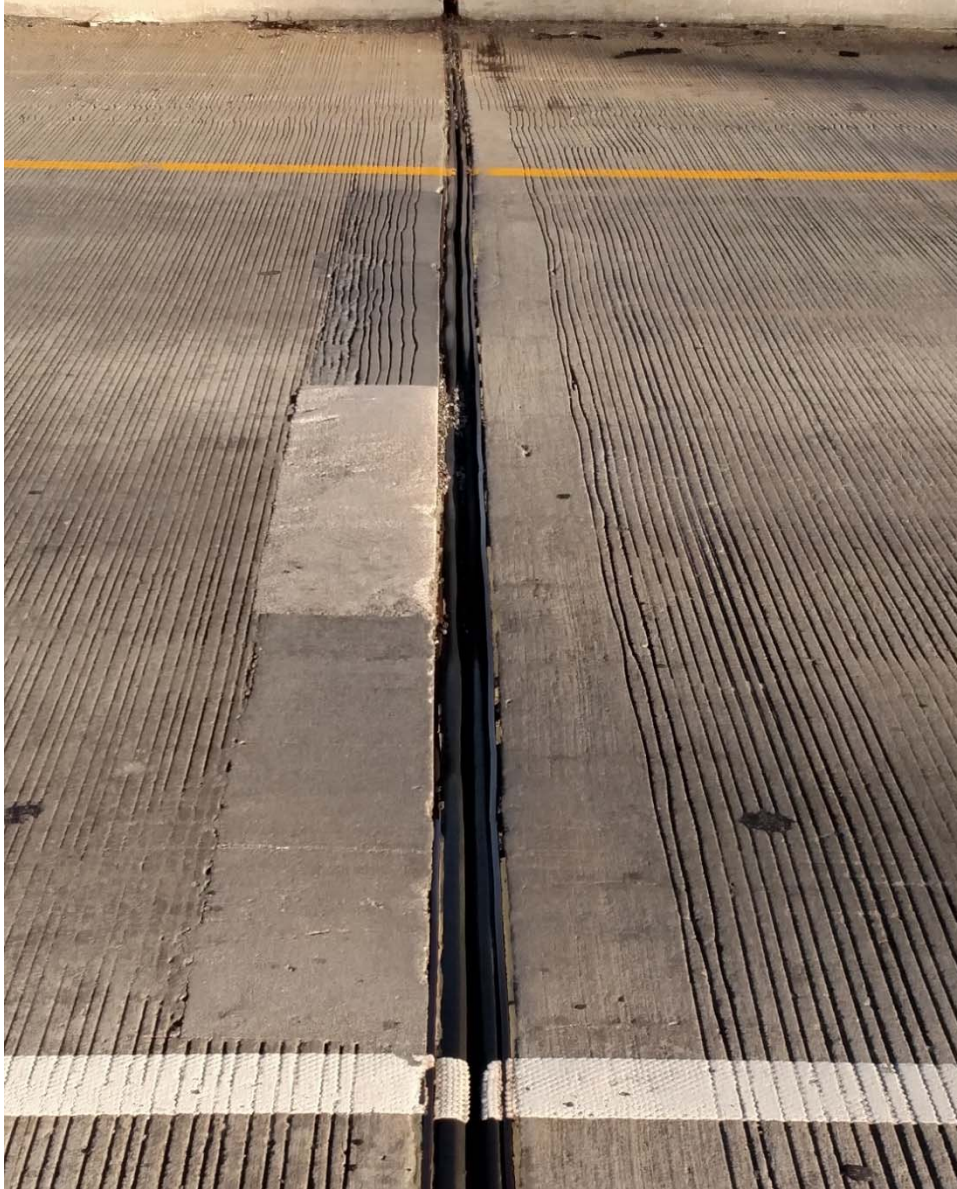
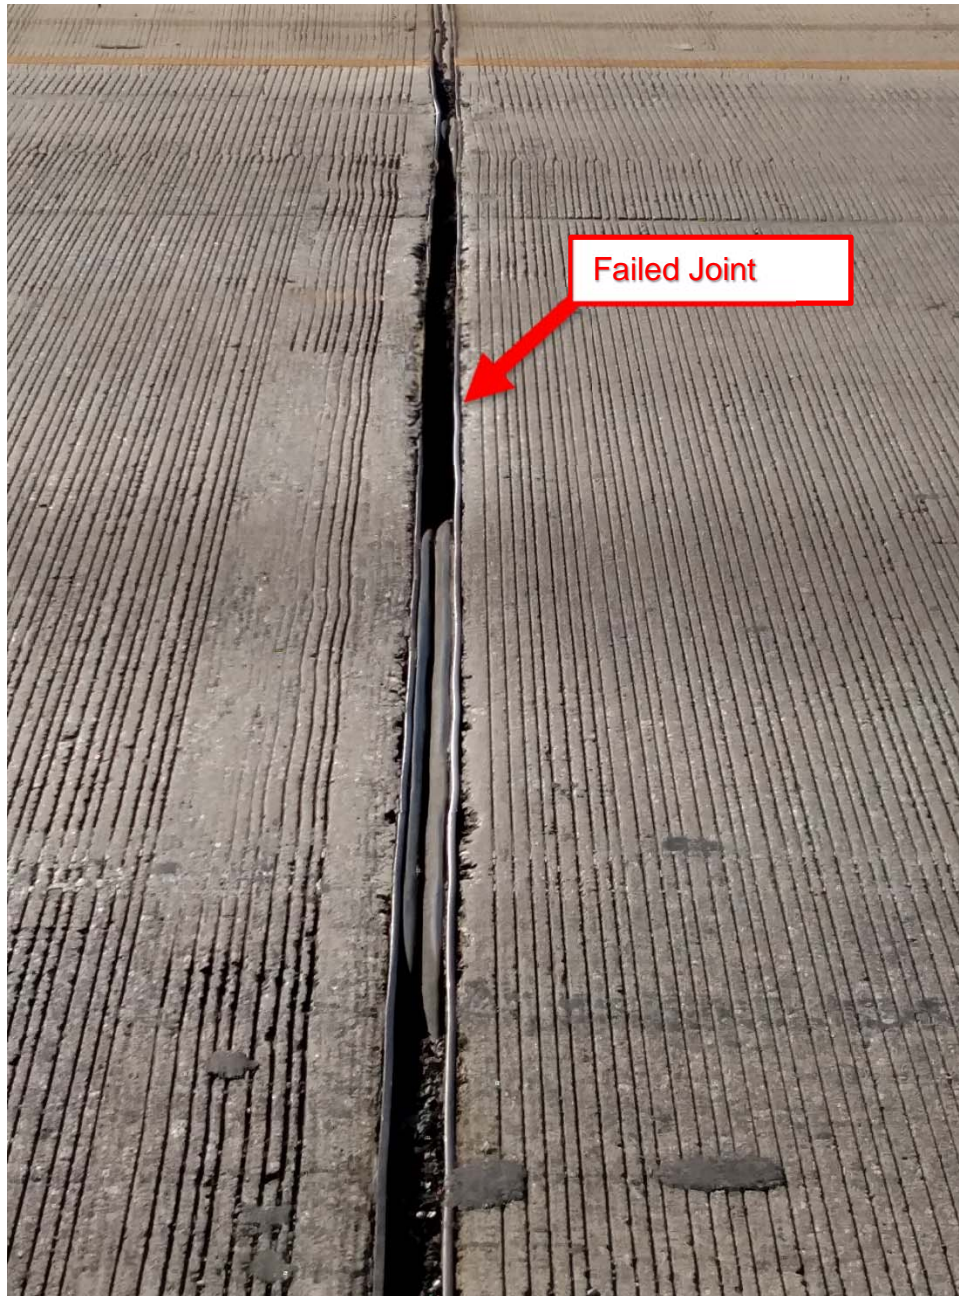
Figure 19 – Compression Seal (Northbound)

Figure 20 – Compression Seal (Southbound)

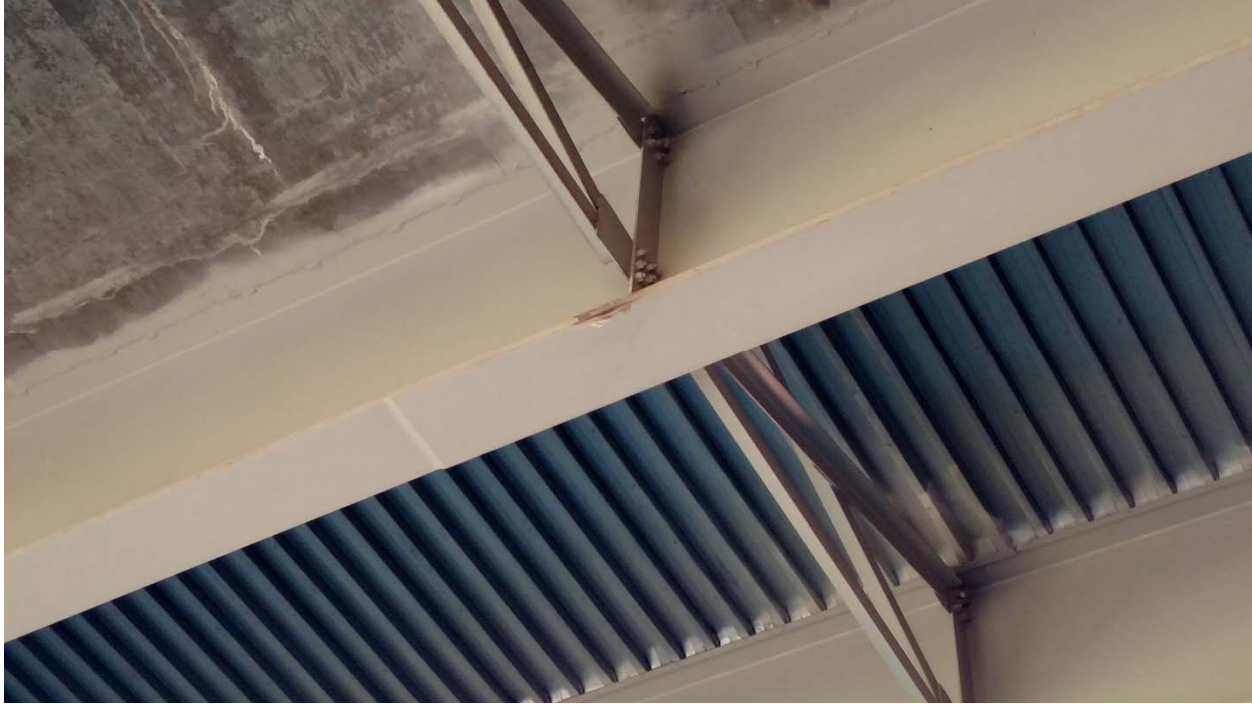
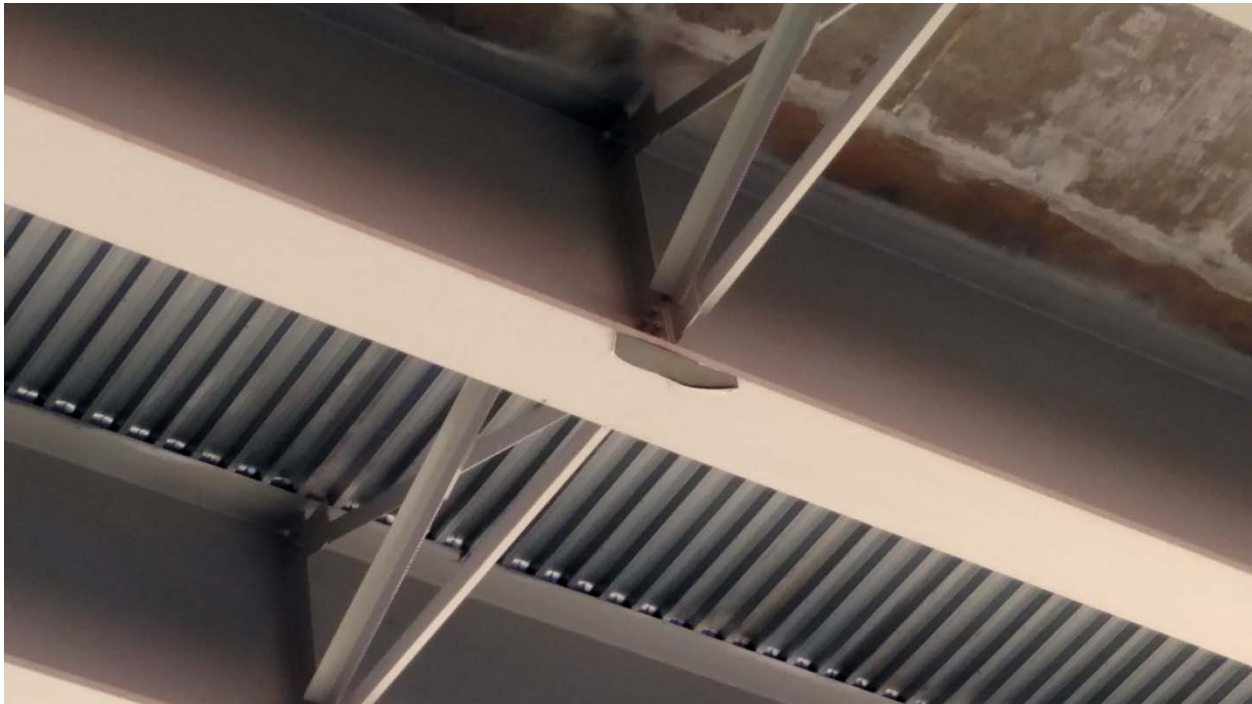
The paint is in excellent condition. There are two locations where paint is peeling (Figures 21 and 22) at cross frame locations. No evidence of warping of the cross frames or girder flanges was noticed.

Figure 21 – Paint Peeling at Cross Frame

Figure 22 – Paint Peeling at Cross Frame

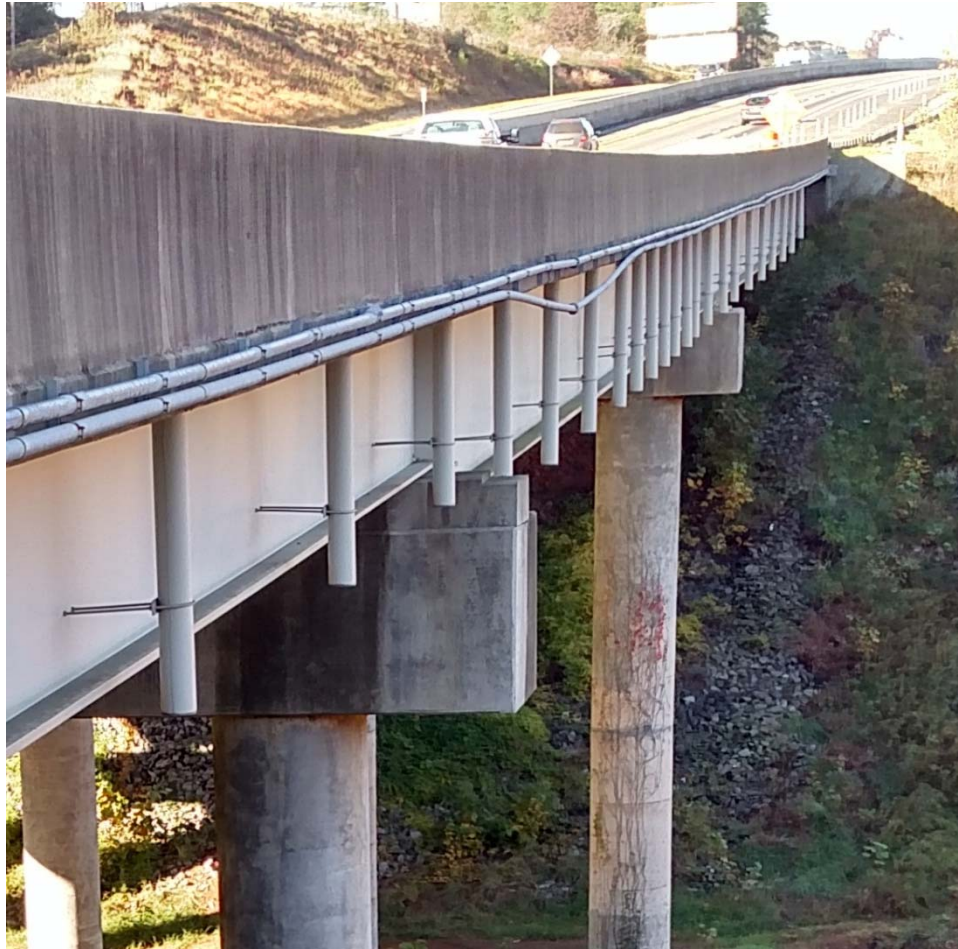
Two utility lines occur on the northern side of the bridge. Most of the anchors attaching the utility lines to the bridge appear to be in good condition. It was noted that one utility line appears to have become detached from the bridge near Bent 3 (Figure 23). No work required to the utility lines.

**Figure 23 – Utility Line detached from Bridge**

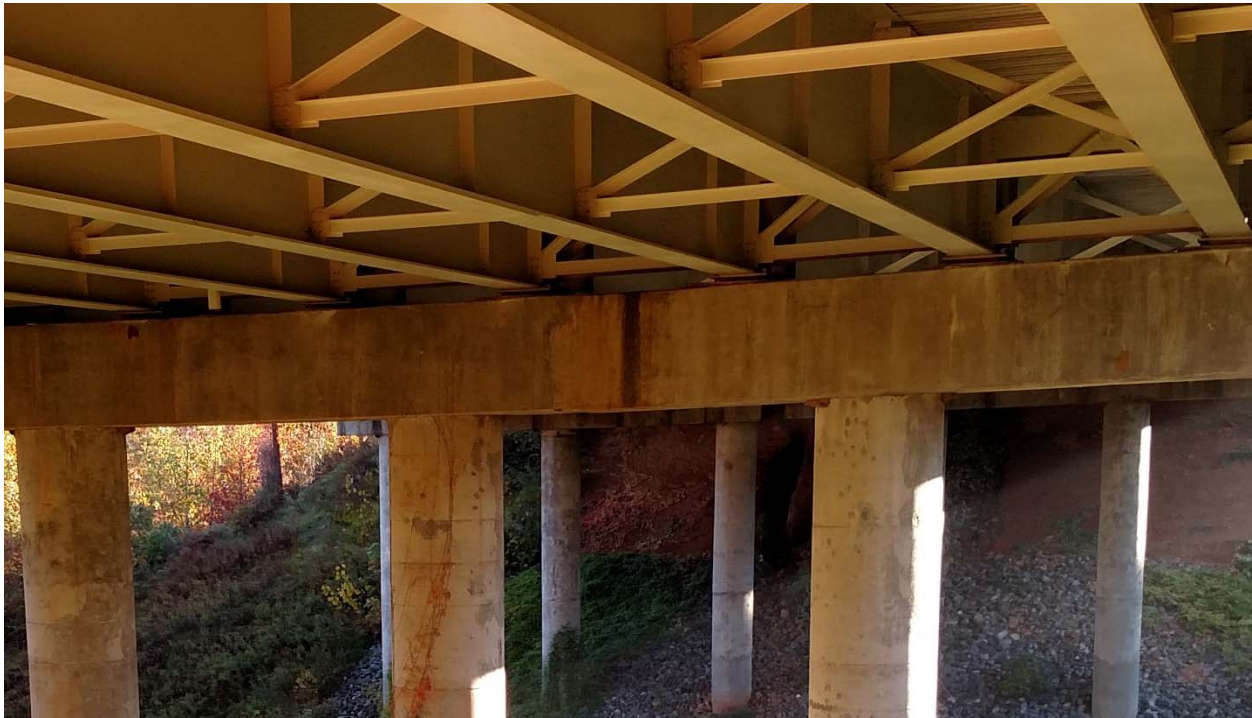
The existing piers are in good condition. The concrete caps for all piers have no noticeable deficiencies. Some staining of the pier caps has occurred and this is the result of the water penetration occurring at the failed expansion joints or the concrete deck closure pours (Figure 24). No delamination or spalling of the pier caps or columns was noticed. No work required at the interior bents.

Figure 24 – Staining at Pier Cap (Southbound)
