# Bridge Assessment Report

## I-85 Over Thicketty Creek

Project ID: P027114

February 26, 2016

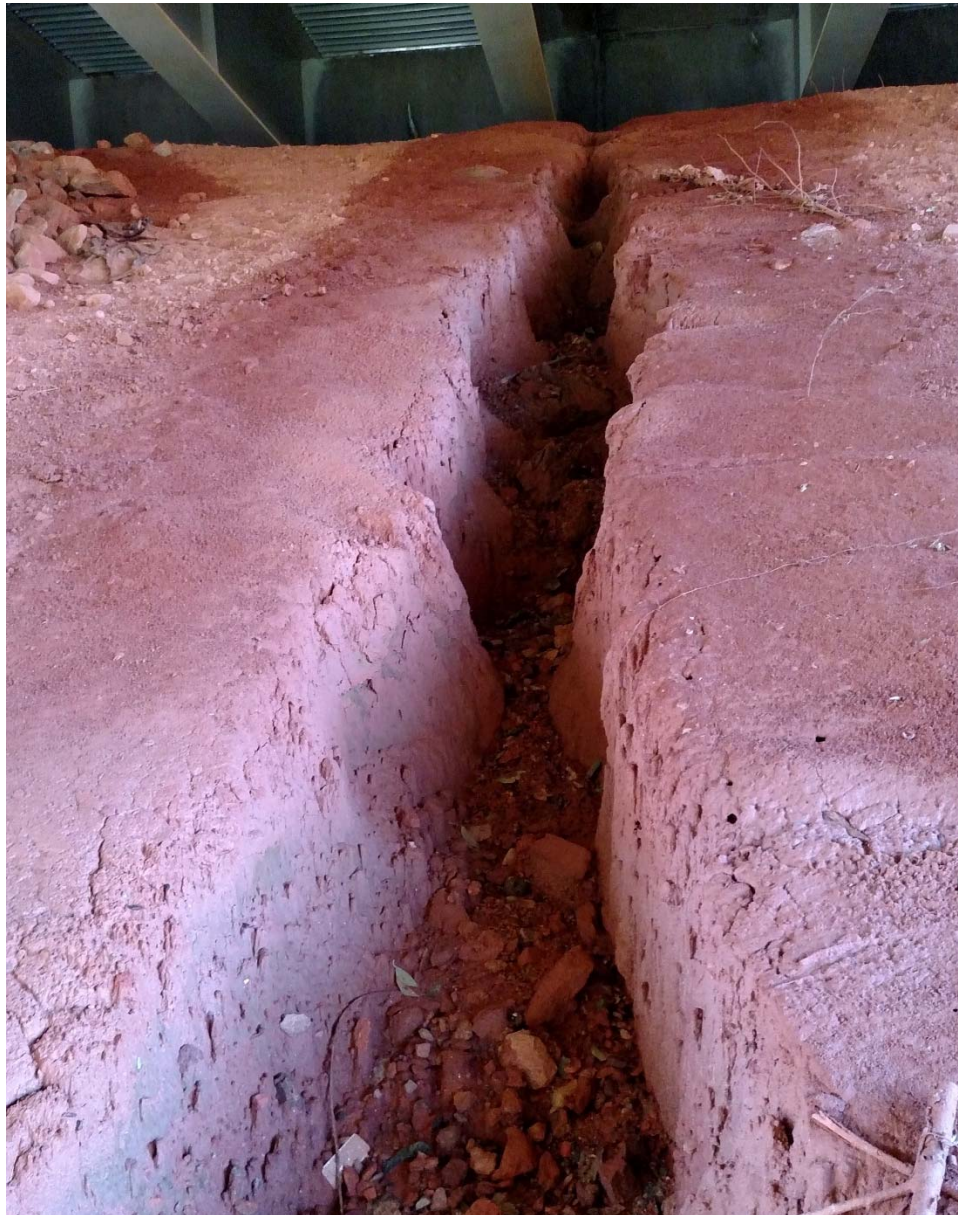
Each embankment at the end bents is experiencing significant erosion, apparently from the water penetrating the concrete deck and from the deck drains. The most severe erosion is occurring at End Bent 4 (Figure 31). The depth of erosion is approximately 5-6 ft deep and several feet wide. It is recommended that the end bent grading and existing riprap be repaired. A large tree growing was also noted at End Bent 1 which needs to be removed (Figure 29). At the bent cap for End Bent 4 (southbound) water infiltration is causing minor erosion at the face of the bent cap and the top of the fill slope. This is occurring on the underside of the bent cap (Figure 32). Refer to Part III below for the full summary of work.

**Figure 27 – Embankment Erosion at I-85 Northbound Closure Pour  
(End Bent 1)**

- The end bent fill slopes shall be repaired to the grade established in the original bridge construction drawings and as indicated in the attached "I-85 over Thicketty Creek Southbound Section".
- All tree/shrub vegetation within 5' of the bridge edge shall be removed.

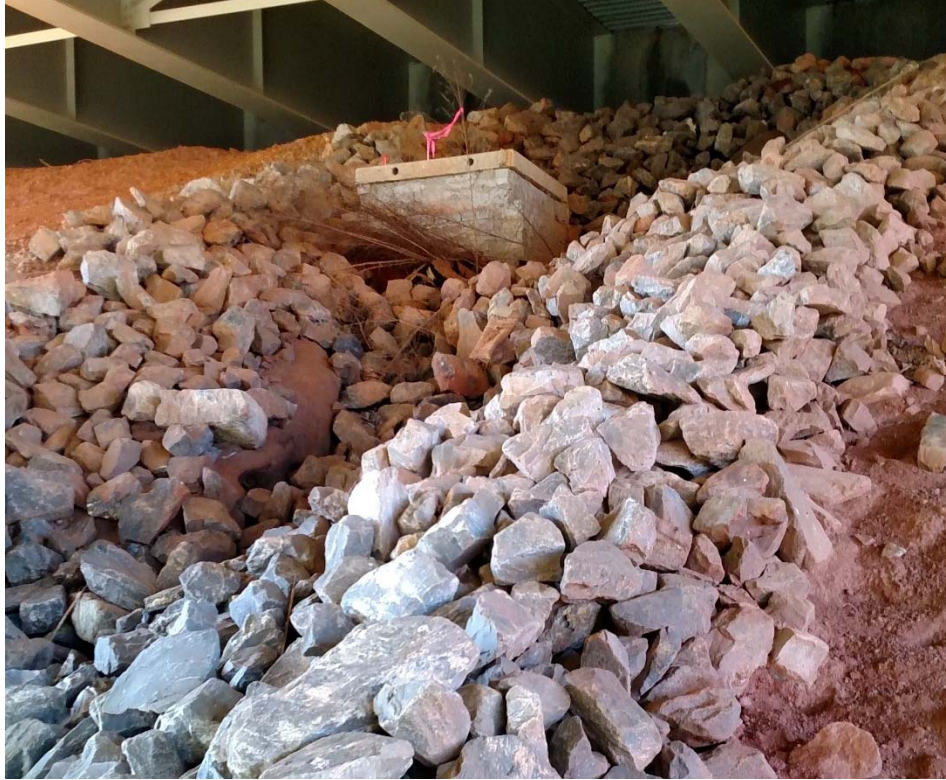
Figure 28 – Erosion at Deck Drains (End Bent 1)

- A closed drainage system shall be added to capture the water of the 3 deck drain pipes nearest to each end bent. The closed drainage system shall conform to the notes and schematic details shown in the attached "Deck Drainage Modifications".

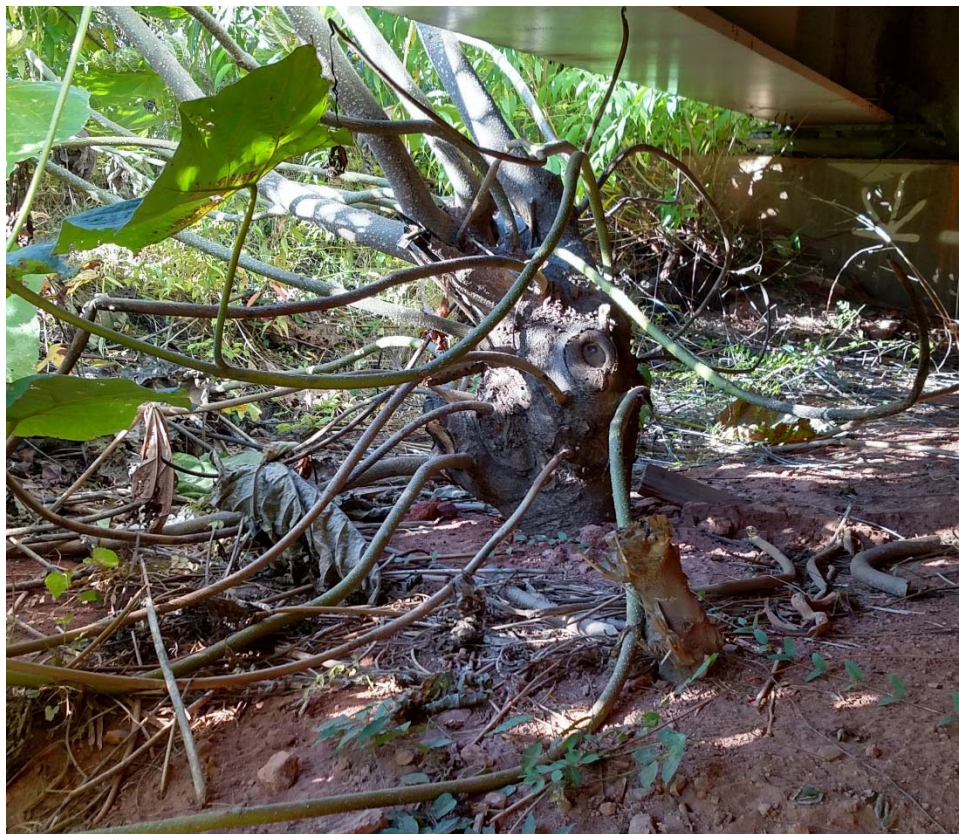
Figure 29 – Tree Growth at End Bent 1

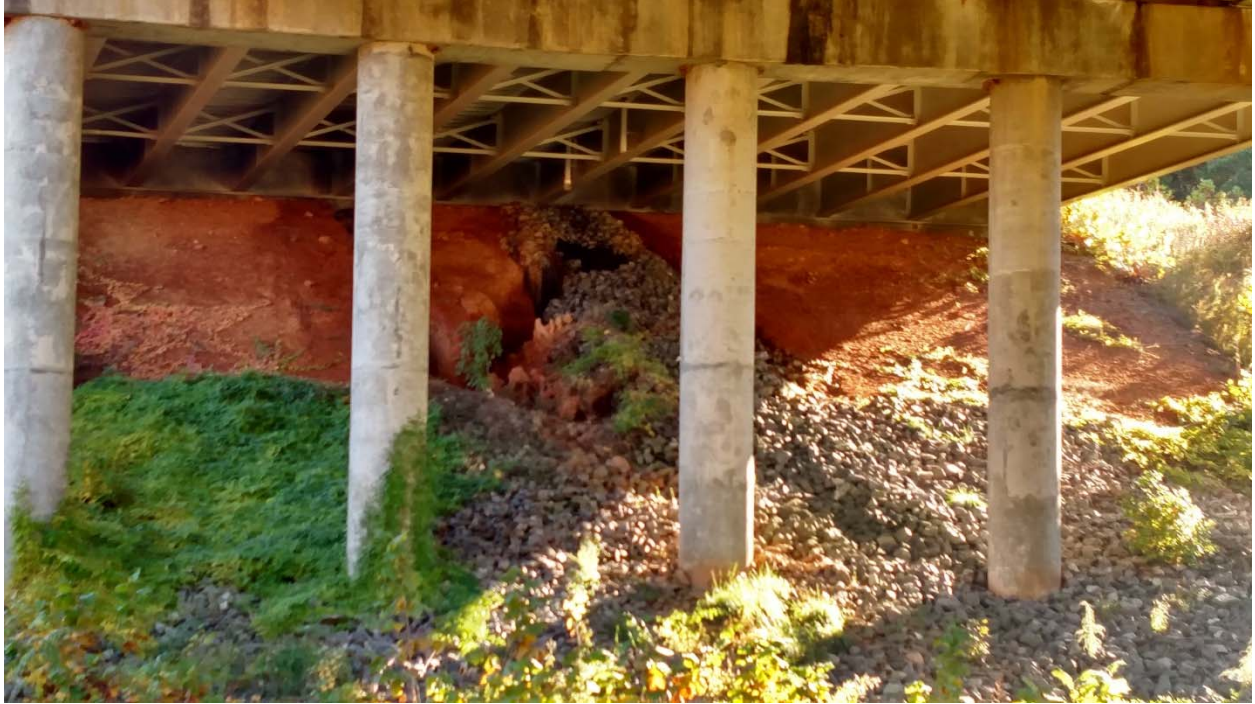
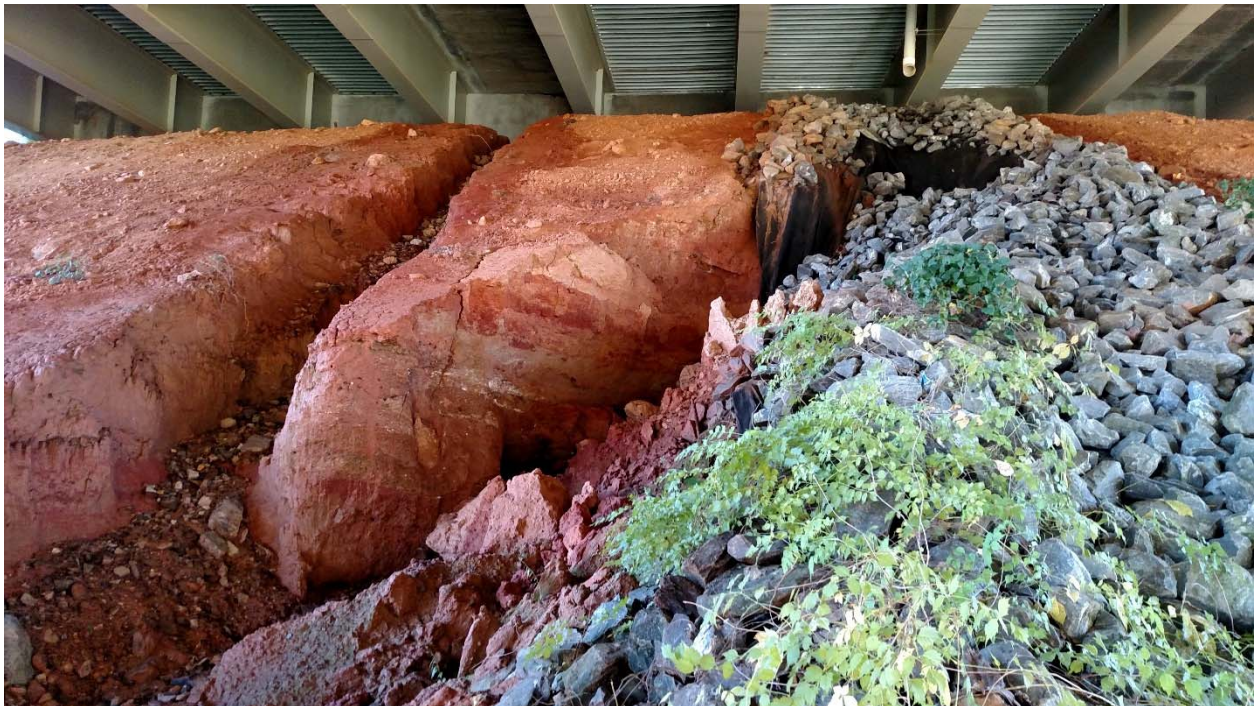
Figure 30 – Embankment Erosion at End Bent 4

Figure 31 – Embankment Erosion at End Bent 4

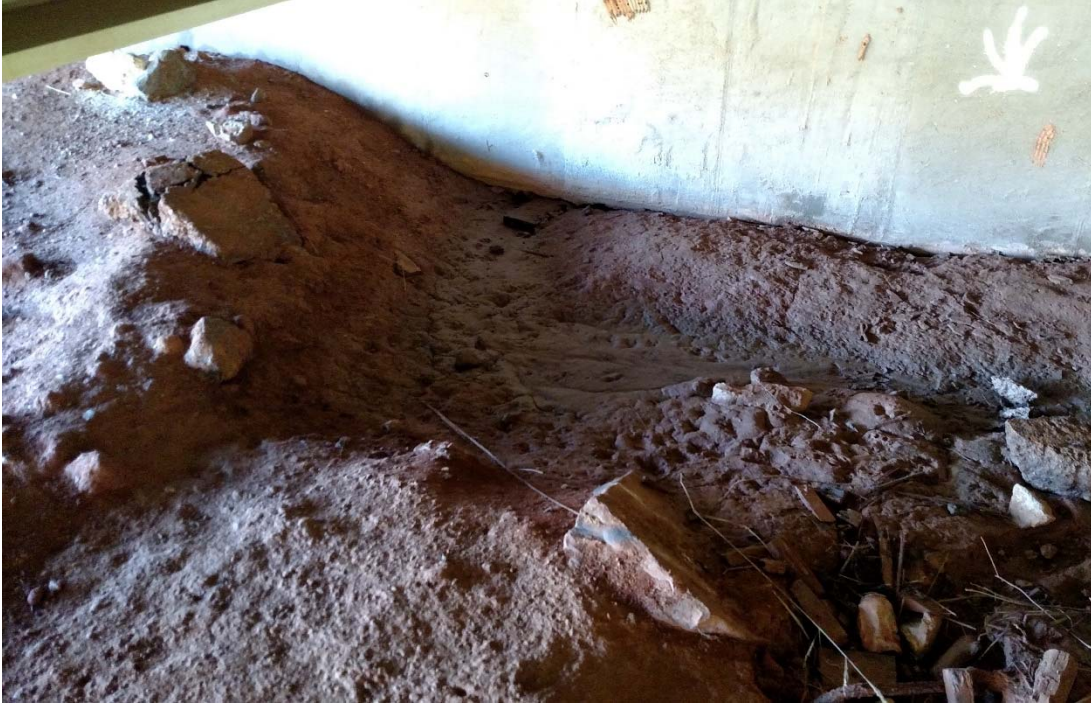
Figure 32 – Water Infiltration under End Bent 4
