## SCDOT BRIDGE INSPECTION FORM

(008) BRIDGE ID: 3210002040300

(005) ROUTE: LEXINGTON I- 20

(006) CROSSING: SOUTHERN RWY &amp; FRTG RD

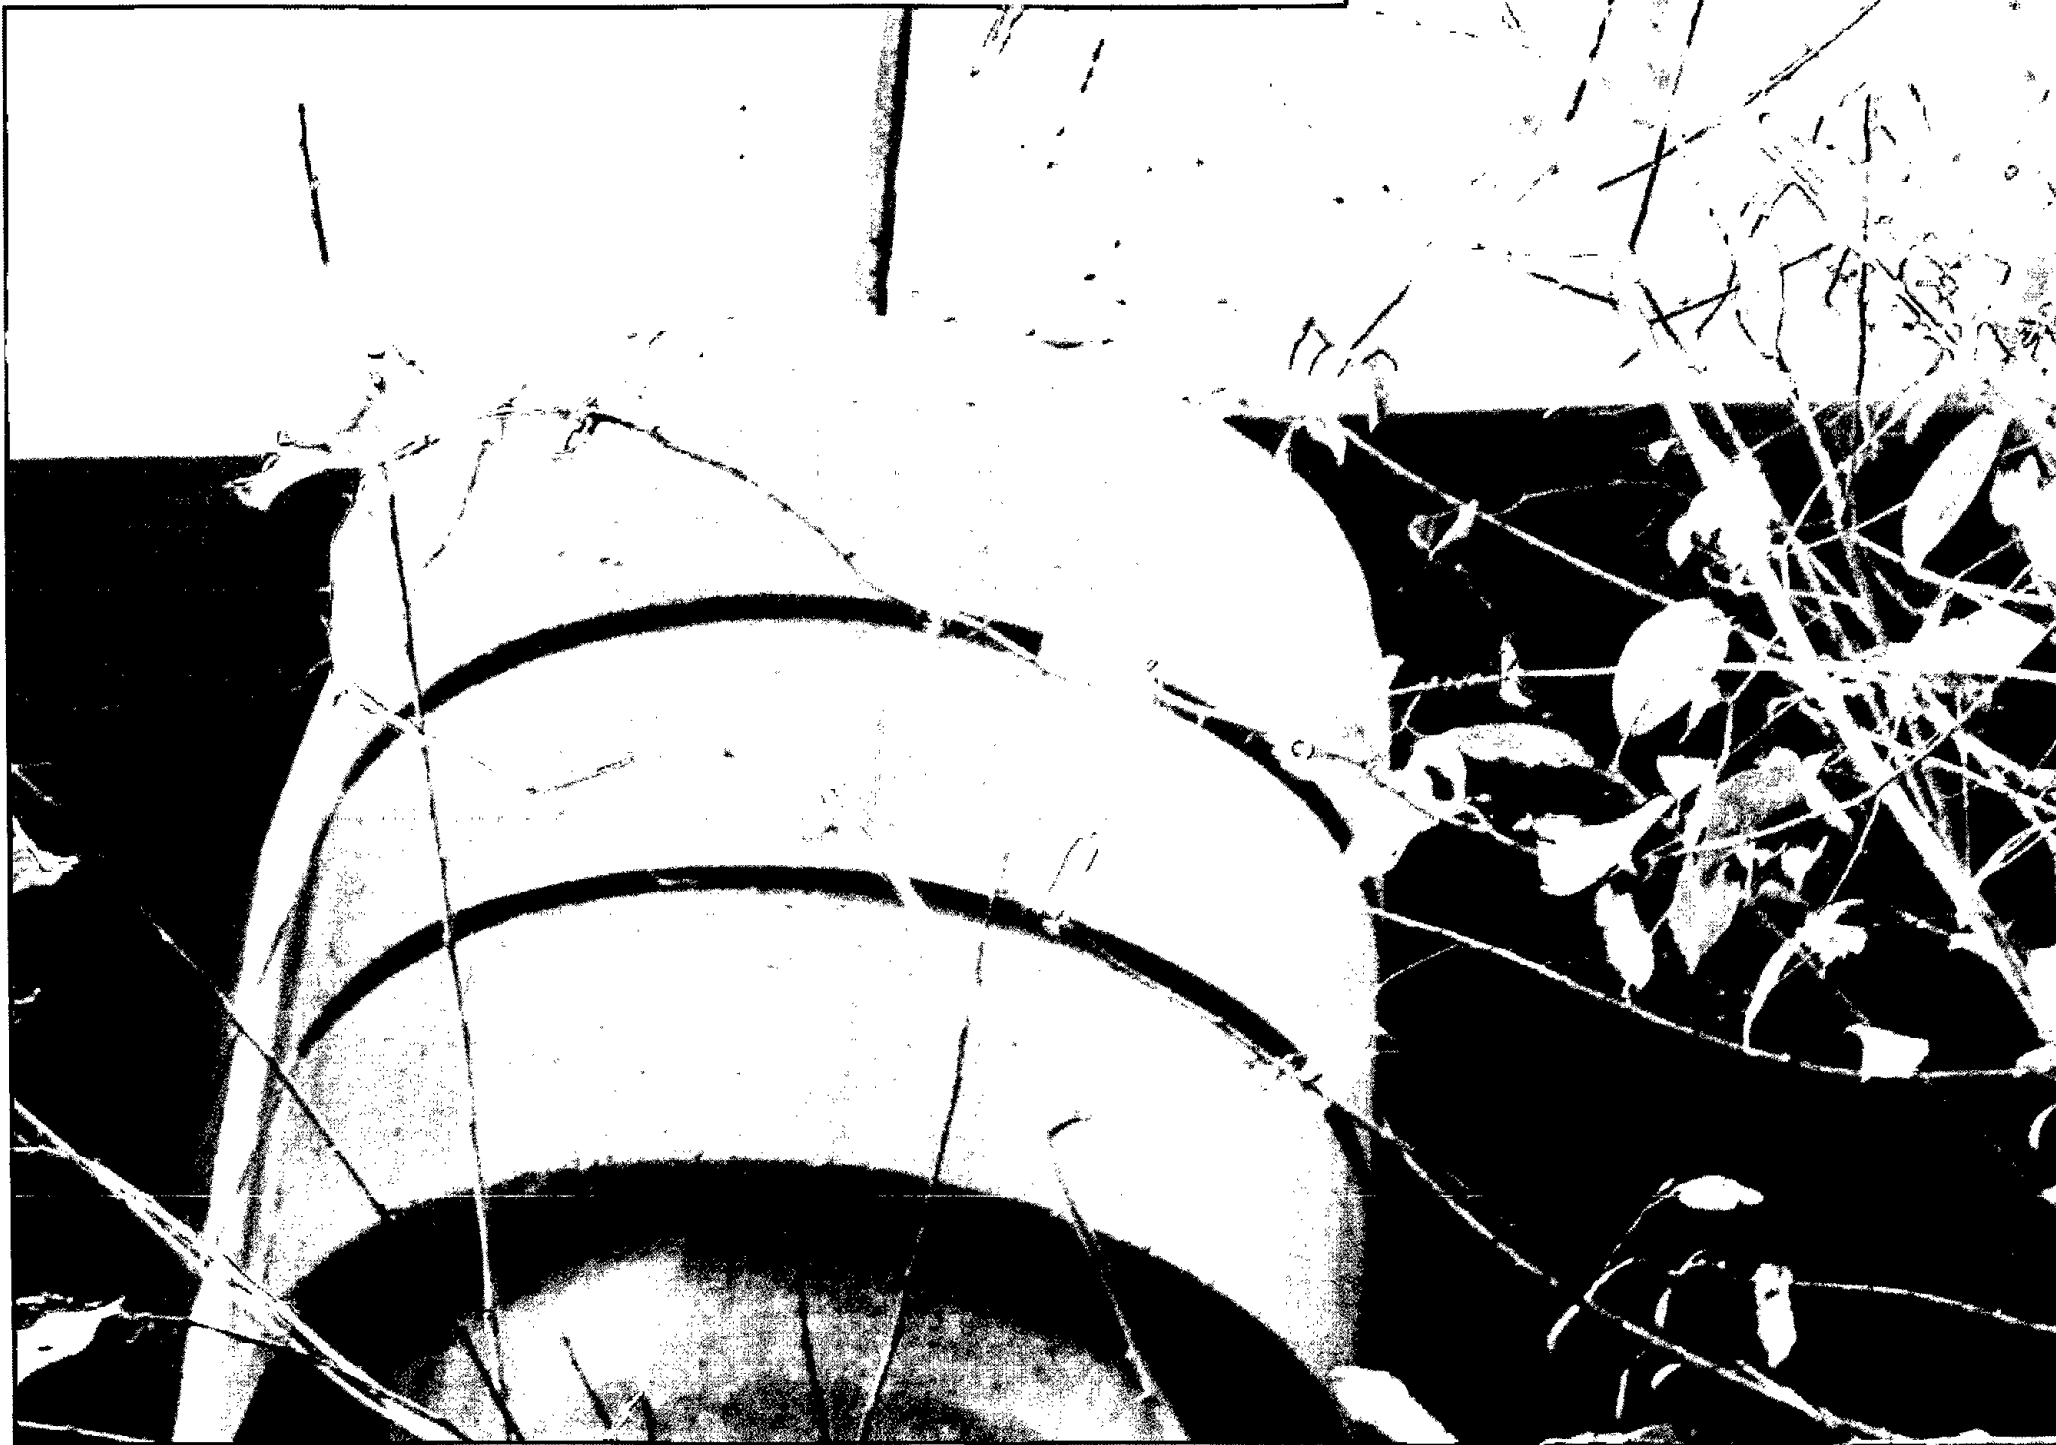
**3210002040300 I-20 Southern R/R & FRT Road 12/3/13**  
**Beam 5 bent 2 span 1 has a large spall w/rust.**

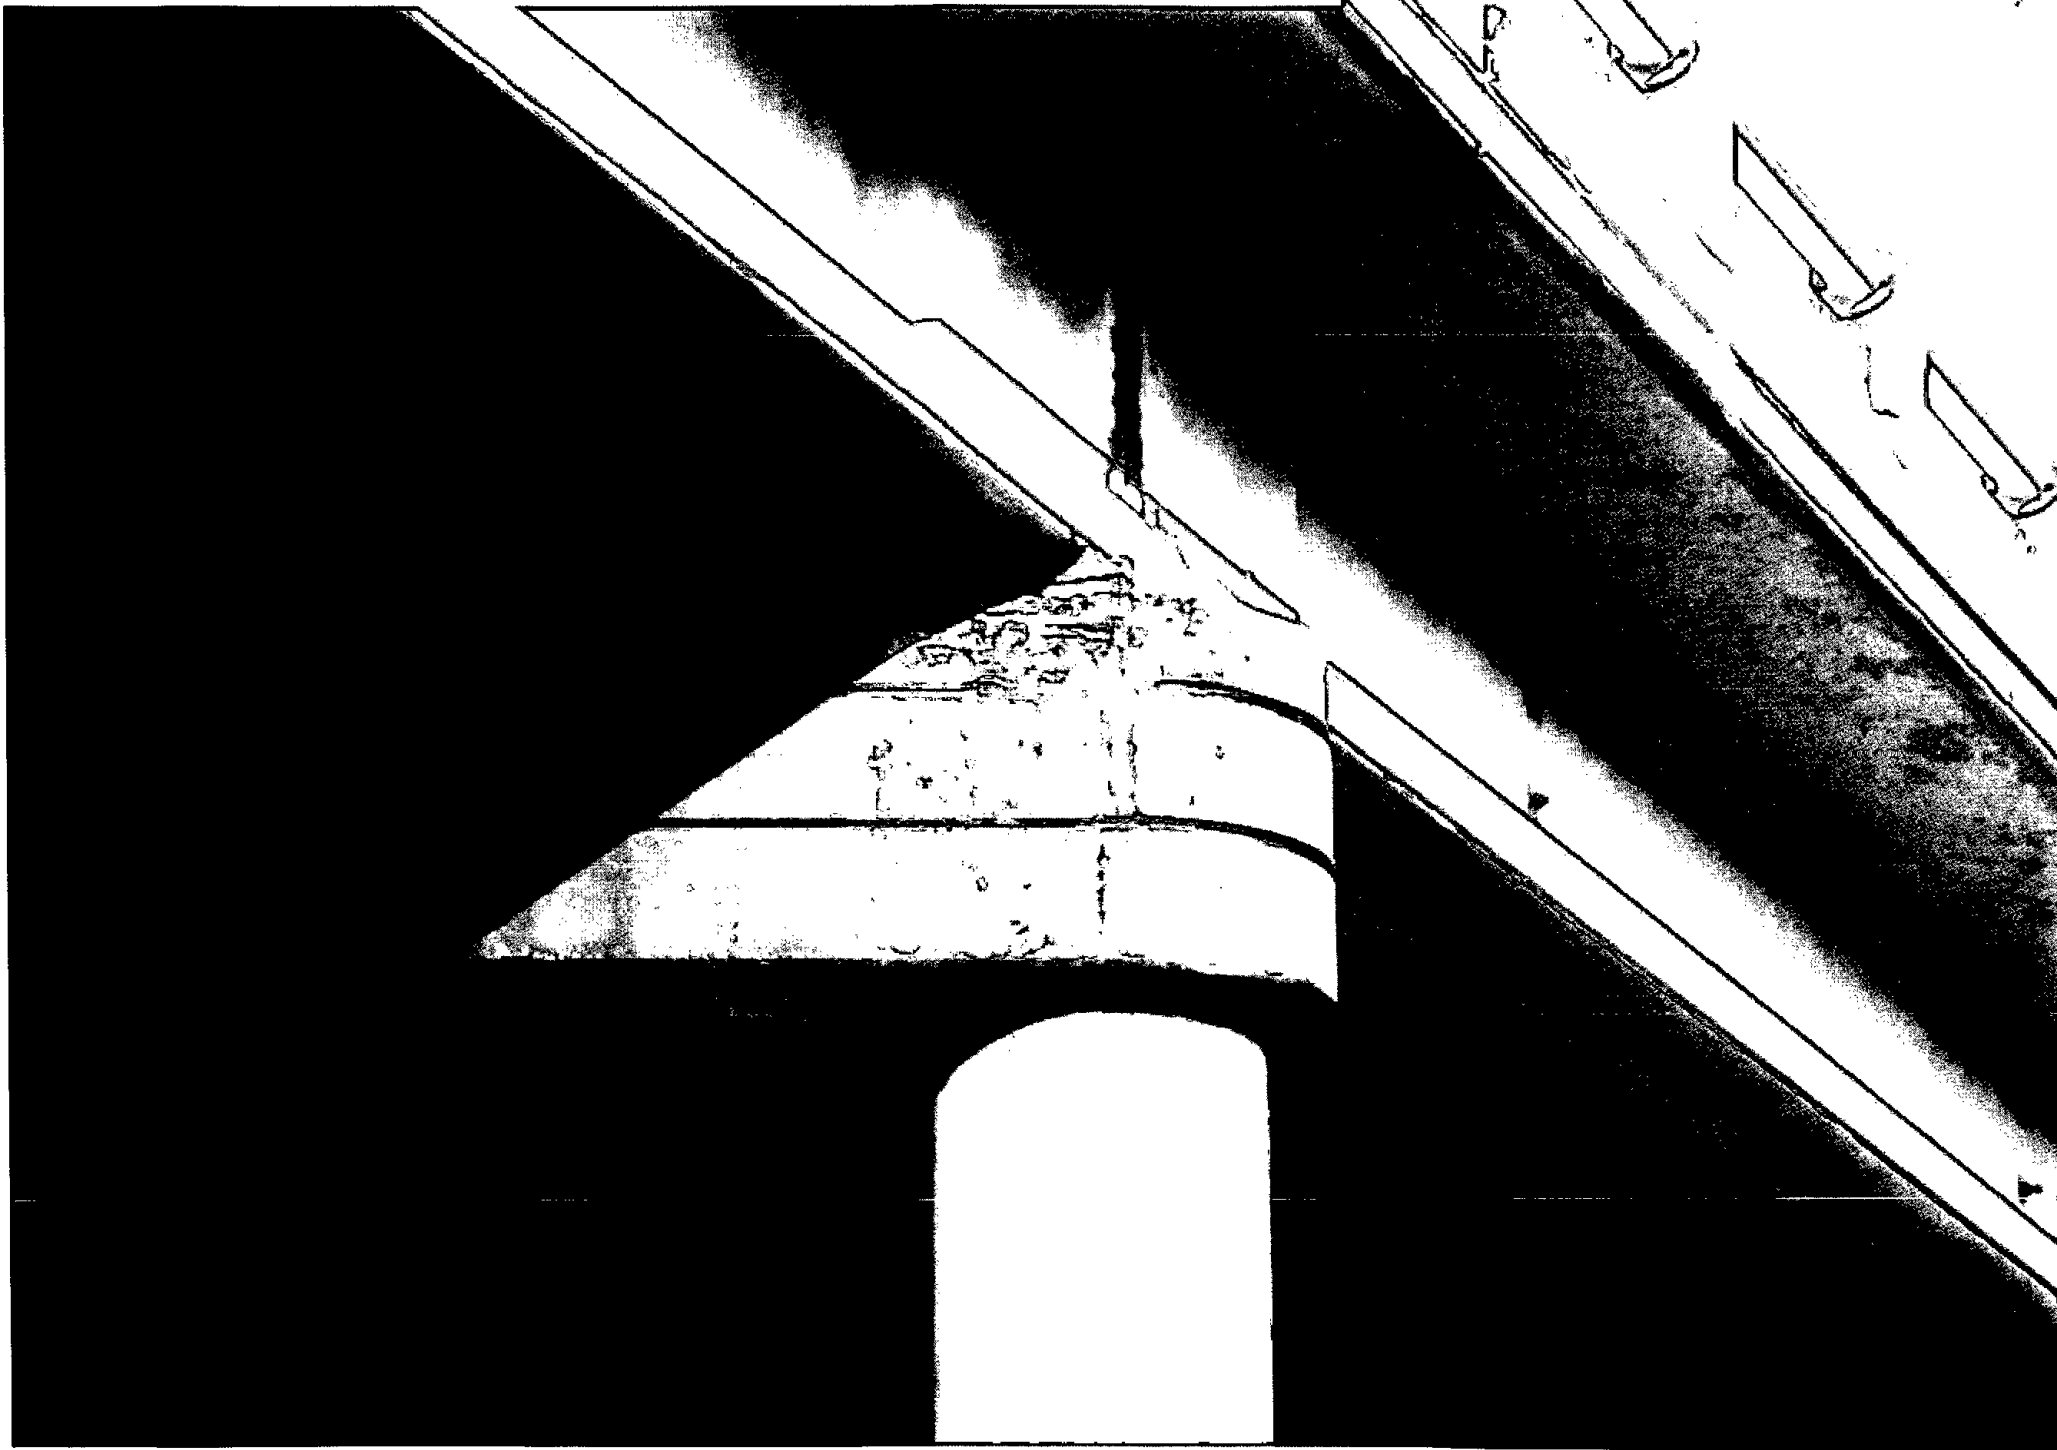
Large spall w/rust under beam 5, 1'x3', West side, (see photo).

**3210002040300 I-20 Southern R/R & FRT Road 12/3/13**  
**Bent 4 has a large spall w/rust under beam 5, West side.**
