SCDOT BRIDGE INSPECTION FORM

(008) BRIDGE ID: 3210002020300
(005) ROUTE: LEXINGTON I- 20
(006) CROSSING: SOUTHERN RWY & FRTG RD

(009) LOCATION: 3MI E OF LEX
(026) FUNCTIONAL CLASS: 11

Bridge ID: 32-1-00020-2-03-00

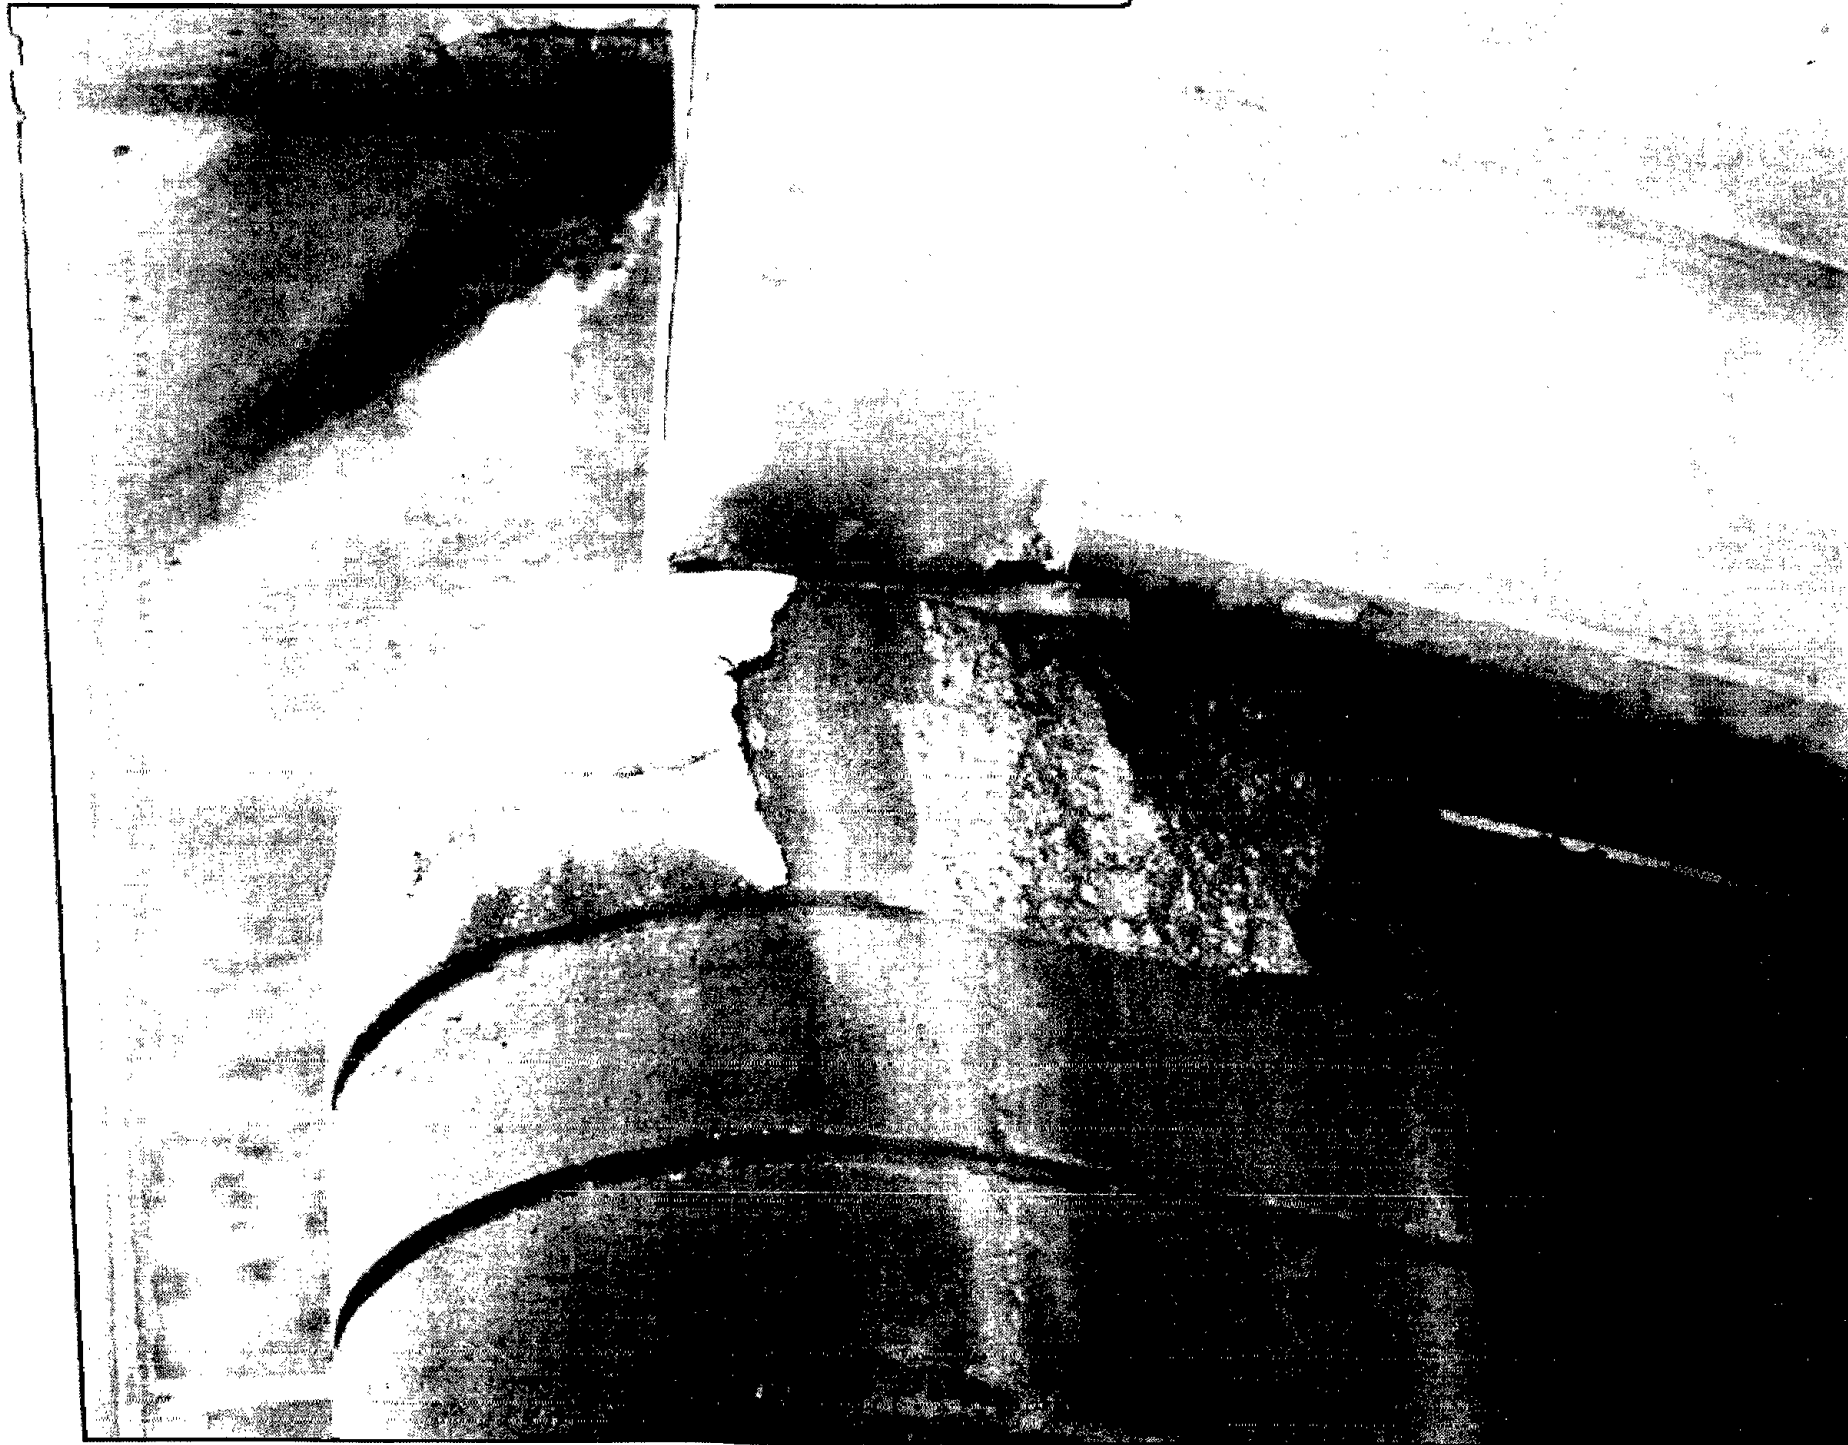
Large spalls w/rust under beam 1, 1'x2', West side, (see photo).

3210002020300 I-20 Southern R/R & FRT Road 12/3/13
Bent 4 has a large spall w/rust under beam 1, West side.

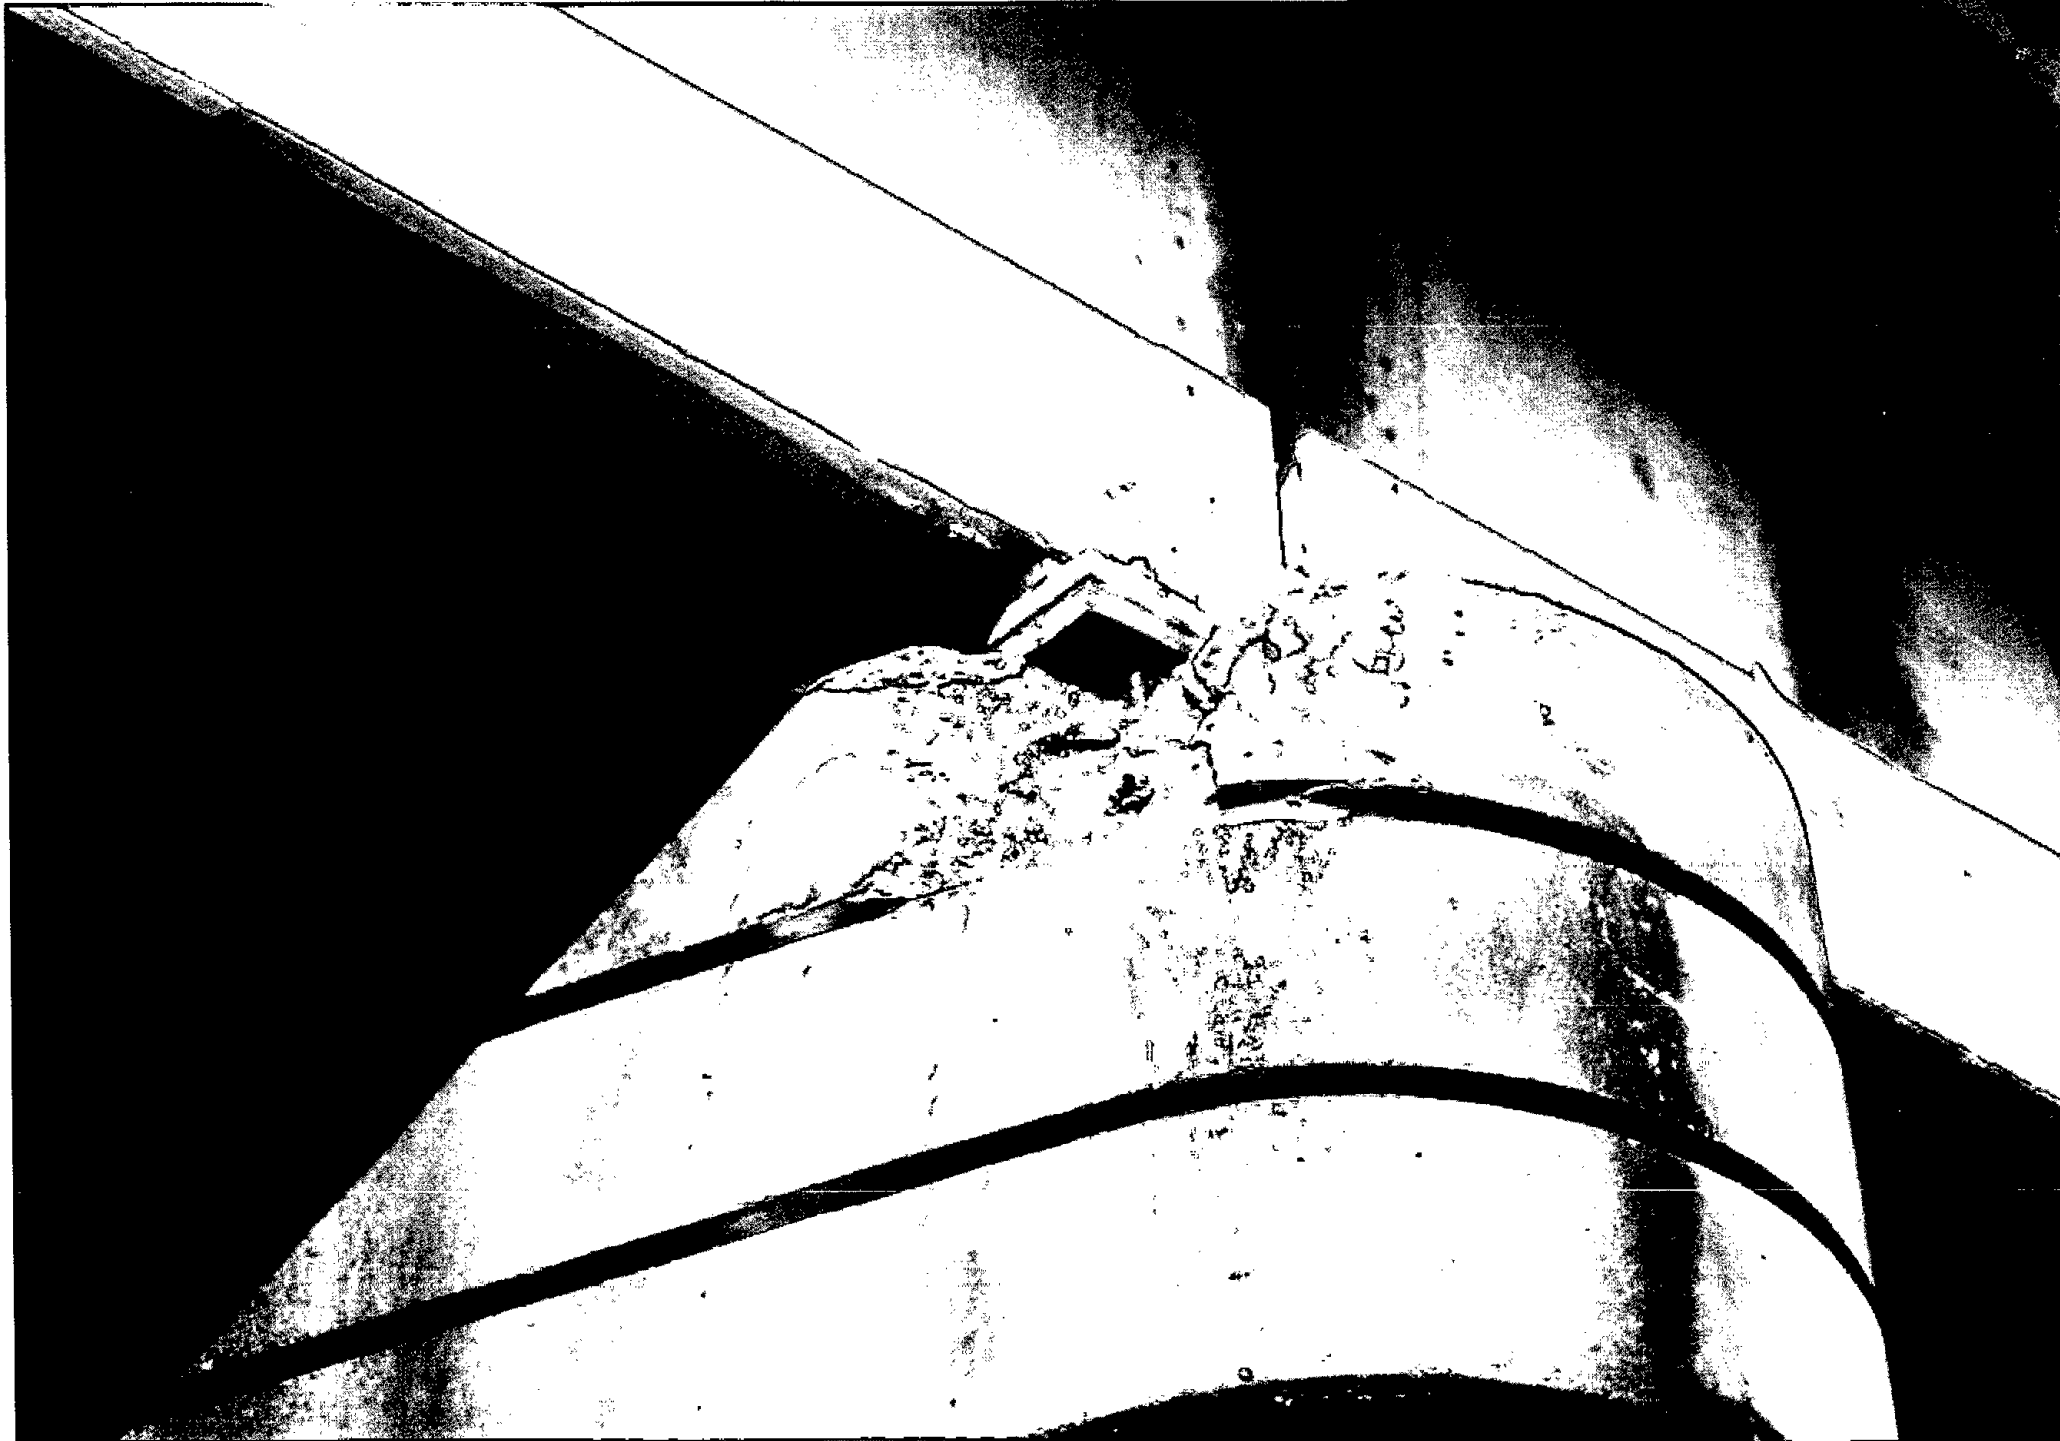
Large spalls w/rust under beam 5, 1'x3', West side, (see photo).

3210002020300 I-20 Southern R/R & FRT Road 12/3/13
Bent 4 has a large spall w/rust under beam 5, West side.
