## LEAD-BASED PAINT INVESTIGATION REPORT

US-1 BRIDGE OVER I-20  
LEXINGTON COUNTY, SOUTH CAROLINA

**March 25, 2019**

F&ME Project No.: G6018.000

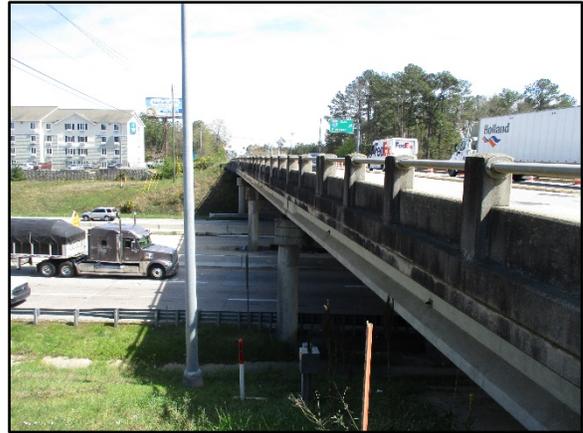
*Photo 1 – US-1 Bridge over I-20 in Lexington, SC.*

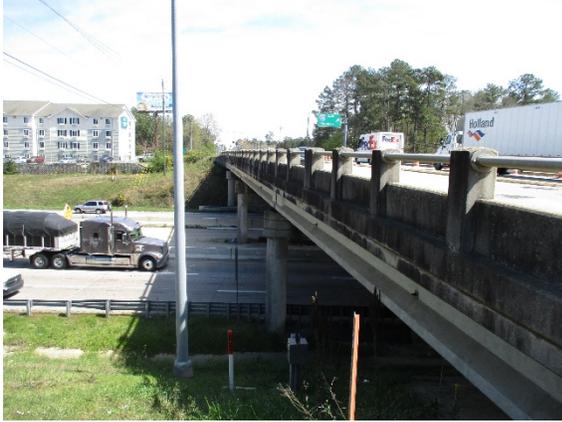
**Photo 1.** North Side View of Bridge

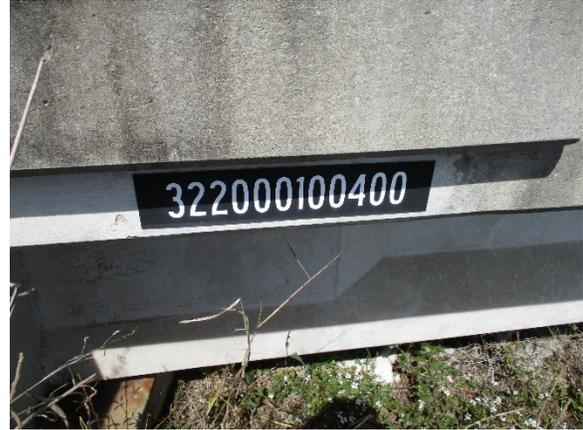
**Photo 2.** SCDOT Bridge Number

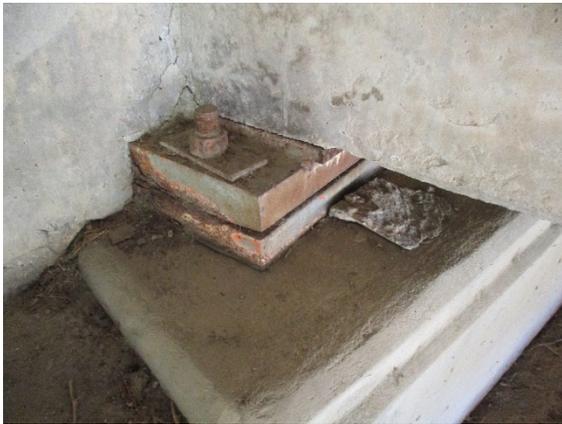
The results from this LBP Investigation indicate that lead is present in paint and/or coatings at levels that equal to or exceed the SCDHEC threshold limit for lead ( $0.7 \text{ mg/cm}^2$ ) on the metal, tie rod washers, and the rod bolts. Refer to the XRF Data Summary Table found in Appendix C for results of XRF scanning.

**Photo 3.** LBP Positive Bent Plate

Components found to contain lead should be handled appropriately. It is recommended that work tasks which require grinding, sanding, cutting torch, or other disturbance of the LBP surfaces identified herein be performed in accordance with federal regulations pertaining to worker protection from exposure to LBP. When lead containing items are disturbed or begin to decay, they become a concern regarding human health and the environment. The typical routes of exposure to lead are through the inhalation or ingestion of lead-contaminated materials. Minimal risk of exposure exists where the lead-containing paint and coating are intact (e.g., has not been aerosolized, free of chipping or flaking, etc.).

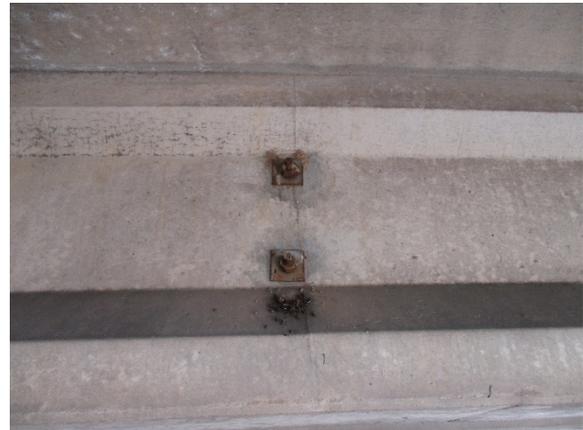
**Photo 4.** LBP Positive Tie Rod Washer

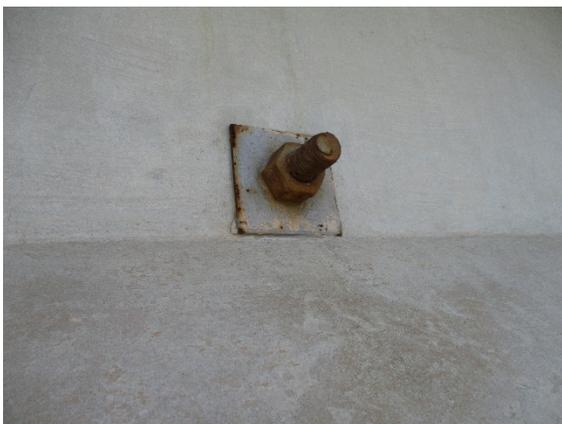
**Photo 5.** LBP Positive Tie Rod Bolt
