Re: Report of Permanent Pipe Camera Inspection - **REVISED**  
US 1 RBO I-20  
Lexington County, South Carolina  
SCDOT Project ID: P030711  
F&ME Project No.: G6018

US 1 Replace Bridge over I-20 - Pipe Culvert Inspection Recommendations

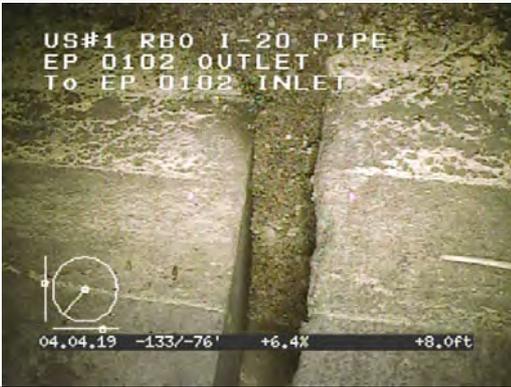
Distance	Fault Observation	Time	Picture
8.0	<b>Roots Fine Joint</b> <b>Position: 7</b> <b>Severity: None</b> <b>Joint</b> <b>Maint Weight: 1</b>	07:37

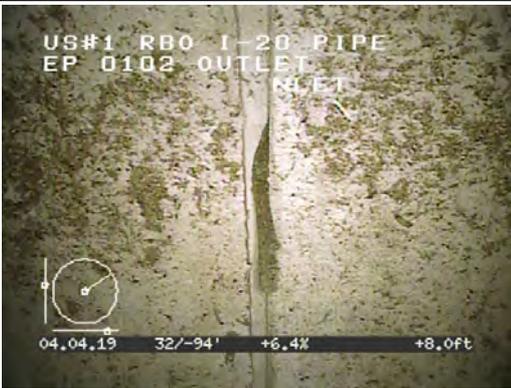
8.0	<b>Roots Fine Joint</b> <b>Position: 2</b> <b>Severity: None</b> <b>Joint</b> <b>Maint Weight: 1</b>	08:08

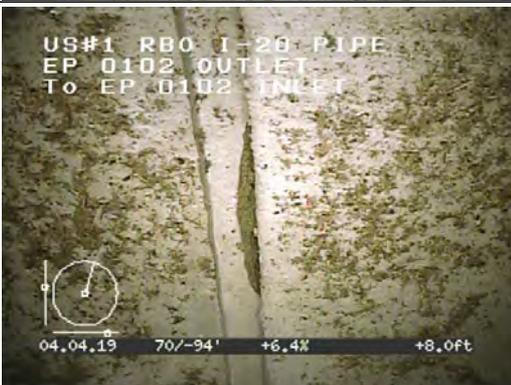
8.0	<b>Roots Fine Joint</b> <b>Position: 1</b> <b>Severity: None</b> <b>Joint</b> <b>Maint Weight: 1</b>	08:25

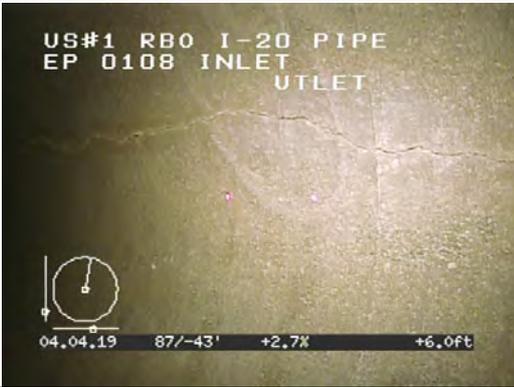
Distance	Fault Observation	Time	Picture
6.0	<b>Crack Longitudinal</b> <b>Position: 12</b> <b>Severity: None</b> <b>Joint</b> <b>Struct Weight: 2</b>	03:51

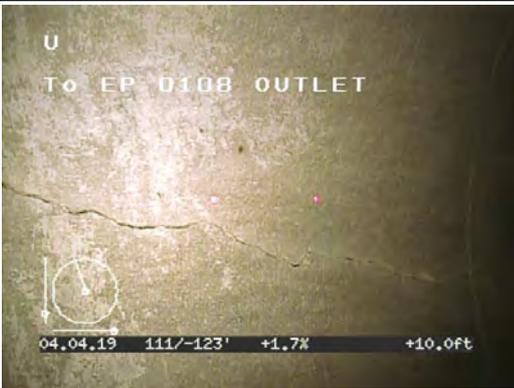
<p>US#1 RBO I-20 PIPE EP 0108 INLET UTLET</p> <p>04.04.19 87/-43' +2.7% +6.0ft</p>
10.0	<b>Picture Number: 2</b> <b>Crack Longitudinal</b> <b>Position: 12</b>	0

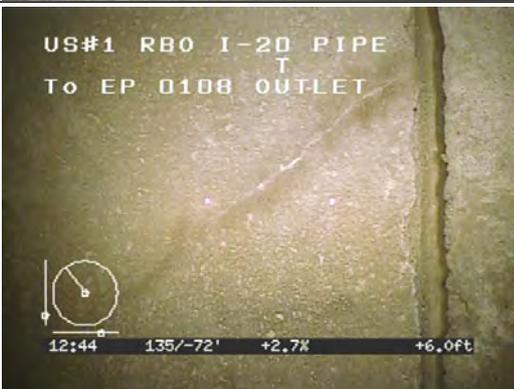
<p>U To EP 0108 OUTLET</p> <p>04.04.19 111/-123' +1.7% +10.0ft</p>
6.0	<b>Crack Longitudinal</b> <b>Position: 11</b> <b>Severity: None</b> <b>Joint</b> <b>Struct Weight: 2</b>	04:21

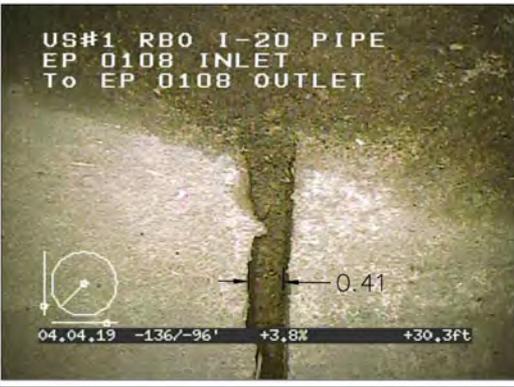
Distance	Fault Observation	Time	Picture
30.4	<b>Roots Fine Joint</b> <b>Position: 7</b> <b>Severity: None</b> <b>Joint</b> <b>Maint Weight: 1</b>	13:18

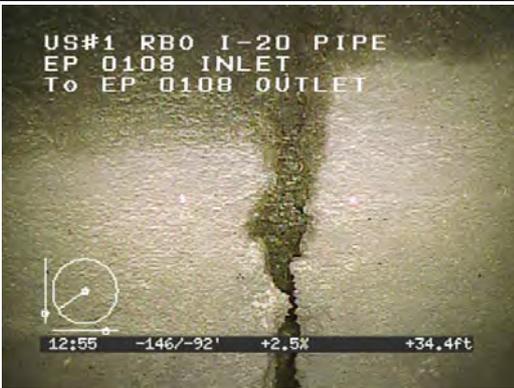
34.4	<b>Roots Fine Joint</b> <b>Position: 7 To 8</b> <b>Severity: None</b> <b>Joint</b> <b>Maint Weight: 1</b>	14:45

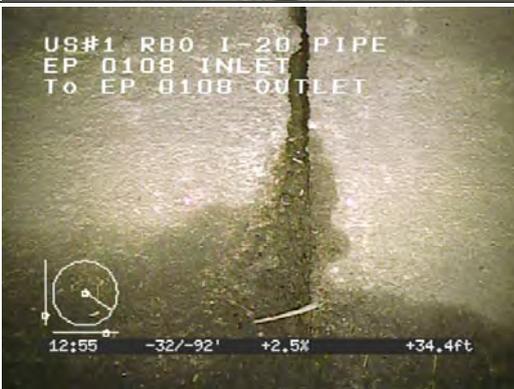
34.4	<b>Roots Fine Joint</b> <b>Position: 8</b> <b>Severity: None</b> <b>Joint</b> <b>Maint Weight: 1</b>	15:22

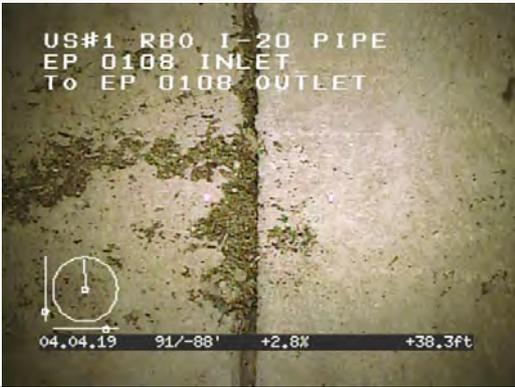
Distance	Fault Observation	Time	Picture
38.3	<b>Roots Fine Joint</b> <b>Position: 12</b> <b>Severity: None</b> <b>Joint</b> <b>Maint Weight: 1</b>	16:16

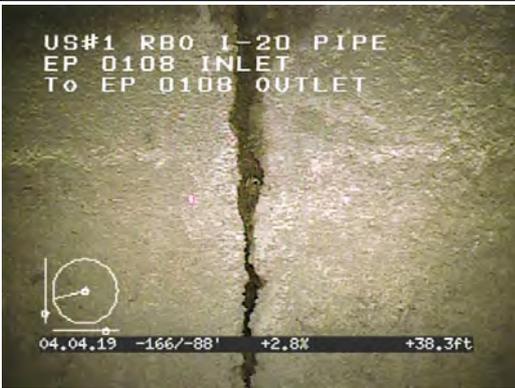
38.3	<b>Roots Fine Joint</b> <b>Position: 8 To 9</b> <b>Severity: None</b> <b>Joint</b> <b>Maint Weight: 1</b>	16:52

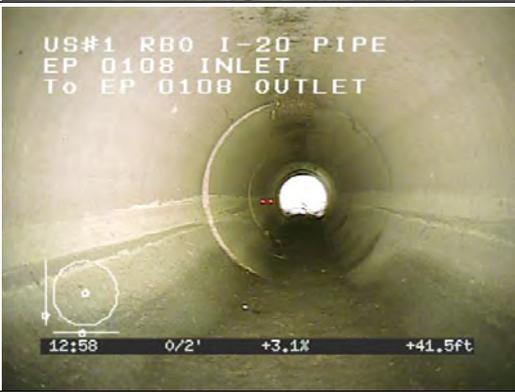
41.5	<b>Obstacle Other</b> <b>Position: 5 To 7</b> <b>Severity: None</b> <b>Cont Defect: F01</b> <b>Percent: 10</b> <b>Remarks: DIRT IN PIPE</b> <b>Maint Weight: 2</b>	17:47

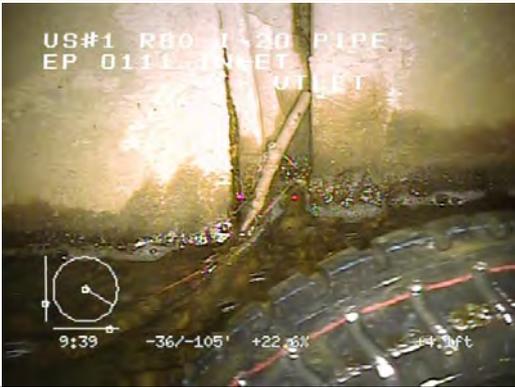
Distance	Fault Observation	Time	Picture
4.1	<b>Roots Fine Joint</b> <b>Position: 4</b> <b>Severity: None</b> <b>Joint</b> <b>Maint Weight: 1</b>	04:13

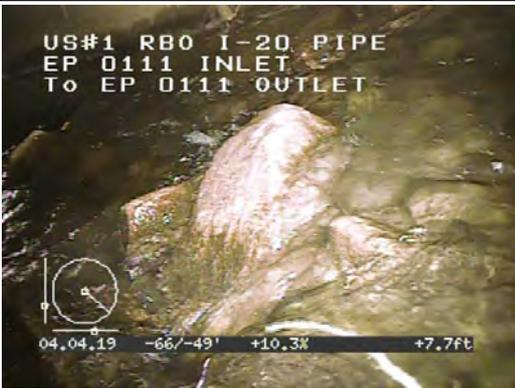
7.7	<b>Obstacle Rocks</b> <b>Position: 5 To 7</b> <b>Severity: None</b> <b>Percent: 10</b> <b>Maint Weight: 2</b>	05:46

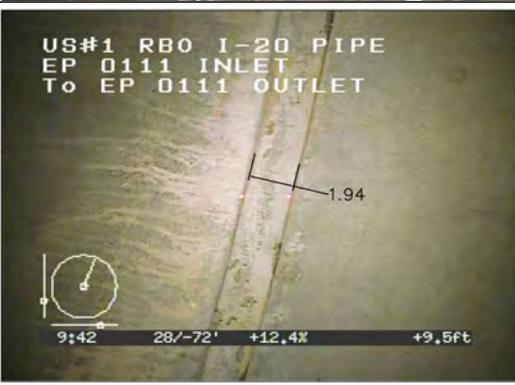
9.5	<b>General Observation</b> <b>Severity: None</b> <b>Remarks: GAP OBSERVATION</b>	07:19

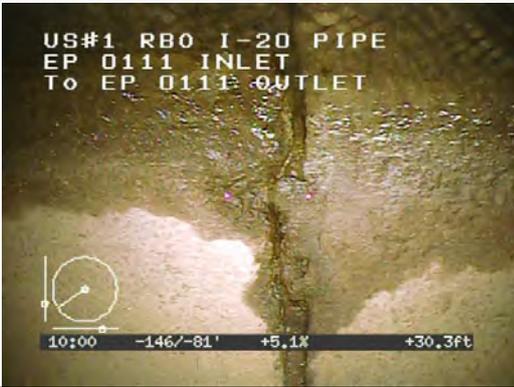
Distance	Fault Observation	Time	Picture
30.3	<b>Roots Fine Joint</b> <b>Position: 8</b> <b>Severity: None</b> <b>Joint</b> <b>Maint Weight: 1</b>	16:40

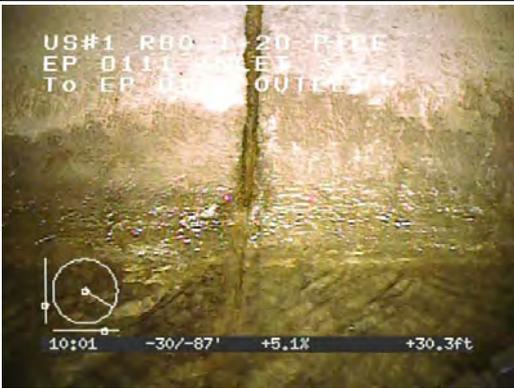
30.3	<b>Roots Fine Joint</b> <b>Position: 4</b> <b>Severity: None</b> <b>Joint</b> <b>Maint Weight: 1</b>	17:29

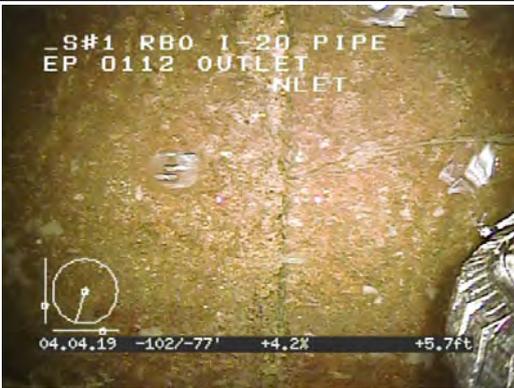
5.8	<p style="text-align: center;"><b>Roots Fine Joint</b>  <b>Position: 6</b>  <b>Severity: None</b>  <b>Joint</b>  <b>Maint Weight: 1</b></p>	03:38

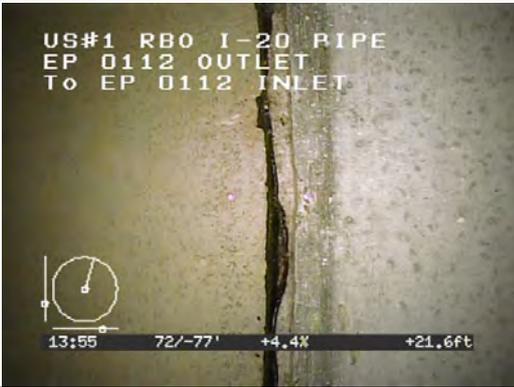
Distance	Fault Observation	Time	Picture
21.6	<b>Intruding Sealing Ring</b> <b>Position: 12 To 2</b> <b>Severity: None</b> <b>Percent: 5</b> <b>Maint Weight: 2</b>	09:15

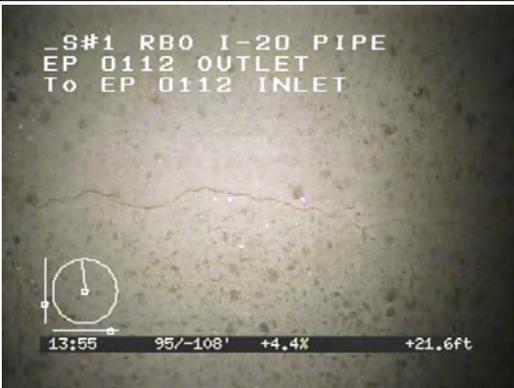
<p>US#1 RBO I-20 PIPE EP 0112 OUTLET To EP 0112 INLET</p> <p>13:55 72/-77' +4.4% +21.6ft</p>
21.6	<b>Crack Longitudinal</b> <b>Position: 12</b> <b>Severity: None</b> <b>Joint</b> <b>Struct Weight: 2</b>	09:30

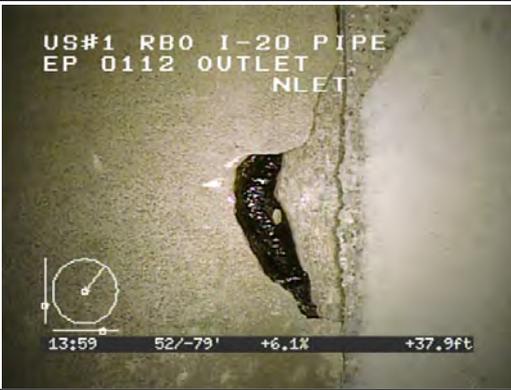
37.9	<p style="text-align: center;"><b>Intruding Sealing Ring</b>  <b>Position: 1 To 1</b>  <b>Severity: None</b>  <b>Percent: 5</b>  <b>Remarks: TAR VISIBLE AT CHIPPED SPIGOT</b>  <b>Maint Weight: 2</b></p>	12:43

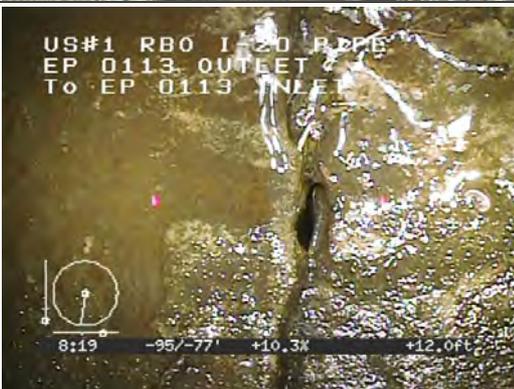
12.0	<p align="center"> <b>Roots Fine Joint</b>  <b>Position: 7</b>  <b>Severity: None</b>  <b>Joint</b>  <b>Maint Weight: 1</b> </p>	07:02

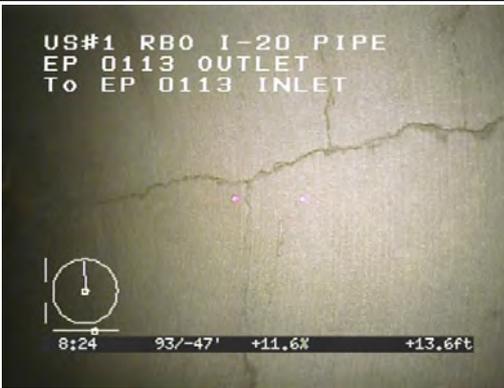
13.6	<p style="text-align: center;"><b>Crack Multiple</b>  <b>Position: 11 To 1</b>  <b>Severity: None</b>  <b>Joint</b>  <b>Struct Weight: 3</b></p>	11:07

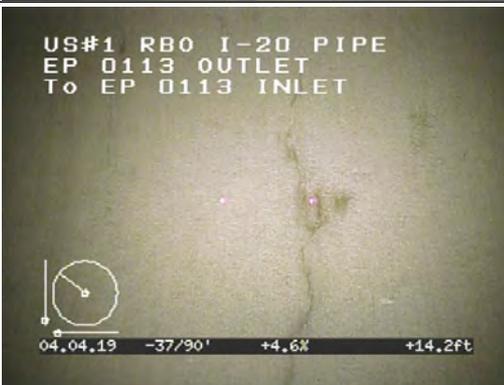
14.3	<p style="text-align: center;"><b>Crack Circumferential</b>  <b>Position: 9 To 11</b>  <b>Severity: None</b>  <b>Struct Weight: 1</b></p>	10:10

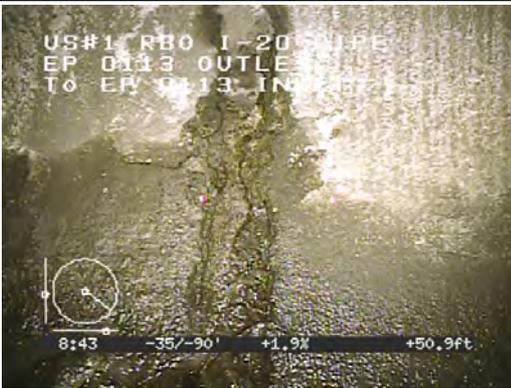
<p>US#1 RBO I-20 PIPE EP 0113 OUTLET To EP 0113 INLET</p> <p>04,04,19 -121/-82' +1.8% +50.9ft</p>
51.0	<b>Roots Fine Joint</b> <b>Position: 4 To 5</b> <b>Severity: None</b> <b>Joint</b> <b>Maint Weight: 1</b>	30:09

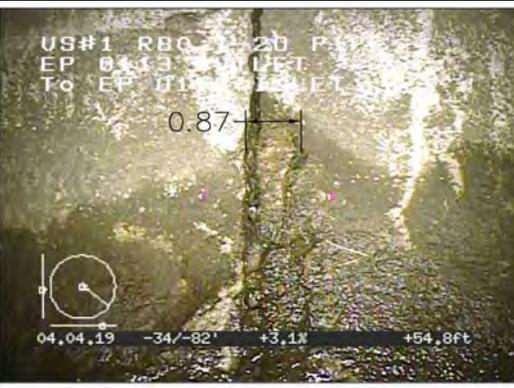
54.8	<b>Roots Fine Joint</b> <b>Position: 5</b> <b>Severity: None</b> <b>Joint</b> <b>Maint Weight: 1</b>	32:29

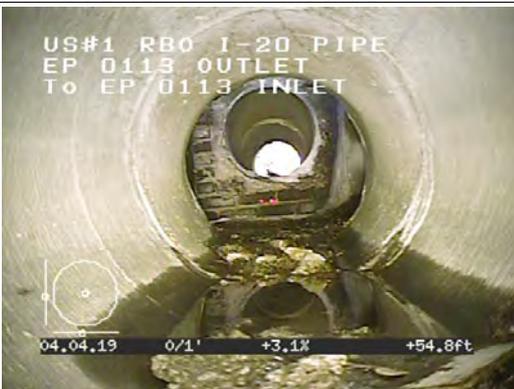
54.8	<b>Obstacle Other</b> <b>Position: 6</b> <b>Severity: None</b> <b>Percent: 10</b> <b>Remarks: DEBRIS</b> <b>IN PIPE</b> <b>Maint Weight: 2</b>	33:16

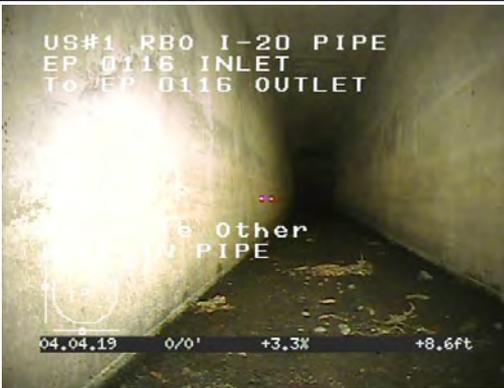
8.7	<p><b>General Observation</b>  <b>Severity: None</b>  <b>Remarks: CHANGE TO RECTANGLE CULVERT</b></p>	05:20

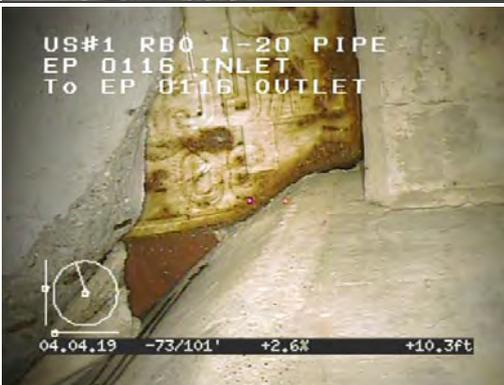
10.3	<p><b>Repair Other</b>  <b>Severity: None</b>  <b>Joint</b>  <b>Remarks: METAL USED FOR PATCH</b></p>	07:01
