**ASBESTOS & LEAD-BASED PAINT
ASSESSMENT REPORT
U.S. HIGHWAY 701 BRIDGE
REPLACEMENT PROJECT
HORRY and GEORGETOWN COUNTIES, SOUTH CAROLINA
S&ME Project No. 1611-13-009**

Reference: Asbestos and Lead-Based Paint Assessment Report
U.S. Highway 701 Bridge Replacement Project
SC File 22.124B
Horry and Georgetown Counties, South Carolina
S&ME Project No. 1611-13-009

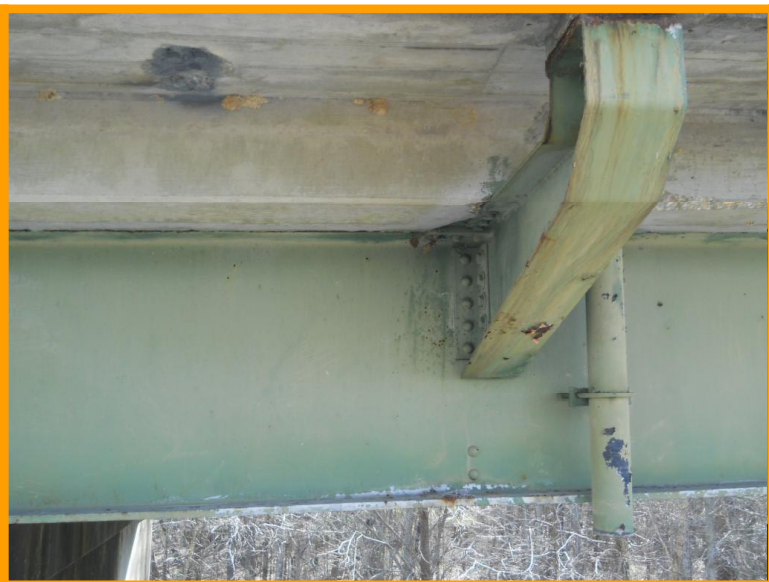
For the purpose of this assessment, painted surfaces exceeding the SCDHEC disposal limit of 0.7 mg/cm^2 are considered lead-based paint and are applicable to OSHA regulation. Based on the lead testing performed, lead concentrations applicable to SCDHEC and EPA disposal standards were identified on the yellow painted asphalt striping and the green painted beams and associated brackets.

1. Lead-based paint on support associated with a beam spanning the Great Pee Dee River.

Destructive actions (sanding, burning, demolition, component removal, paint preparation) to the lead-containing paint surfaces will require the contractor comply with the standards of SCDHEC and OSHA, including but not limited to proper disposal, initial exposure monitoring, the use of personal protective equipment, and medical surveillance. If additional painted components are discovered during demolition activities, the paint should be tested prior to any destructive actions (sanding, burning, demolition, component removal, paint preparation) or disposal.

SCDHEC Regulation 61-107.19 permits demolition materials painted with lead-based paint ($\geq 0.7 \text{ mg/cm}^2$) to be disposed in a permitted Class Two (C&D) or Class Three Subtitle D, Municipal Solid Waste (MSW) landfill. However, accumulations of paint waste (chips, dust, or flakes) from the identified areas of lead-based paint may be classified as hazardous waste, which requires disposal in a Subtitle C (hazardous waste) landfill. The hazardous waste regulations include Title 40 Code of Federal Regulations parts 260 through 272. A sample of accumulated paint waste should be collected for analysis via Toxicity Characteristic Leaching Procedure (TCLP) to determine the waste's lead content and hazardous waste characteristics.

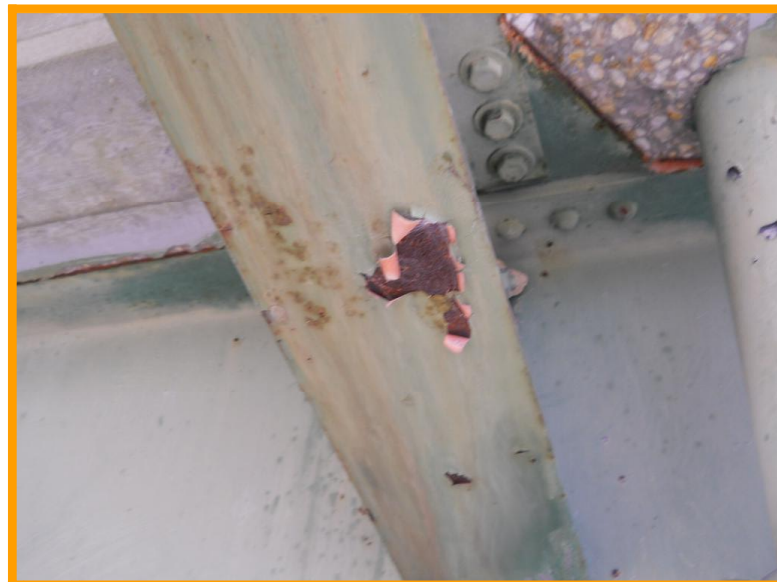
2. Lead-based paint on support associated with a beam spanning the Great Pee Dee River.

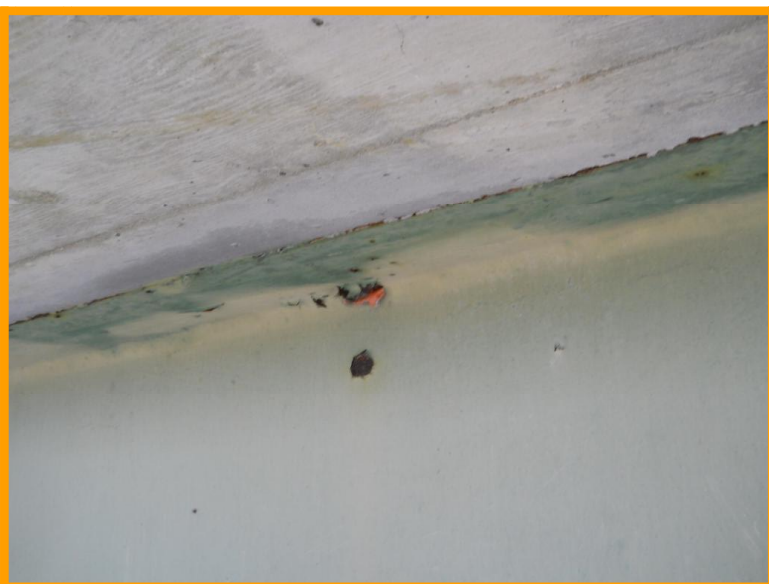
3. Lead-based paint on a beam spanning the Great Pee Dee River.

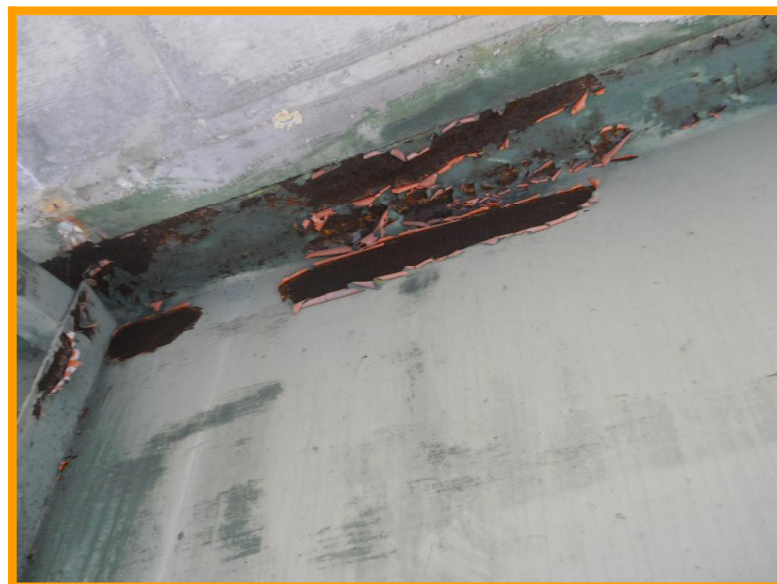
4. Lead-based paint on a beam spanning the Great Pee Dee River.
