# Asbestos & Lead Paint Survey Report

S-46-103 Bridge over Fishing Creek  
York County, South Carolina  
Bridge No. 4670010300100

September 4, 2013  
Terracon Project No. 73138128

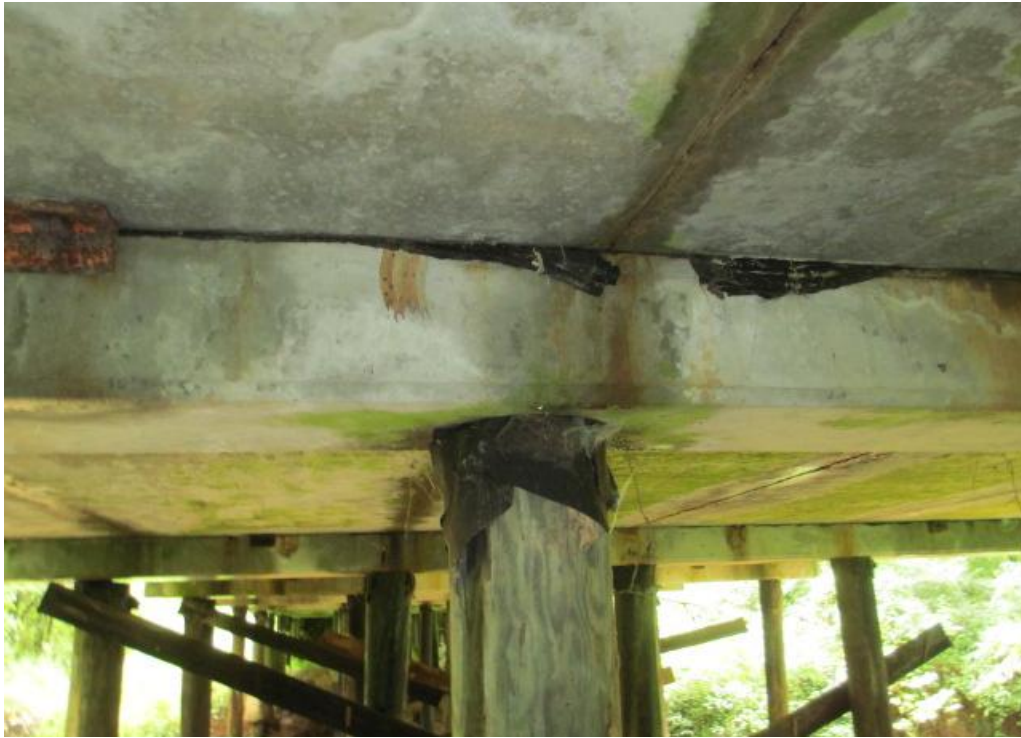
Based on the results of laboratory analyses, no asbestos was detected in the friction barrier samples collected from the bridge. These results were confirmed by TEM analysis. Asbestos laboratory analytical reports are included in Appendix B.

**Photo 3** View of thin friction barrier found between wooden piers and concrete caps and thick friction barrier found between the caps and the decking.

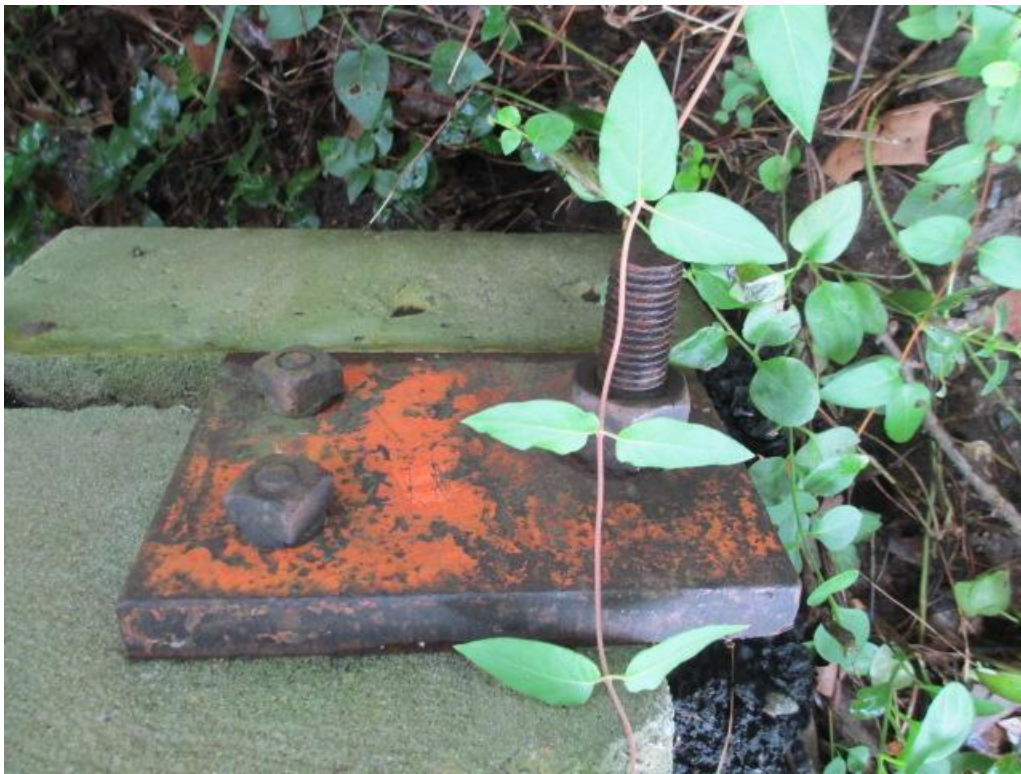
Laboratory analysis detected lead concentrations greater than 0.06% by weight. SCDHEC regulations require that lead painted demolition debris be disposed in a permitted Class II landfill. Landfills should be contacted to determine their specific disposal requirements. Metal components painted with lead-based paint may be recycled however the recycler should be contacted to determine their specific requirements. Additionally, the provisions in the OSHA Standard for Lead (29 CFR 1926.62) should be followed by contractor personnel conducting work activity during the demolition. A summary of the lead paint laboratory results is presented in Table 2 in Appendix A. The analytical report is included in Appendix B.

<b>Sample Number</b>	<b>Description</b>	<b>Location</b>	<b>Lab Result</b>
<b>LP-1</b>	<b>Orange</b>	<b>Decking Brackets</b>	<b>12%</b>

**Photo 4** View of painted orange decking brackets.
