LEAD BASED PAINT INVESTIGATION REPORT

S-41-37 (ROCKY CREEK RD.) OVER ROCKY CREEK
BRIDGE # 417003700100 (SCOPE BRIDGE # 4170003700100)
SALUDA COUNTY, SOUTH CAROLINA

May 22, 2019

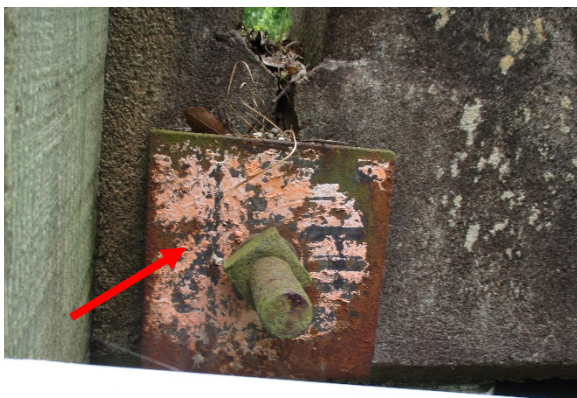
The XRF results indicate that LBP is present on the tie-rod washers located on the sides of the bridge and the L-brackets located on the underside of the bridge deck. For more information regarding the specific descriptions and locations of the items that were scanned, refer to the Appendix C – XRF Data. Also, Appendix E – Site Photographs, shows top and underside views of the bridge. Appendix D - Personnel Certification provides the LBP certifications for FME personnel.

Reading No.	PbC (mg/cm ²)	Component	Substrate	Side	Condition	Color
1	1.01	Calibrate				
2	1.01	Calibrate				
3	1.00	Calibrate				
4	11.6	Tie-rod Washer	Metal	A	Poor	Orange
5	7.87	Tie-rod Washer	Metal	C	Poor	Orange
6	35.0	L-Bracket	Metal	C	Poor	Orange
7	18.39	L-Bracket	Metal	A	Poor	Orange
8	LOD	Sleeve	Metal	C	Poor	Gray
9	LOD	Sleeve	Metal	C	Poor	Gray
10	LOD	Sleeve	Metal	C	Poor	Gray
11	0.93	Calibrate				
12	1.02	Calibrate				
13	1.00	Calibrate

Photo 5. Tie-rod Washer is Positive for Lead.

The results of this LBP investigation determined that there are lead-based paints or coatings on the tie-rod washers located on the sides of the bridge and the L-brackets located on the underside of the bridge deck. These components can either be thrown away with the general construction and demolition debris, or they can be segregated and taken to a metal recycling facility that accepts lead coated materials. No other coated or painted bridge components containing lead were found. During the bridge demolition activities, some painted surfaces may be exposed. If paint is exposed and it is determined to contain levels of lead ≥ 0.7 mg/cm², the coated/painted components will need to be handled and disposed of properly. Proper handling includes the avoidance of creating lead dust, as well

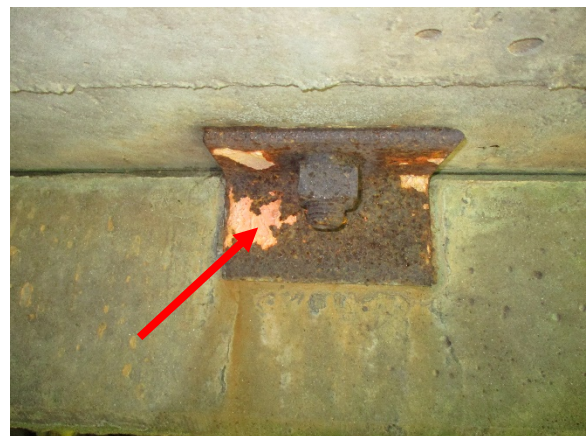
Photo 6. L-Bracket is Positive for Lead.
