ASBESTOS CONTAINING MATERIAL INVESTIGATION REPORT

S-41-78 (SHILOH RD.) BRIDGE OVER PERSIMMON CREEK
BRIDGE #417007800200 (SCOPE BRIDGE ID # 4170007800200)
SALUDA COUNTY, SOUTH CAROLINA

May 22, 2019

FME Project No.: G6100.050

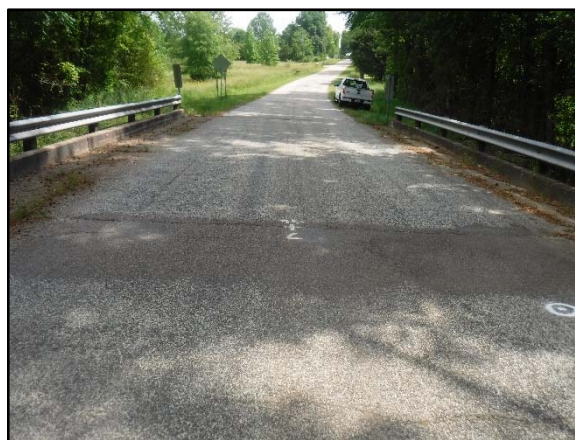
Photo 1 – S-41-78 (Shiloh Road) Bridge over Persimmon Creek, in Saluda county, SC

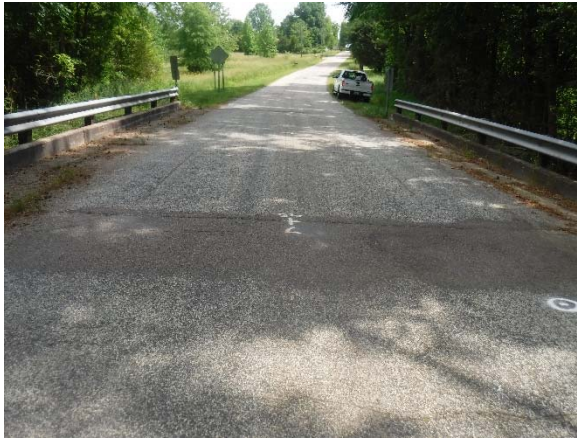
Photo 1. Top View of Bridge.

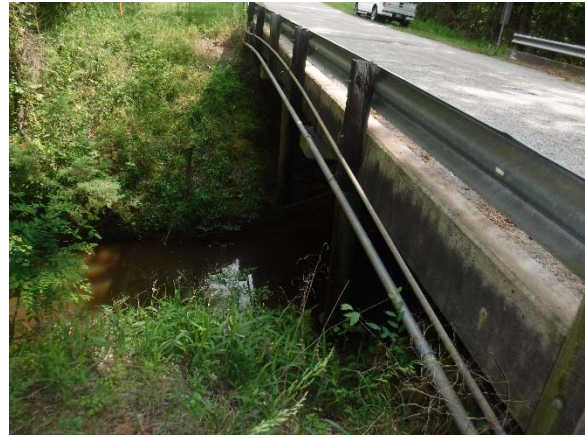
Photo 2. East Side View of Bridge.

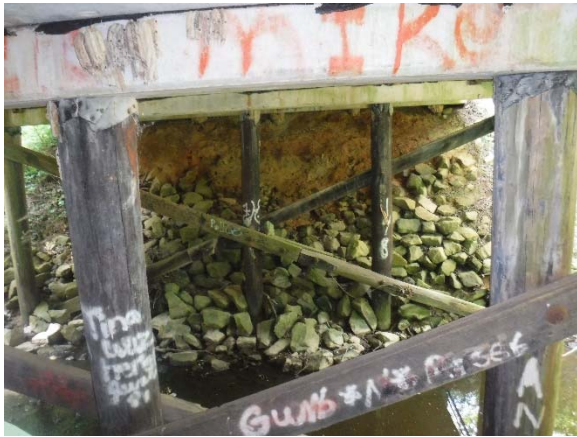
Photo 3. Underside View of Bridge

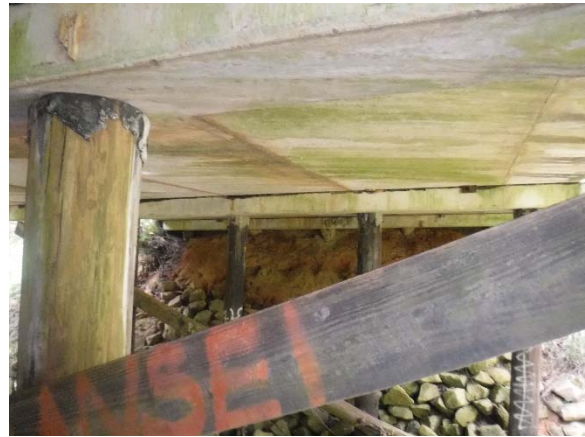
During the investigation, the timber pile cap felt, and bond break pads were the only suspect materials observed associated with the subject bridge. Three (3) random samples of each of the suspect materials were collected for laboratory analysis, and their physical characteristics were recorded. The remaining bridge materials (i.e. concrete, steel, etc.) were not considered suspect and were not sampled.

Photo 4. Timber Pile cap Felt.

It is our understanding that the existing bridge structure will be demolished. All accessible suspect materials have been sampled and analyzed by an accredited laboratory and found to contain no ACM. Therefore, there are no foreseen special handling or disposal requirements, regarding asbestos, that will be required for the demolition of this bridge.

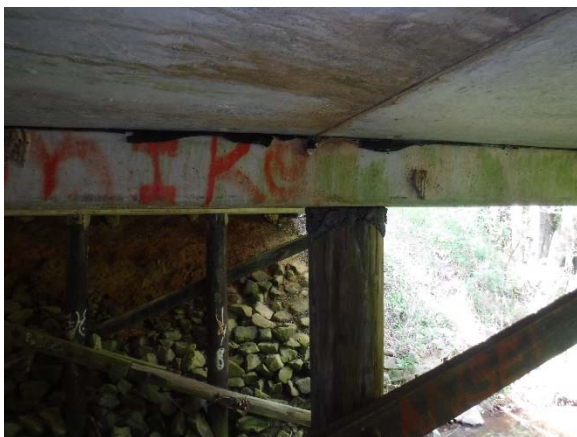
Photo 5. Bond Break Pad

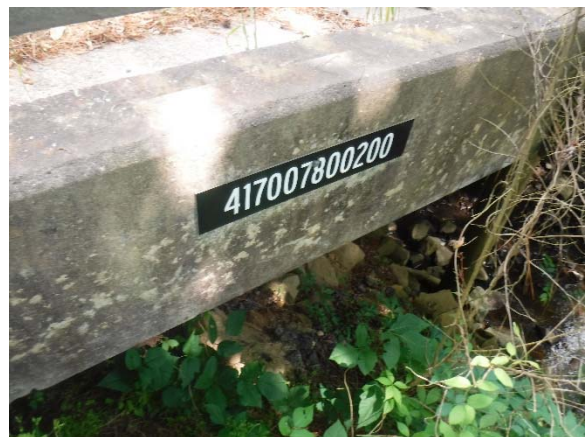
Photo 6. Bridge Identification Placard
